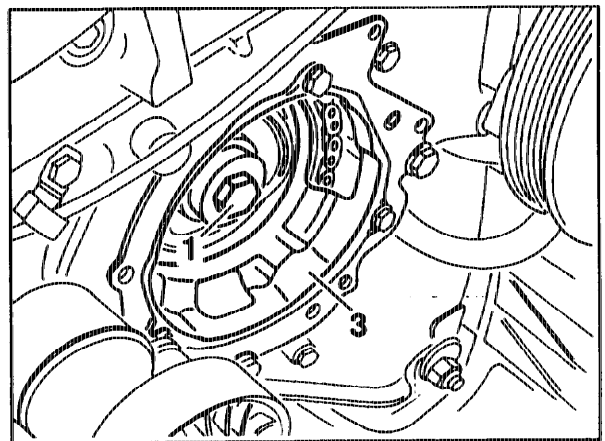
P43-2001-13

Engine cannot be switched off when cold (was SI 07.1/37 and 43/6)

Damaged piston vacuum pump (model up to May 1986).

The centering sleeve should be installed as an aid when removing the injection pump. It prevents the injection timing device jamming when cranking the engine.

If this problem exists on models manufactured prior to this date, which do not have a second drilling in the oil spray nozzle for the oil supply of the piston vacuum pump, or for performing work which requires taking off the vacuum pump, remove the centering sleeve and install in modified seal for improving the oil supply.

- 1 Remove flange shroud, fan and belt (see Repair Instructions Group 13, Op. No. 342).
- 2 Remove piston vacuum pump (see Repair Instructions Group 43, Op. No. 618).
- 3 Remove centering sleeve (3). It must no longer be installed.

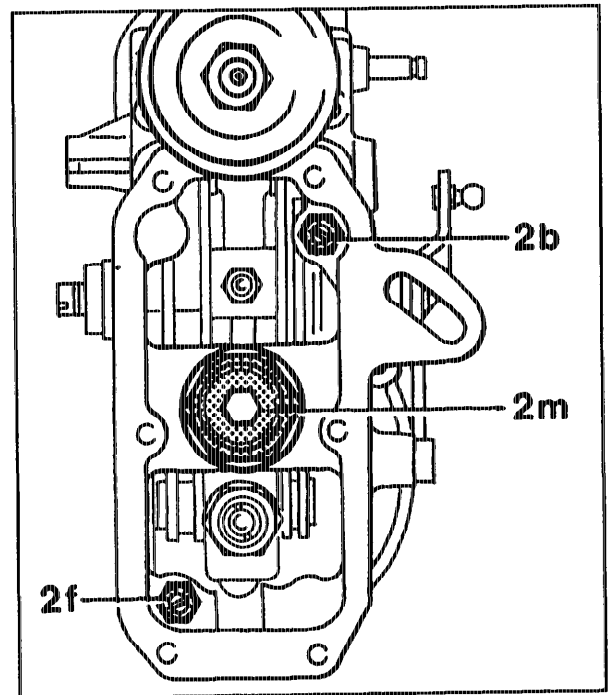
P07.11-0001-15

Poor engine output, sluggish acceleration, top speed is not reached.

8 Increase full load quantity.

a) **Engines without anti-jerk control (AJC):**

- Turn slotted screw (2f) about 1/4 turn to the
left.

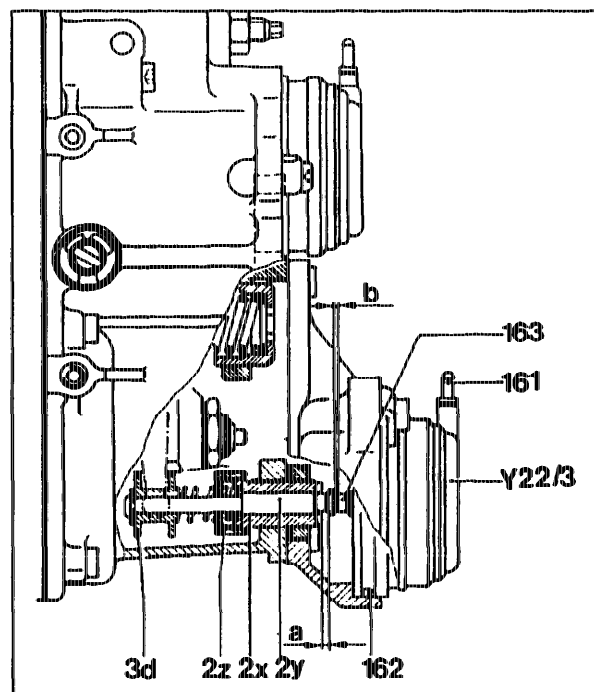
P07.11-0002-15

When inserting servomagnet, no resistance should be felt; shorten lift rod (163) of servomagnet (Y22/3) up to max. 0.3 mm if necessary.

b) Engines with anti-jerk control (AJC):

- Remove AJC servomagnet (Y22/3) and flange.

- Slacken lock nut of sliding pin (2y).
- Turn sliding pin (2y) about 1/4 turn to the left.
- Tighten lock nut of sliding pin (2y).
- Bolt on flange and insert servomagnet (Y22/3) without O-ring (162).

- Install servomagnet (Y22/3) with O-ring (162).
- Check injection pump for leaks.
