# NHTSA Investigation EA13-003 Summary of Tests and Analysis

Mercedes-Benz

# Overview W211 HDPE 80L Fuel Tank System

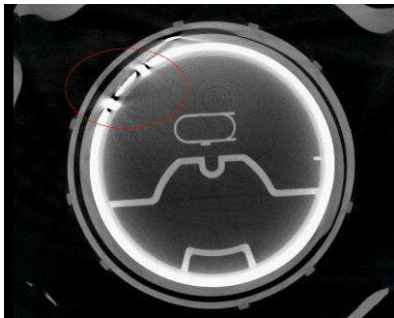
Pinched wires (CT)

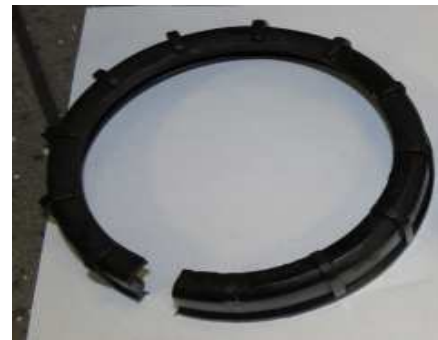
Broken ring nut,  
probably resulting  
from over-torquing

- ❑ Review indicated a number of different improper service techniques and ways these techniques can lead to leak conditions
  - Over-torquing ring nut
  - Insufficient tightening of ring nut
  - Failure to replace seal
  - Use of wrong ring nut
  - Damage to service cover port seals

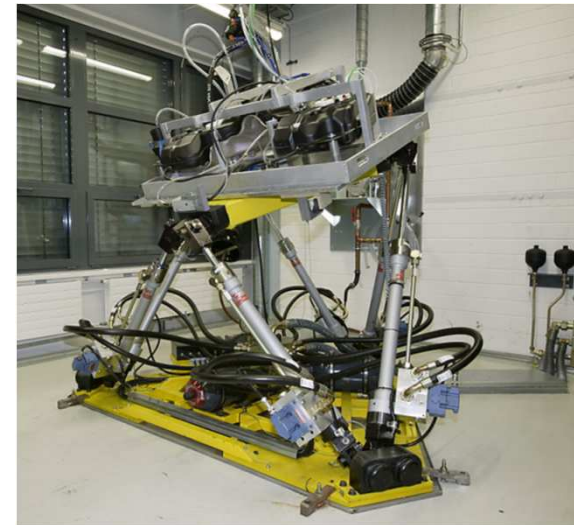
- ☐ Tanks filled with different amounts of fuel were tested
- ☐ 2 different driving cycles: city and mountain driving
- ☐ Tests show extreme conditions necessary for fuel to move out of containment well
- ☐ Additionally in real world driving situations evaporation significantly reduces accumulation

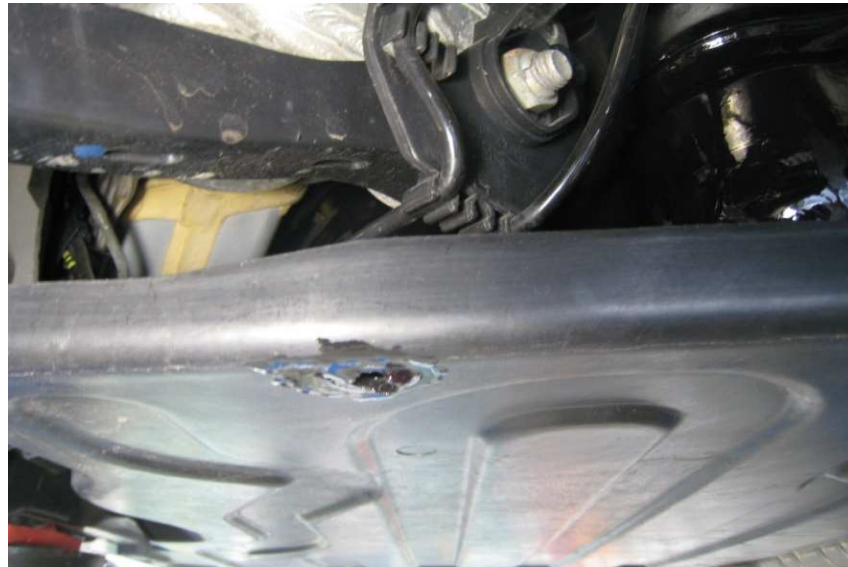
- ☐ Containment capacity of underbody cover measured
- ☐ Significant amount of liquid will be contained in underbody cover
- ☐ Liquid in cover subject to further evaporation

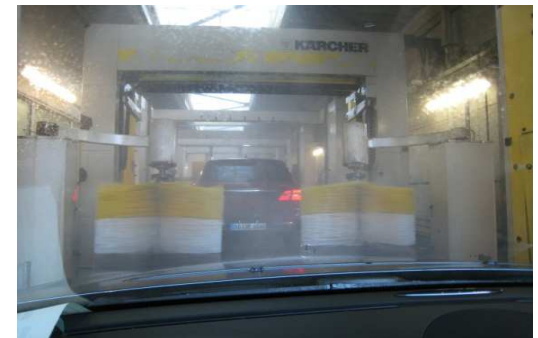
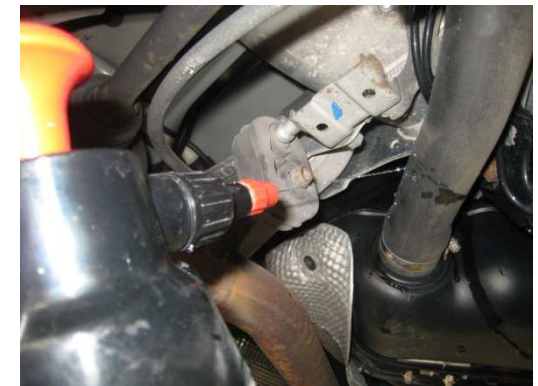
- ❑ Tests included:
  - Water-jet sprayer test
  - Car wash station test
  - High-pressure steam cleaner test
  - Heavy rain simulation test in SHED chamber
  - Vapor intrusion test in SHED chamber

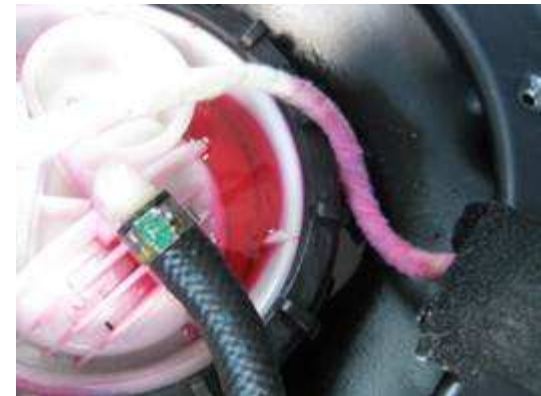
- ❑ Tests included:
  - Test of potential wicking effect of fuel along wiring harness
  - Cabin pressure differential test

- Leak proof sealing performance of cover plates confirmed, even under worst-case conditions
- No wicking of fuel up wiring harness into passenger compartment
- No pressure differential
