14 Emissions control system, intake manifold, exhaust manifold

Modification Notes Engine 103 Combustion IV KE Injection

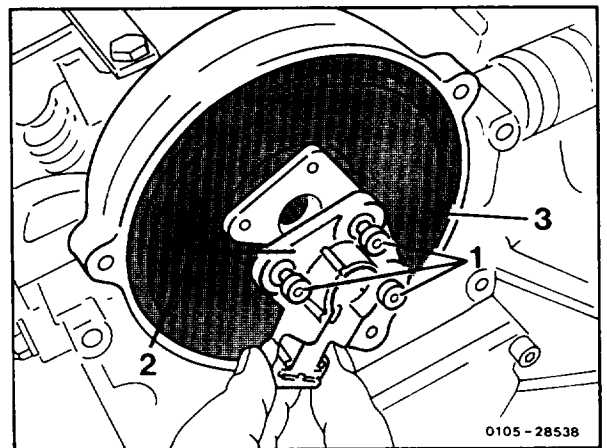
Engine cuts out when accelerating, has poor throttle response, occasionally stops

1. Ignition spark occasionally jumps to ground within distributor rotor arm.
2. No carbon in distributor cap or distributor cap scorched at carbon mount.

- 1 Securing screw
- 2 Distributor rotor arm
- 3 Sealing plate

1. Remove distributor rotor arm. If signs of scorching are visible on the flange on the rear, replace. In order as of 03/86.
2. Replace distributor cap. Production tolerances modified as of 01/86.

When removing and installing the distributor cap, it is important to ensure that the carbon does not strike the dome of the rotor arm and is damaged.

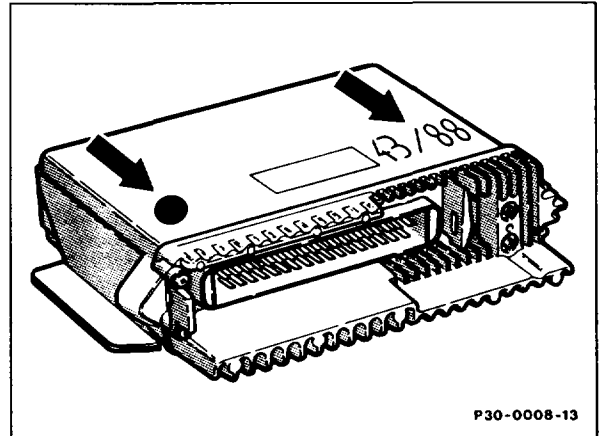
ASR indicator light comes on when driving and electronic accelerator pedal moves into emergency running mode (cannot easily be depressed after short idle travel)

1. Control unit of electronic accelerator pedal.

Check production date of control unit part no. 126 545 07 32 (see ill.).

Control units with production dates from 16/88 up to 43/88 must be replaced with a control unit as of production date 44/88 (identification: yellow dot) or by the control unit part no. 126 545 08 32 (as of August 1989) if this fault occurs.

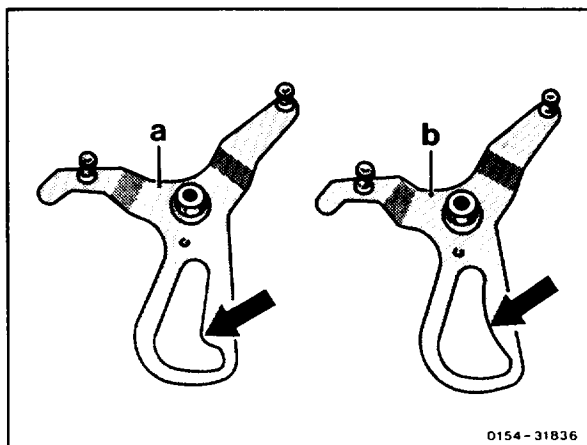
Electric cruise control: changes in speed (surging) of about 2 – 3 km/h at intervals of 3 – 4 s. This relates to the 50 – 80 km/h speed range

Shape of the fulcrum lever.

- a 1st version
- b 2nd version

Install new fulcrum lever, part no. 103 070 28 21.

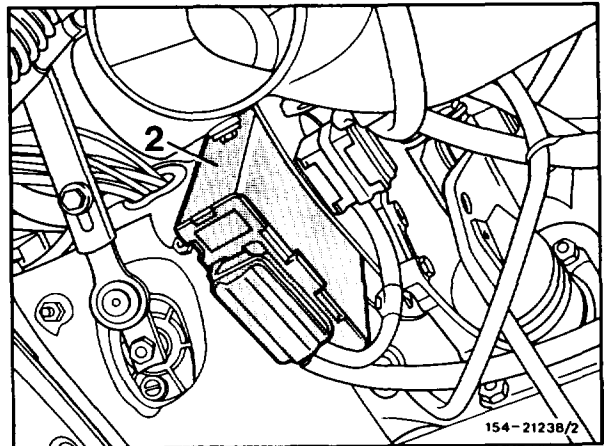
Location on model 107

Cruise control sometimes does not operate

Poor contacts at the control unit (2) as a result of the sockets widening.

Bend in sockets; ensure that the connector is correctly assigned.

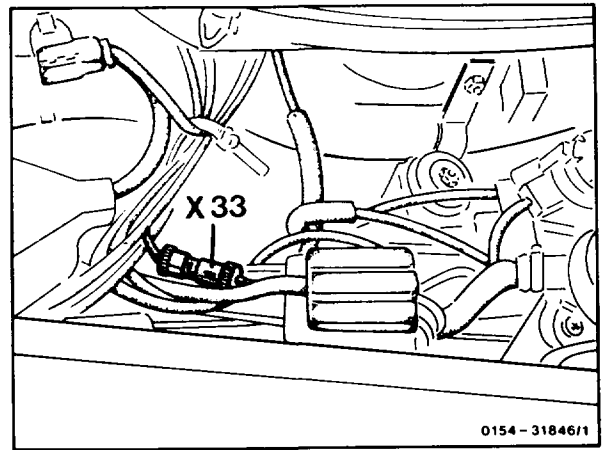
Location X33 on model 107 in area of plug connection of cruise control actuator

Decel fuel cutoff is not deactivated when cruise control operated. Can be checked by disconnecting the coupling of the decel fuel cutoff microswitch (S27/2) at the fulcrum lever. The jerking then no longer occurs.

1. Test the plug connection of the white wiring X26 (contact 11) or X33. If the plug connection X26 (contact 11) or X33 is not plugged together, the ends of the cables are at the following points:

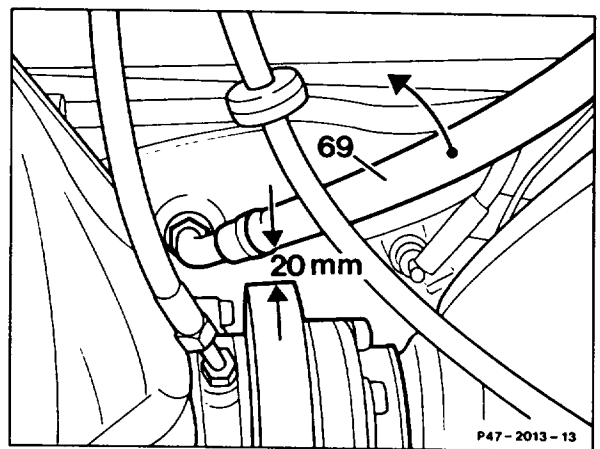
Fuel hose between fuel pump and fuel tank has chafing points

Minimum clearance of 20 mm between fuel hose (intake hose) and the inner ring mass of the left input shaft not maintained. The vehicle must be standing on its wheels ready for the road in order to check the clearance.

1. Disconnect ground cable of the battery.
2. carefully drain fuel tank (Atlas Copco delivery pump).
3. Detach fuel hose (69) at the fuel strainer, collect the remaining fuel.
4. Swivel fuel hose (69) in direction indicated by arrow until clearance of 20 mm is achieved.
Tighten bolt connection (28 Nm).
5. Fill fuel tank as specified (see above for pump).
6. Connect ground cable of battery.
7. Run engine for a short time.
8. Check fuel hose connections for leaks.

The fuel hose must be replaced if it has visible signs of chafing.

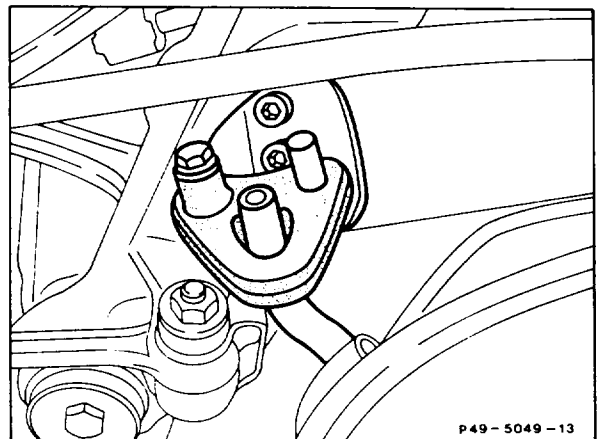
Fig. 1

Steering wheel vibration

Install modified rubber ring at center muffler on left (Fig. 1). On vehicles without KAT, install additional fixture with rubber ring to the left front muffler (Fig. 2). Attach the top bracket with the front, left bolt of the tunnel closing plate. Weld the bottom bracket to the left exhaust pipe.
