Mercedes S-Class Misfire

By Andy Cape, Cape Auto Diagnostics, Cape Town

- 1995 Mercedes W140 S-Class
- M119 V8 Engine

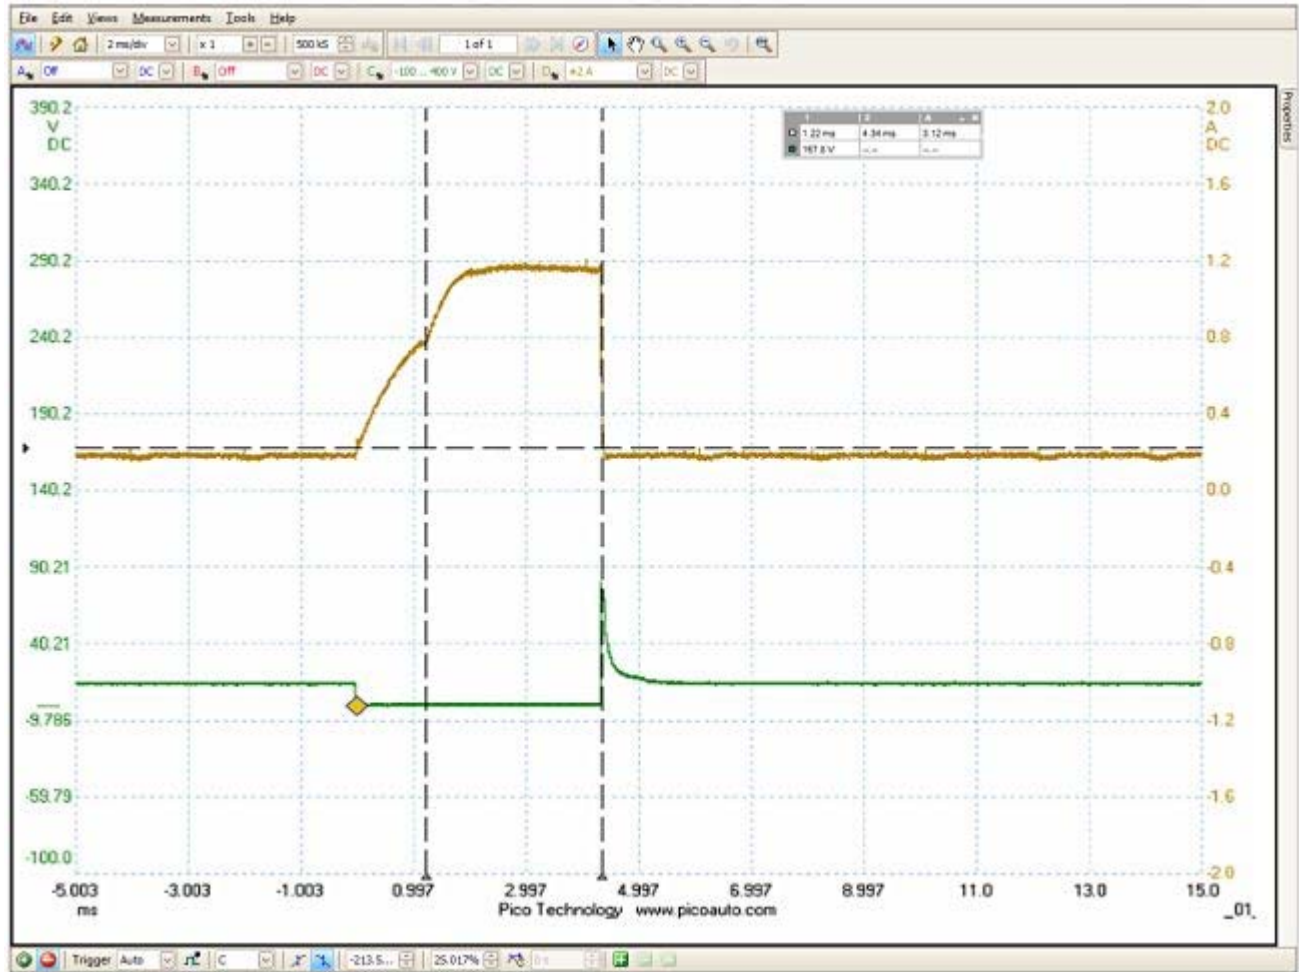
Injector 6 was double checked with the scope and was found working but unsettled. The injector open time changed quickly (± 1 ms) and in turn the engine idle speed also changed:

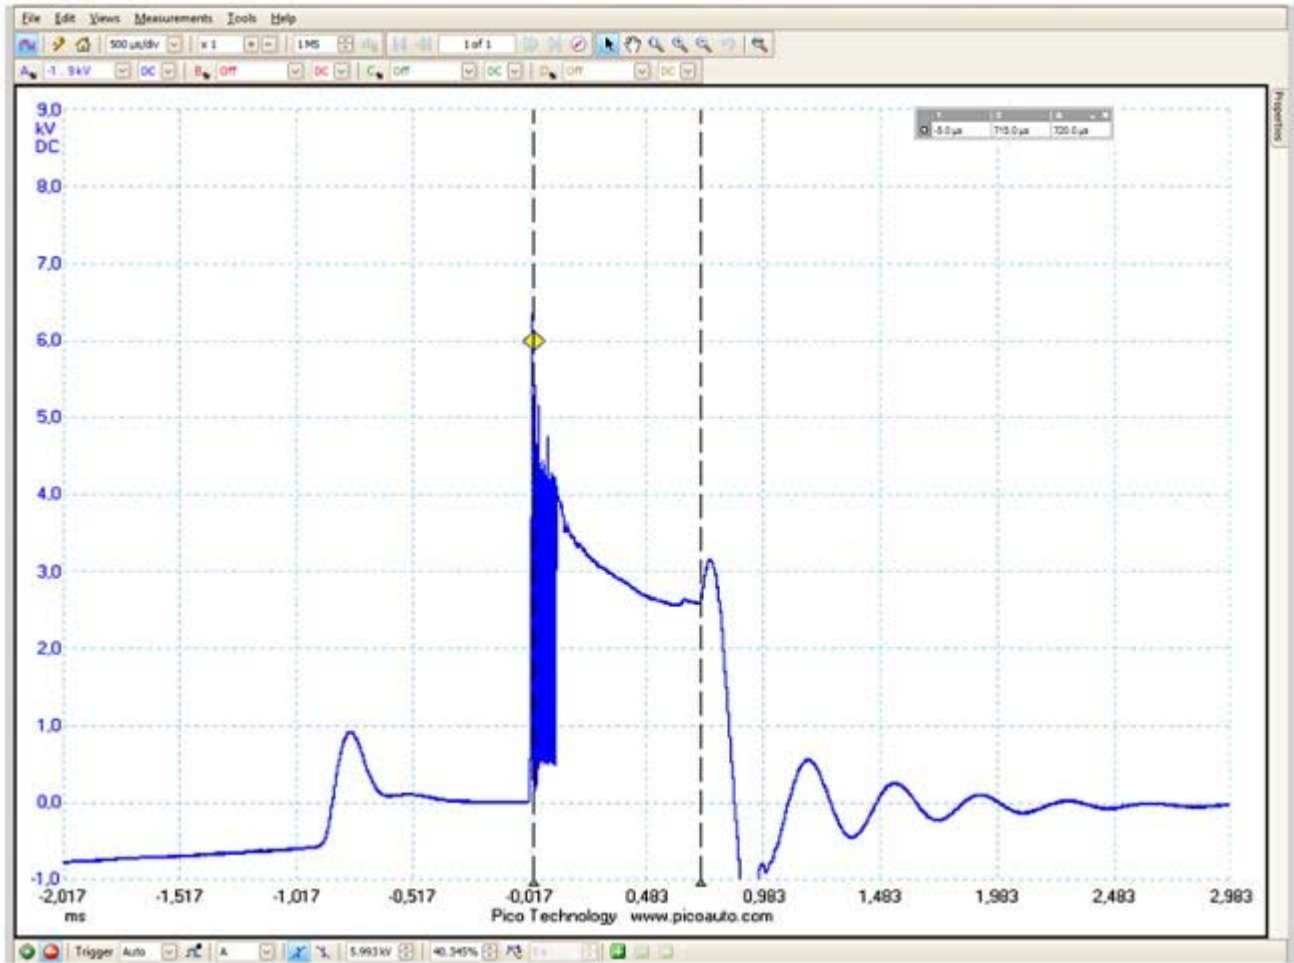
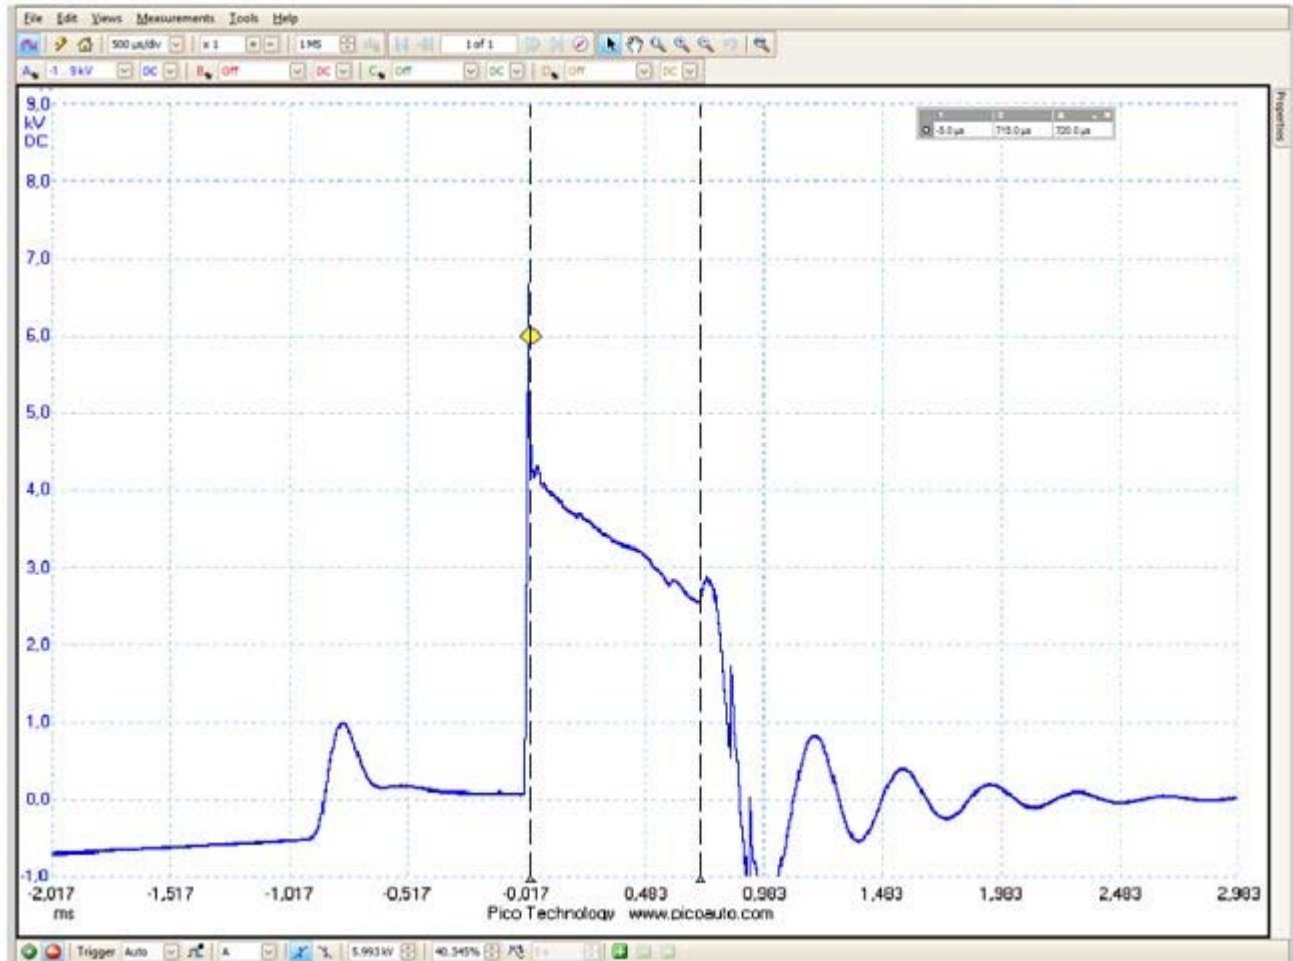
The king lead was checked and showed two typical waveforms:

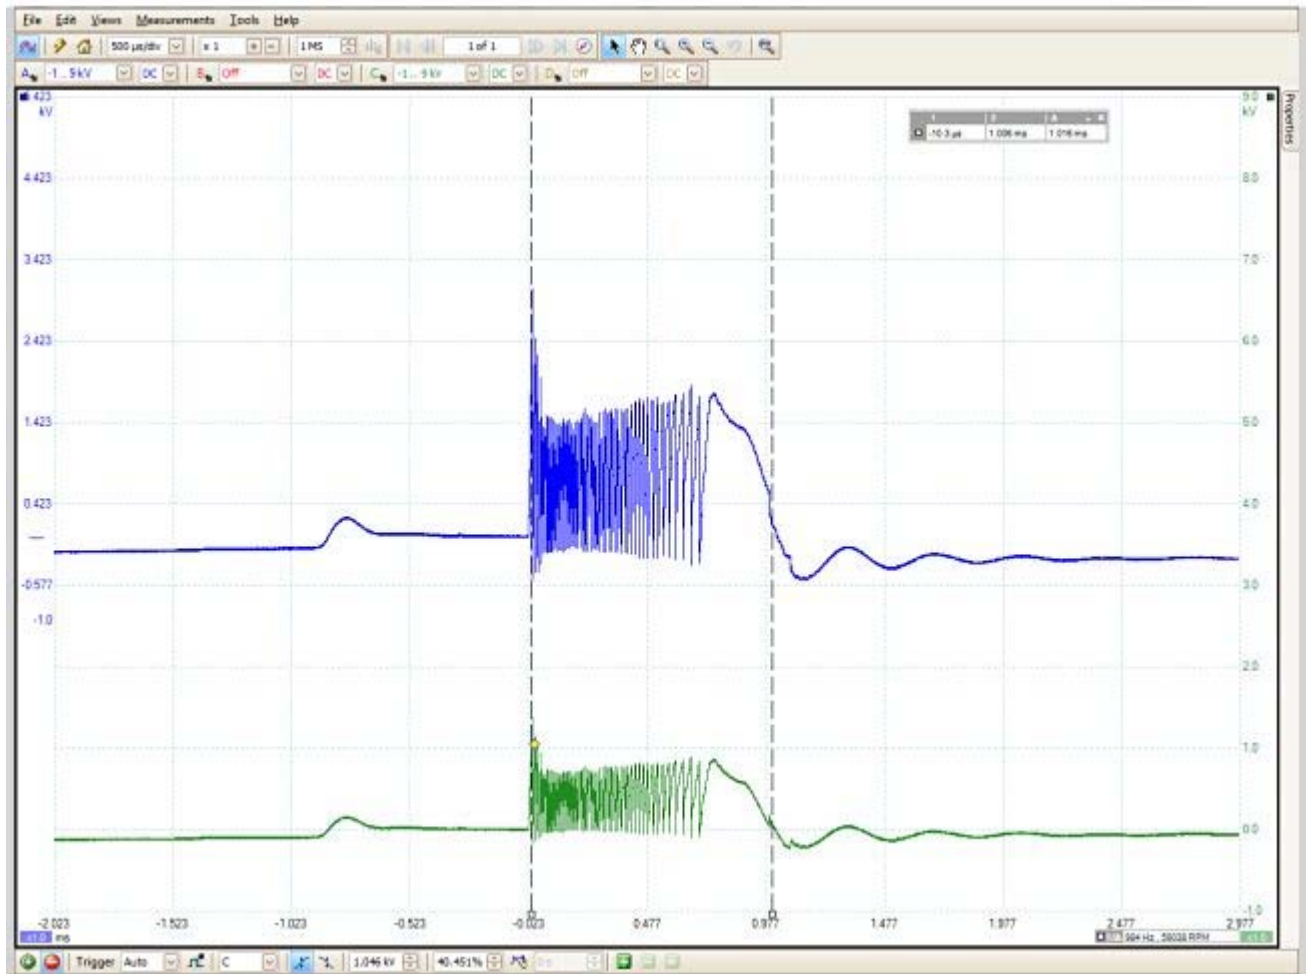
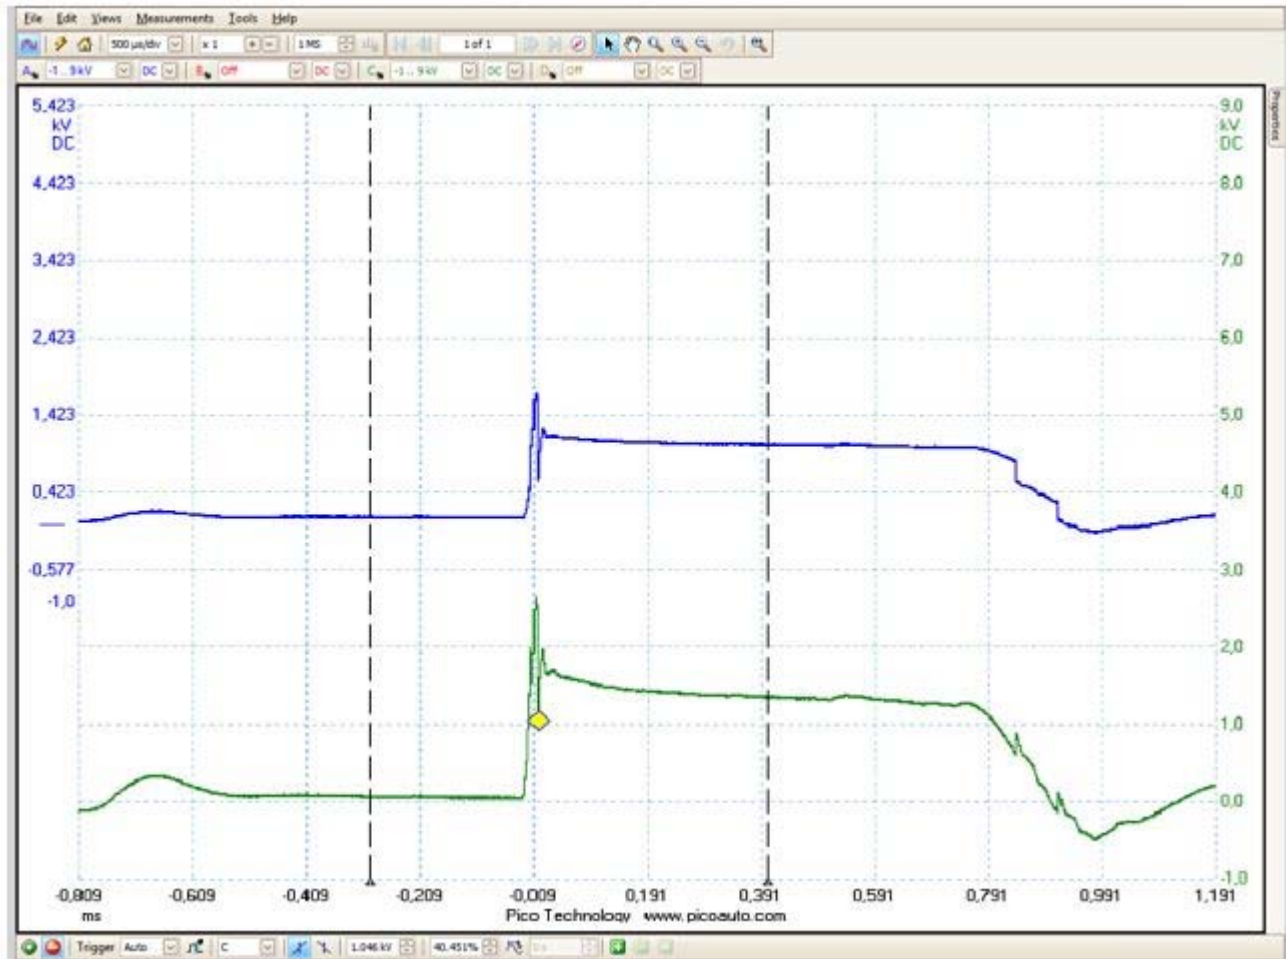
The spark plug leads were then checked at cylinders four and seven, and the kV was found too low and unstable returning waveforms such as the two below:

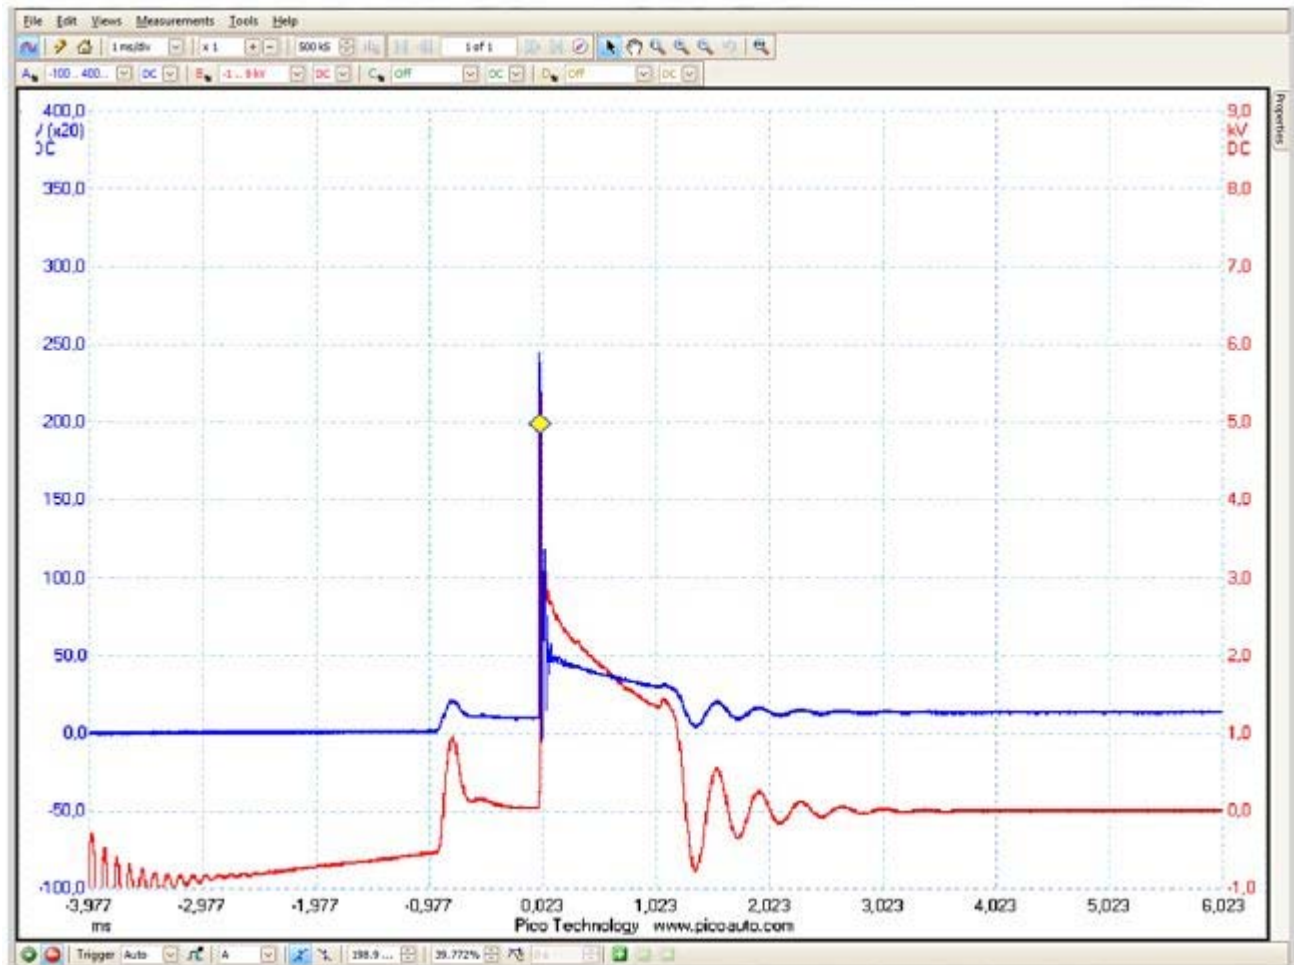
The primary ignition was measured and compared to the king lead. The primary voltage wave (Ch A) looked normal, but there were abnormal signals on the king lead (Ch B). Here is an example of a good waveform:

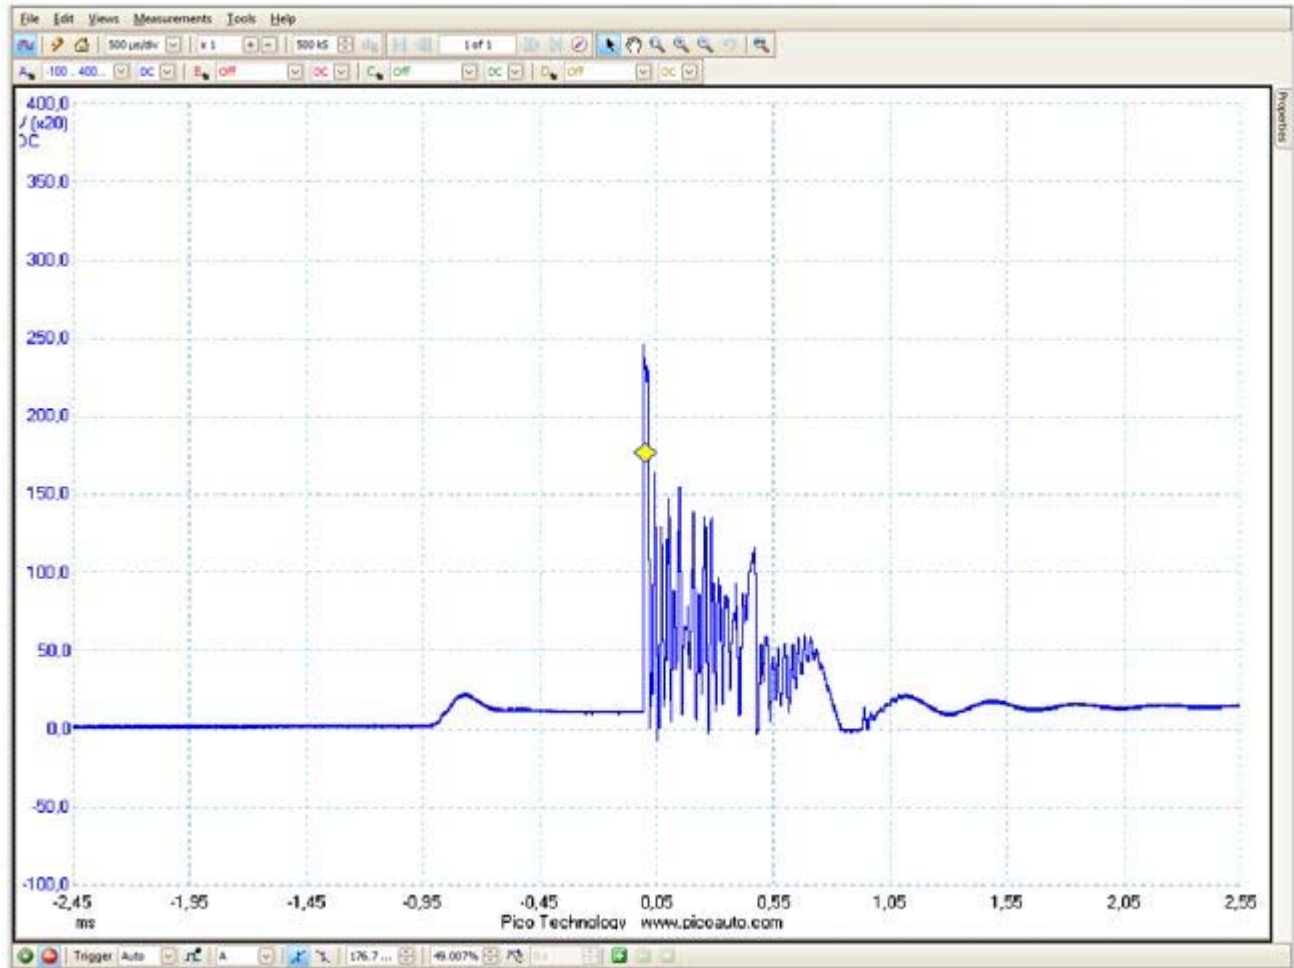
Every three or four firings the voltage was jumping in the same manner as when the secondary kV was measured at the spark plugs previously. In addition the engine was juddering in the same manner as the following unstable waveform:

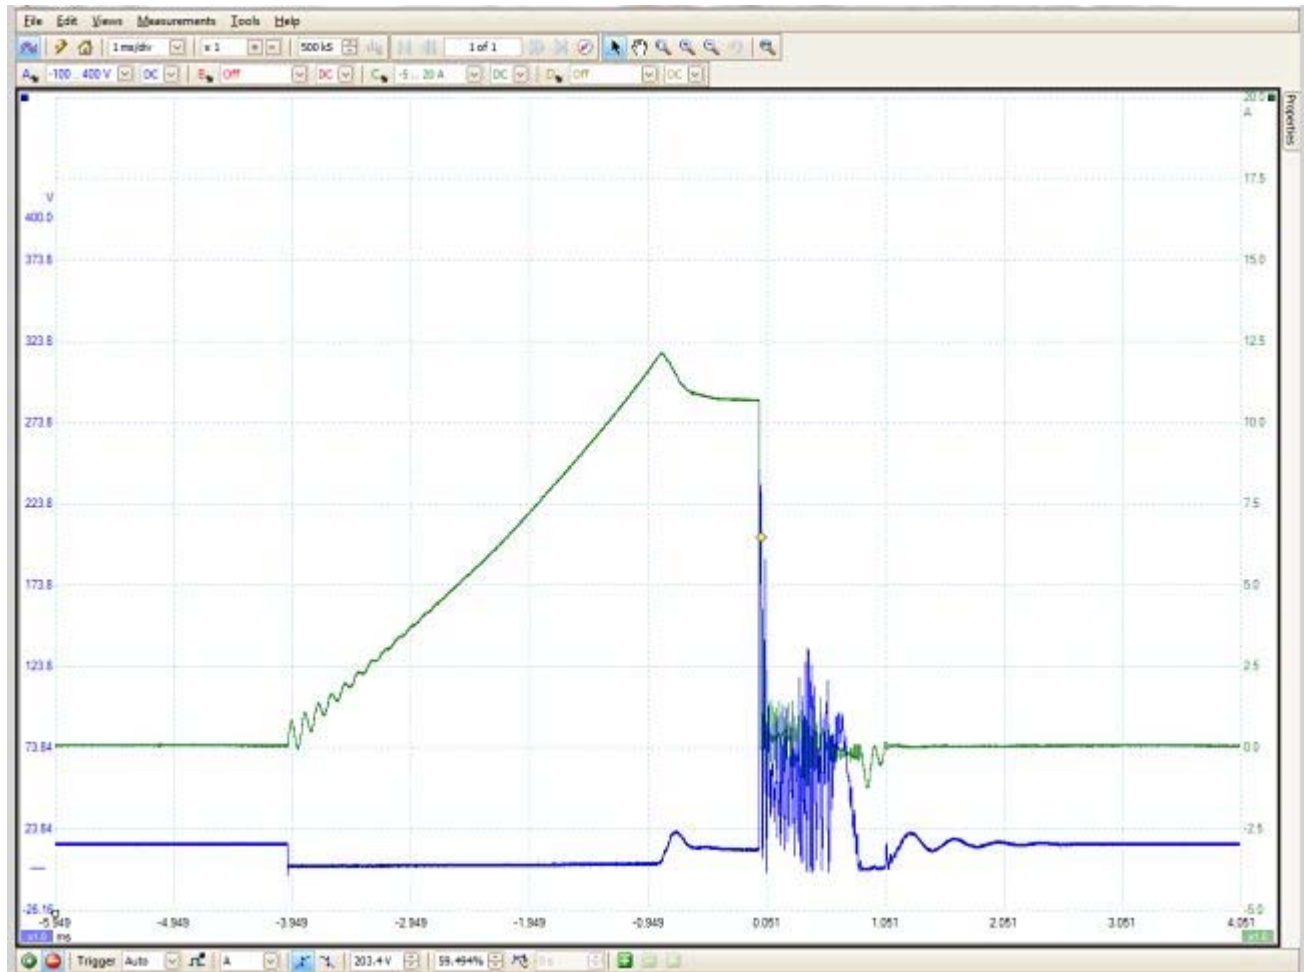
However, the primary current was showing normal signals:

The interference at the primary ignition was misleading when viewing the diagnostics results. This was proven because the temporary connection of a good coil did not change the recordings. Due to this, we moved our attention on to the distributor.

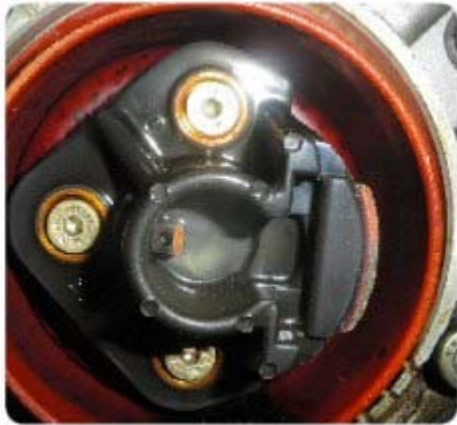
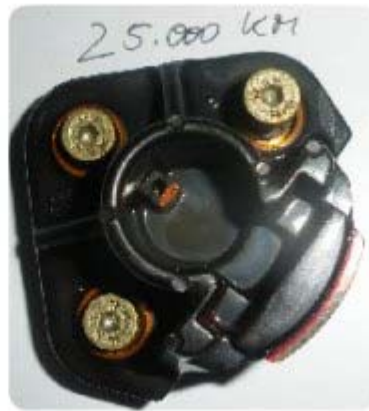
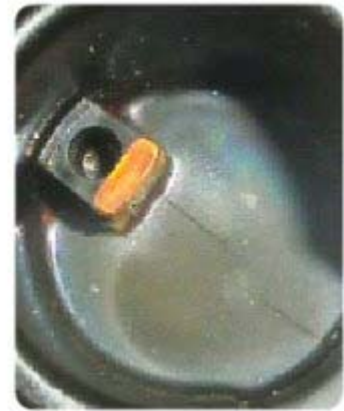
Only once the distributor was removed, was it possible to see where the high voltages had broken through on the back side and jumped against the engine block. This resulted in all energy being lost under the cap, and nothing being delivered to the plugs. The problem had started when the misfiring at idle speed was first noticed. Various small cracks in the casing, starting from the distributor centre pin, were growing in length over a short time. The distributor was later cut for investigation to identify that cause of the problem.

The high voltage shot out at the glass fibre 1 kilohm resistor and made a conical hole in the casing.

In the above left image, the distributor is shown still in place; you can clearly see the discolouration in the middle. Both the centre and right images show the micro cracks.

Once the distributor had been replaced the waveforms showed the expected signals.

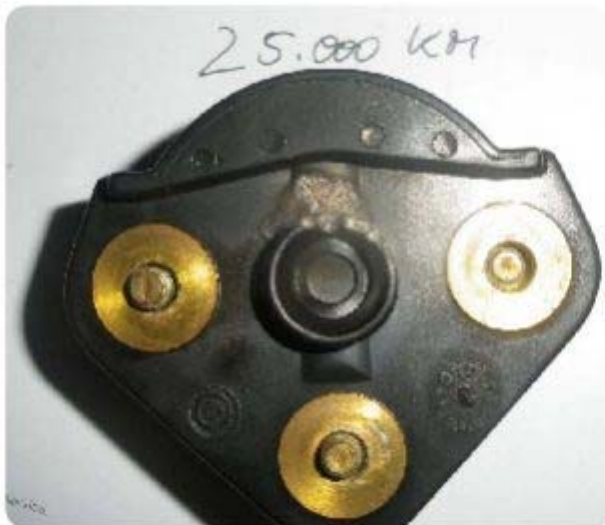
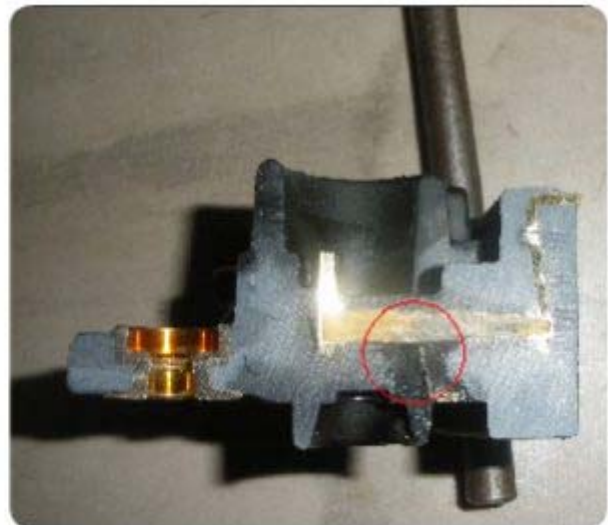
The left image below shows the rear of the distributor, revealing the outlet for the high voltage, while the right image shows the distributor cut in half, displaying the exit taken by the high voltage at the resistor.
