Vacuum pump Mercedes Benz diesel

Damage due to wear on the cam disk

Vehicle: Mercedes Benz	Product: v acuum pump
Various models from model year 1968 with diesel engine	PIERBURG No.: 7.20208.../7.20547.../7.20607...

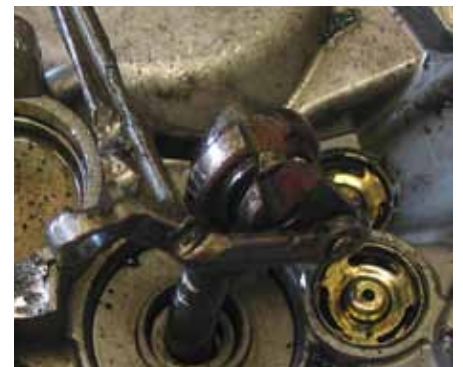
Damage: Completely destroyed cam follower
