DTB

Date: June 4, 2008
 Order No.: S-B-09.20/29
 Supersedes:
 Group: 09

SUBJECT: Model 164.122/822
Model 211.022
Model Sprinter Van
Models Equipped with Engine OM642 BlueTec Diesel

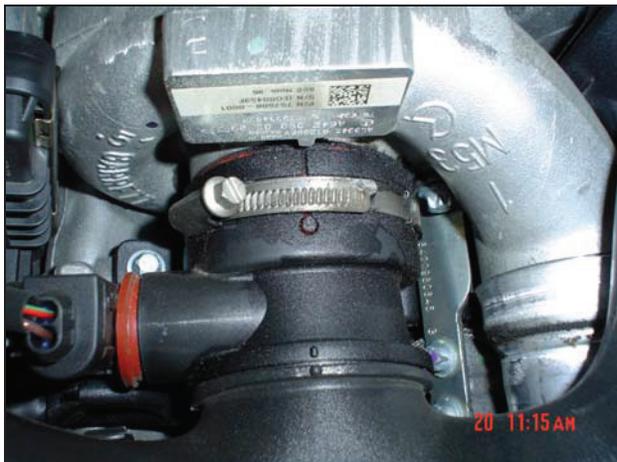
If you receive customer reports in the above model vehicles of oil leakage at the air intake duct downstream of the air filter to the turbocharger, the cause may be a damaged or incorrectly installed seal. To resolve, perform the below procedure.

Figure 1 S-B-09.20/29
 External oil leakage

1. If the seal ring between turbocharger and air intake duct is leaking (Figure 1), is damaged or has been installed incorrectly (Figure 2), the seal must be replaced.

2. Observe the installation sequence. The seal should be installed on the connection fitting (air intake) of the turbocharger and not in the intake pipe, before the pipe is installed on the turbo charger.
3. Inspect the clamp and replace if necessary. Tighten to 4 Nm.

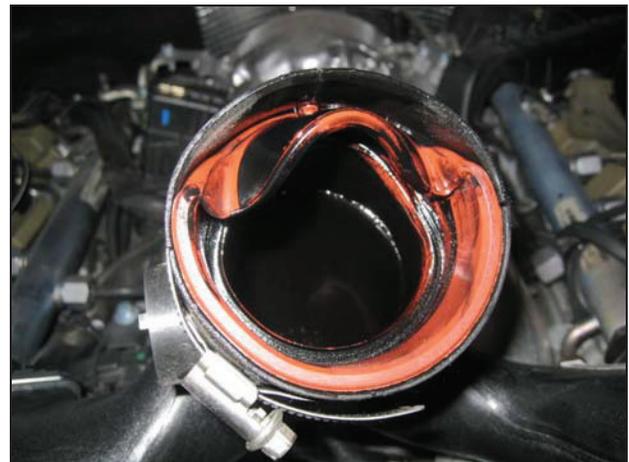
Figure 2 S-B-09.20/29
 Seal ring is crushed due to incorrect installation

This seal was not installed wrong. Every seal does this. The seals were installed at the factory. The seal is drenched with oil. The Turbo sucks in air so hard that it tries to suck in this seal. The volume of air being sucked in is also sucking oil out of the crankcase ventilation system. This can be stopped. This happens to every OM642 and OM651 BlueTec from 2007 to 2020.

In this Service Bulletin Mercedes shows us a red seal that's deformed. Mercedes says the seal was installed wrong. This seal was installed by the factory. They all deform like this because they're soaked in oil and the Turbo is sucking so much air at full throttle. To slow down the oil going into the Turbo, Mercedes has updated the Oil Separator (PCV valve) 14 times. In Europe, Mercedes redesigned the Crankcase vent system and installed a sophisticated version of the Catch Tank. Mercedes won't do that for the North American market because they would have to recall every BlueTec they've ever built. The goal is to stop the oil from leaving the crankcase. If you have a 2018 or older BlueTec, the Oil Separator is one of the first things that needs to be replaced. The older the engine, the more out dated the Oil Separator. Oil that's designed to withstand extreme temperatures, fuel dilution and soot, is the other part of the puzzle. This is also what I help owners to understand and choose an oil that's best for their situation.

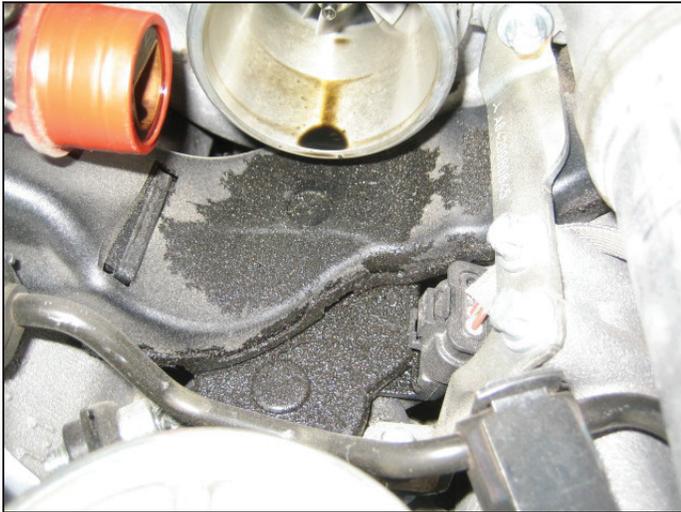
Figure 3 S-B-09.20/29

i **Note:** Engine oil venting occurs on the right hand side of the engine air intake duct. For this reason there is always **some oil** in the engine air intake duct, see (Figure 3). This is no justification for replacing the turbocharger. Turbochargers replaced for this reason will not be covered by warranty.

Mercedes is telling their mechanics this oil in the Turbo is normal. It's not normal. It's also not the Turbo's fault. Replacing the Turbo won't stop the oil. Mercedes has never fixed this problem on the North American versions of this engine. It is still a problem in 2020. There is however a way to mitigate the damage being done by this oil. The leak and the red oil seal are not the problem. The problem is the incredible amount of sludge this oil causes inside the engine. It seems impossible, but sooner or later this oil will bring the engine to a grinding halt right in the middle of the road.

Normal oil accumulation at turbocharger

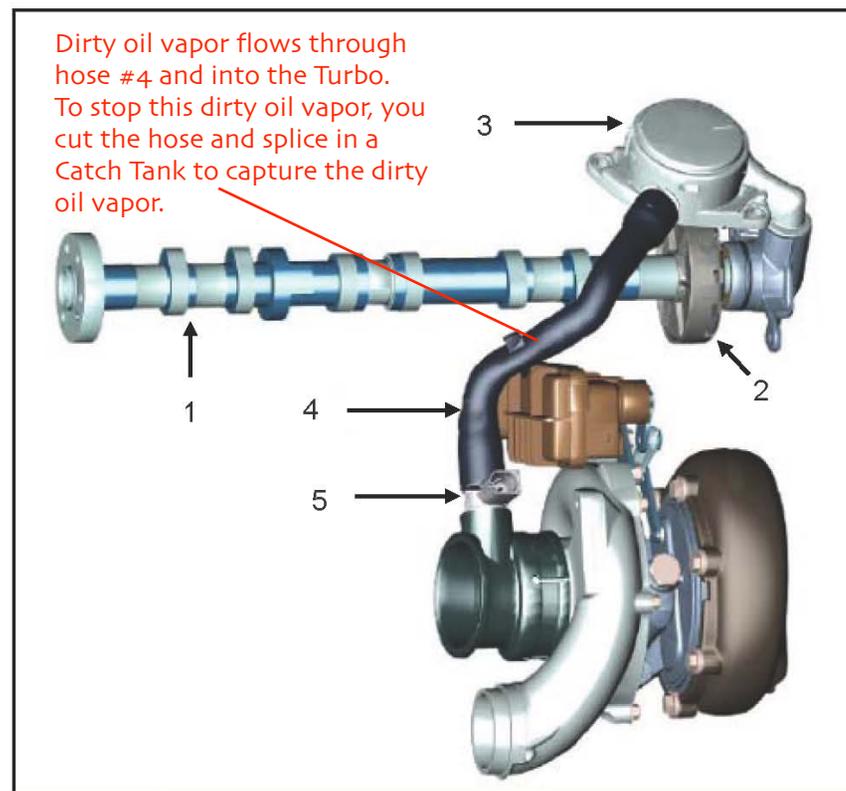
Passenger car illustration, component shape may vary

How does dirty crankcase oil vapor get into the air intake system and the EGR? This is the early OM642 engine. The later OM642 and the OM651 is slightly different but operates the same way. Dirty hot oil vapor goes through hose #4 and into the Turbo. From there the oil vapor coats the EGR, Intercooler and Intake system. It gradually keeps building into a thick sludge. Once the sludge hits a tipping point, the Check Engine lights and Limp Home never stop. Your dealer starts fixing one problem after the other. They never tell you what caused it in the first place and what you need to do to finally put a stop to endless repair bills. A Catch Tank is spliced into hose #4 and the dirty oil vapor is diverted into the Catch Tank. Clean air is returned to the Turbo. The emission system stays clean and works like it should. You can use better oil, because oil vapor is not going to the DPF. The only reason Mercedes uses low SAPS oil is because nothing is stopping it from going into the DPF. Low SAPS oil (MB229.52) can't withstand the extreme heat. They had to remove the important oil additives because they contaminate the DPF. If you use better oils and a Catch Tank, the oil never gets to the DPF.

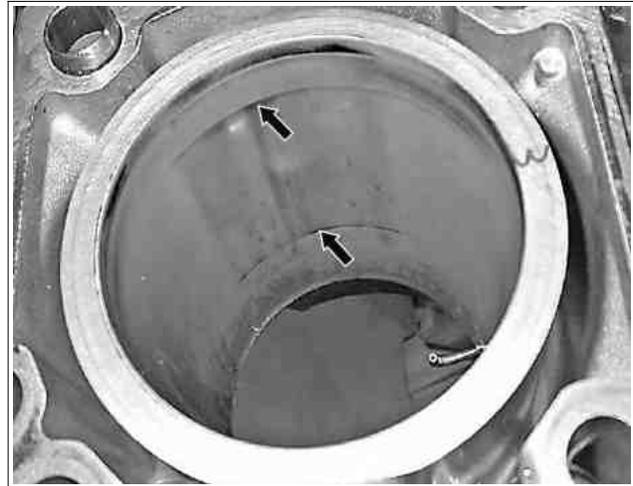
P01.40-2248-11

Ring shaped imprints

Visible in the upper and lower piston ring reversal area are not a cause for concern.

i Reuse crankcase.

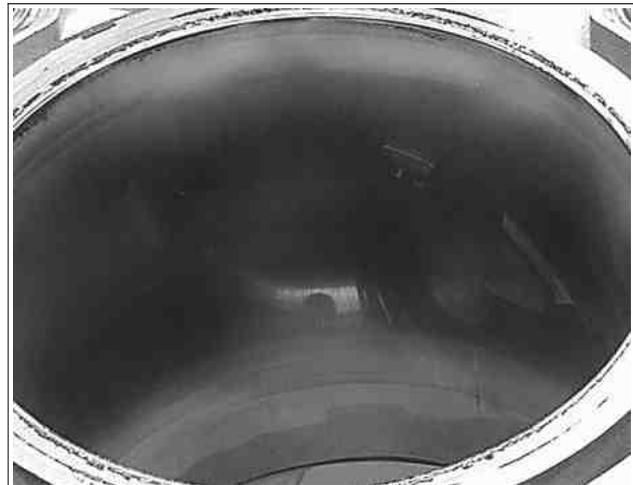
P01.40-2247-11

Brown coloring of cylinder upper surface

Brown coloration (oil varnish) over large areas of the cylinder barrel indicates that the engine has been driven at a high temperature level. This is normal and not a cause for concern.

i Reuse crankcase.

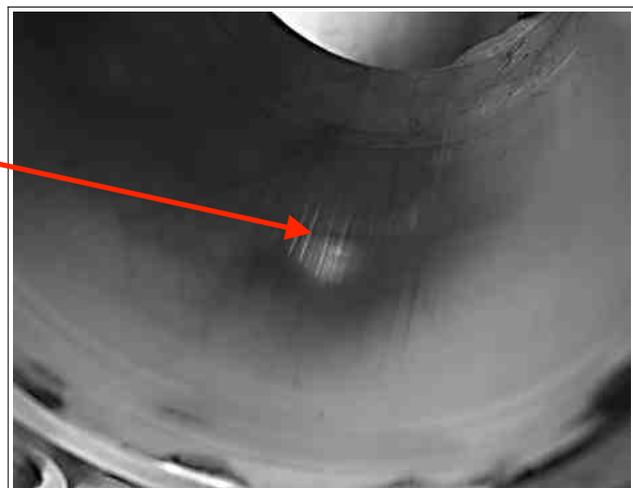
Glazing, smooth spots

Individual glazed spots, e.g. in cylinder center or in area of cylinder head bolts. Full circle impression at the upper and lower piston ring reversing points.

This is what bore polishing looks like in a BlueTec diesel. It was caused by the friction modifiers in Mobil One 5W/30 ESP. Blow-by and excessive crankcase pressure occurs where you see the glazing. In a gas engine, this is bad, but not the end of the world. However, when a BlueTec diesel regenerates the DPF, this glazing allows diesel fuel to enter the crankcase. Soot in the diesel fuel gets into the oil and causes the glazing to worsen. To remove this glazing, you need to use motor oil without the fuel efficiency friction modifiers. Motorcycle oil doesn't have the friction modifiers that cause the glazing. Over time, motorcycle oil will gradually clean off the glazing and return the cylinder walls to their normal look.

Glazed cylinder walls are also caused by excessive idling or slow stop and go city driving. The piston rings are designed so higher RPM's creates more combustion gas that pushes the piston rings tight against the cylinder walls.

i Reuse crankcase but monitor oil Blow-by.

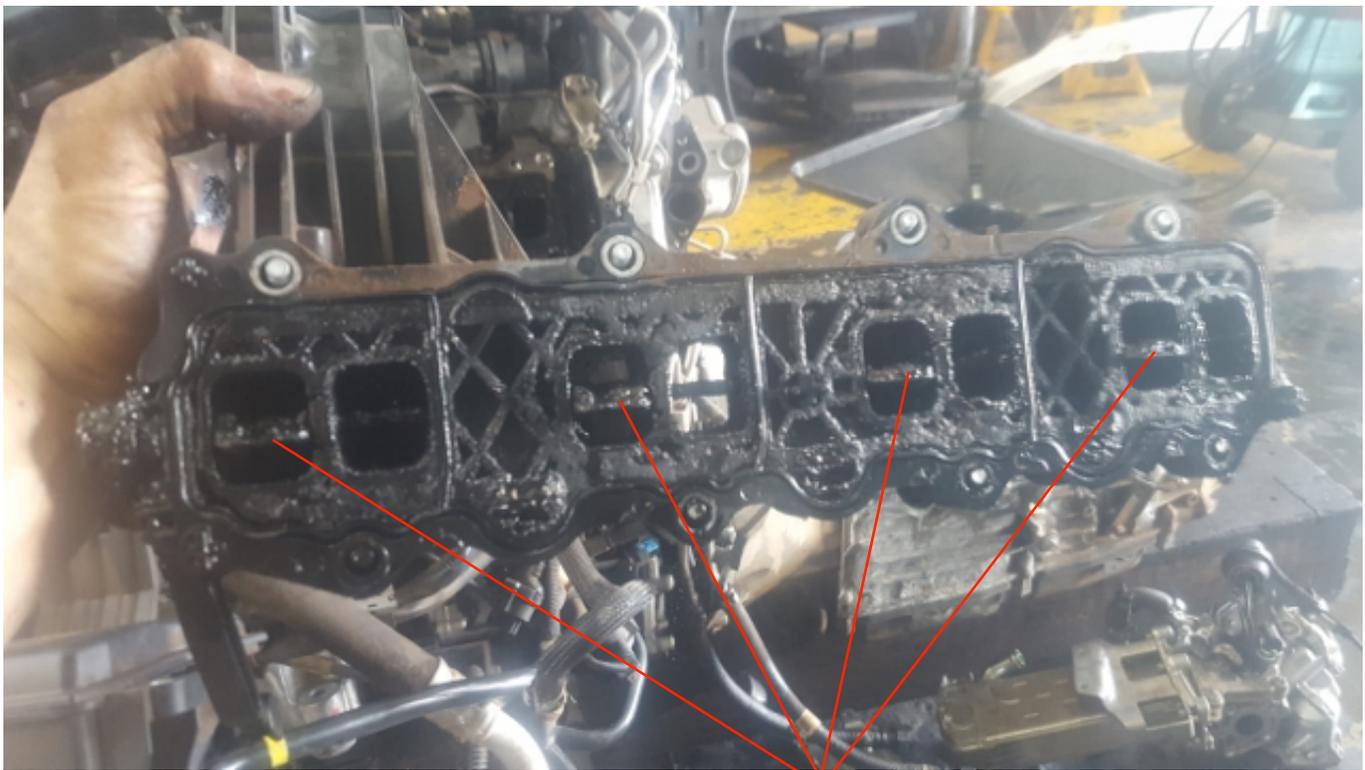
Movable Flaps

These are dirty Swirl Flaps from a OM642 V6 diesel. There are two sets of these flaps. They're also the Intake Manifolds. This is about average for 60,000 miles. The metal butterfly flaps in the manifold are always moving. They are attached to plastic linkage and an actuator motor (M55). As the sludge builds up, the flaps begin to bind-up and the plastic linkage breaks. Heaven help you if a flap breaks off and is sucked into the engine.

When the Plastic linkage breaks the engine goes into the Limp Home mode (A loss of power. Fault Code: P126A00). Then you're forced to remove the flaps and replace the plastic linkage with an updated metal linkage kit. It cost about \$3000 to fix just this mess. The rest of the intake system is also coated with this same oil sludge. The EGR Valve and the EGR Cooler are also filled with the same sludge.

Whenever you see any of these failures, they are a sign the exhaust temperatures are to hot and the engine is full of sludge. Once the engine is cleaned up, installing a Catch Tank will prevent the Swirl Flaps and the rest of the engine from getting like this again.

There is now a new cleaning machine with adapters specifically for the OM642 and OM651 diesel. Any shop that has the equipment can clean all of this sludge without taking half the engine apart. You can preemptively clean this mess up, or wait until the repair bills force you to clean it up. If you clean out the Swirl Flaps before the sludge breaks the plastic linkage, you'll save yourself a major repair bill. The plastic linkage would last the life of the engine if it didn't have to fight this sludge. The problem is, most dealers and repair shops don't have the equipment. They make more money taking everything apart. Not only does cleaning this mess save you the cost of the Swirl Flaps, but the EGR and EGR Cooler will cost \$3000 or \$4000 to repair. When the EGR Cooler becomes clogged with sludge (Fault Code: 170400, P2428 or P2429), it causes the exhaust temperature to exceed the limits for the SCR system. The SCR Catalytic Converter and NOx sensors fail because the clogged EGR Cooler can't cool the exhaust properly. These cost \$4000 to \$5000. Owners also notice exhaust fumes in the vehicle. The exhaust system gets so hot the welds crack. The excessive exhaust temperatures also cause the engine oil to "coke" at the Piston Rings. The Piston Rings get so full of burnt oil the engine uses oil. That causes the DPF to clog with oil sludge. The SCR Catalytic Converter gets so hot that it self destructs (Fault Code: P126A00). The Turbocharger is "exhaust driven", and it will also get so hot the bearings fail and the Impeller blades start to wobble and hit the Turbo housing. In 2015, Garrett and Mercedes upgraded the Turbocharger to a "Sever Duty", which has a thicker housing to withstand the extreme heat. This same sludge has filled the Intercooler and it can no longer cool the air going into the combustion chamber. This causes the exhaust temperatures to climb even higher. Eventually the exhaust temperatures climb so high the engine oil breaks down and the Crankshaft Bearings fail. The engine locks up while driving. It will gradually loose power until it stops running.

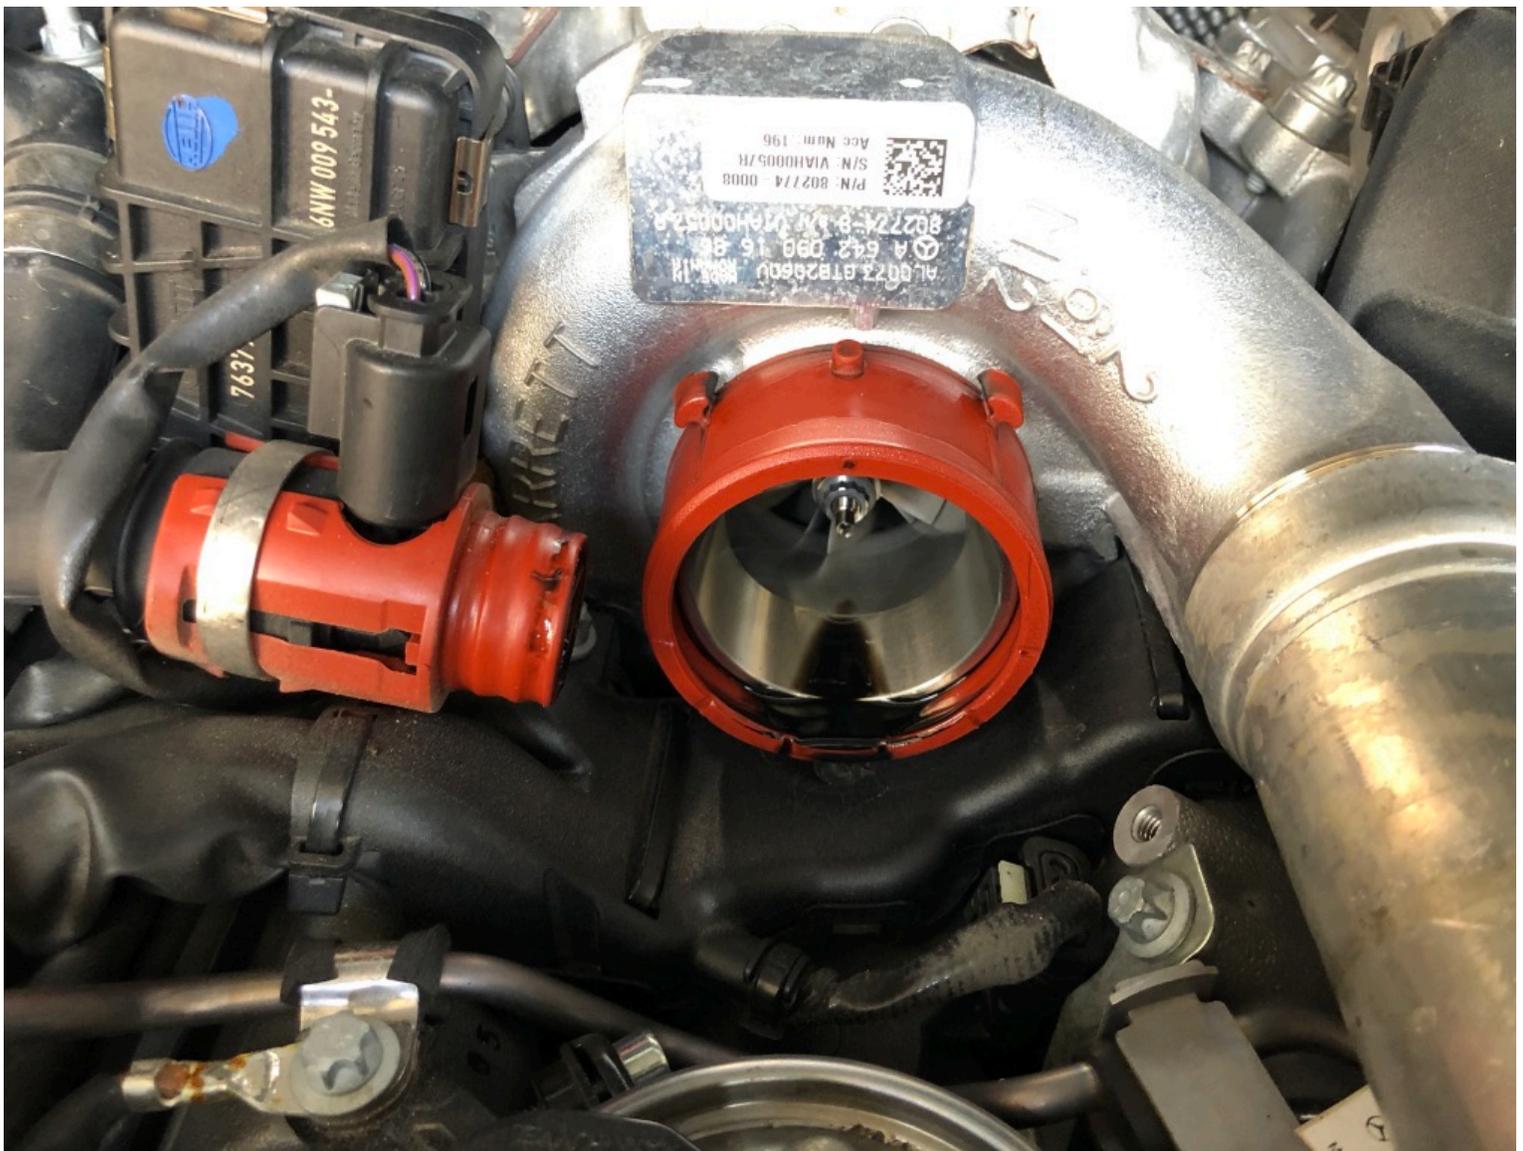
This was sent to me by an owner. This is a Factory rebuilt OM642 BlueTec diesel with 6,000 miles. The original engine locked up at 84,000 miles. All of the maintenance service was done by the same dealer. The dealer replaced the engine but did not clean the Intercooler. The dirty Intercooler is driving up the combustion temperatures so high that the oil is vaporizing and going into the Turbo. This is also the factory Mobil One 5W/30 ESP oil. The owner suspected something was wrong because he got a message the oil level was too high. No one had added oil since the new engine was installed. The dealer also did not update the ECU software or send the ECU to Germany for the factory rebuild program. The ECU dumps too much fuel during regeneration of the DPF. The dealer also failed to update the DPF "Differential Pressure Sensor". This owner drives long trips of over 300 miles per day. No stop and go driving. He also drives in a mild climate. If you don't understand this engine and know what maintenance your dealer should actually be doing, you'll pay dearly for trusting someone else.

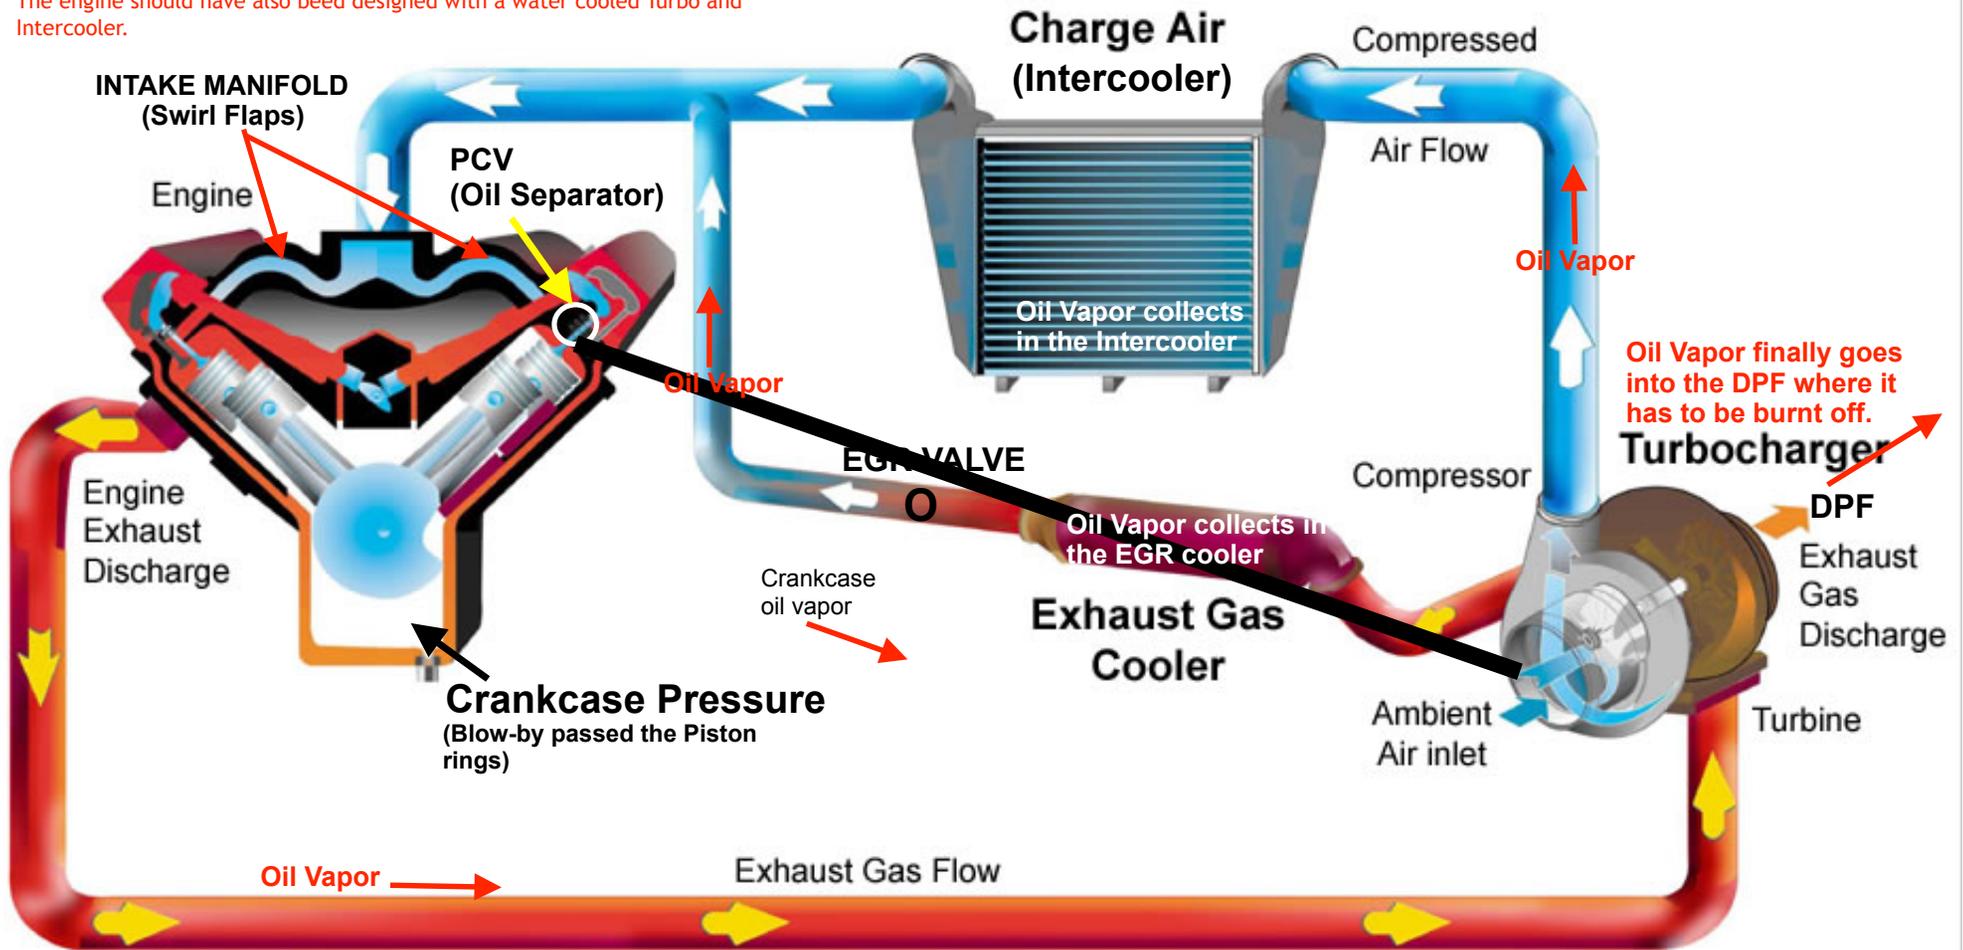
Crankcase oil vapor cannot be vented into the atmosphere. Crankcase oil vapor must flow from the PCV valve into the Turbocharger, where the engine tries to burn the oil vapor in the combustion process. As the oil vapor goes through the Turbo it goes into the Intercooler. From there the oil vapor flows through the Intake Manifold and EGR valve. Then the oil vapor goes into the EGR cooler and out the DPF. As the oil vapor flows through the system, it deposits oil sludge onto everything it touches. As the sludge builds over time, it restricts the air intake cooling. Combustion temperatures get so hot the Piston Rings become packed with burnt oil and finally can't move. The engine starts burning more oil and the cycle becomes even worse. The engine finally locks-up because the oil is so hot it blocks the flow to the crankshaft. When the DPF is contaminated with so much sludge it's a early warning that the engine is close to failing.

Poor quality oil breaks down at the hot piston rings. This causes the Blow-by to increase.

Installing a Catch Tank diverts the oil vapor going into the Turbo and sends it to the Catch Tank. Only clean air is sent to the Turbo. No more oil vapor can build up inside the EGR and Intake system. The DPF stays clean and the emission system works as it was designed.
