7G-TRONIC (722.9) in the Workshop Tips and Tricks

Service Information Brochure

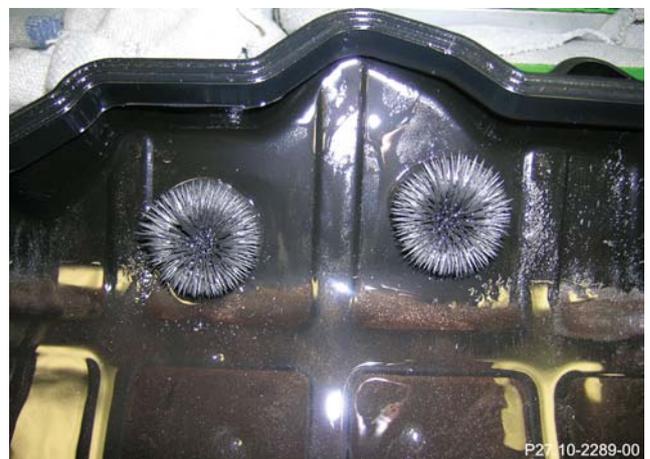
If there is a significant amount of wear debris in the transmission oil pan (see picture), it must be assumed that the torque converter lockup clutch is already seriously damaged.

Oil pan with significant wear debris

In this case, it is recommended that the entire transmission including torque converter be replaced because the shavings will have spread out within the transmission. In addition, the oil cooler must be flushed. If an additional oil cooler with thermostat is installed, this must also be replaced because it cannot be flushed (thermostat does not open until temperature of approx. 85 °C is reached).

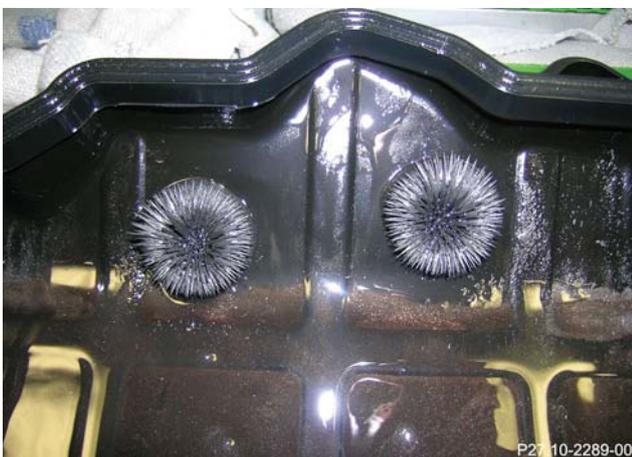
If the above-specified fault codes occur in combination with significant wear debris, there is mechanical damage inside the transmission or torque converter. In this case, the transmission and torque converter must be replaced and the oil cooler must be flushed as per the current documentation. If an additional oil cooler with thermostat is installed, this must also be replaced because it cannot be flushed (thermostat does not open until temperature of approx. 85 °C is reached).

Oil pan with significant wear debris

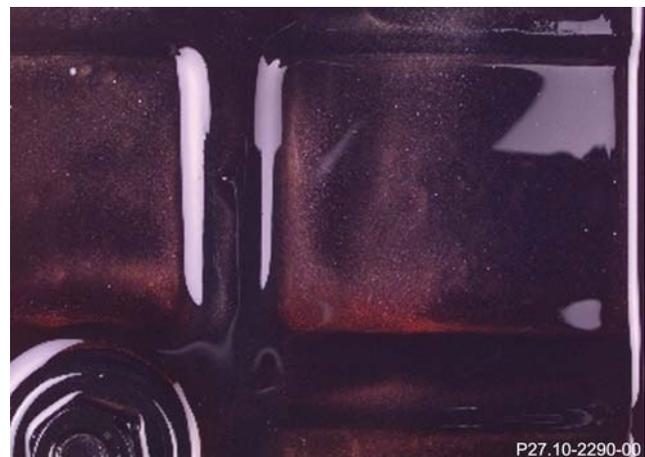
A pattern of wear debris in the oil pan which corresponds to the picture "Oil pan with normal wear debris" does not justify replacement of the transmission because this is normal wear debris which collects in the oil pan during operation.

Oil pan with normal wear debris

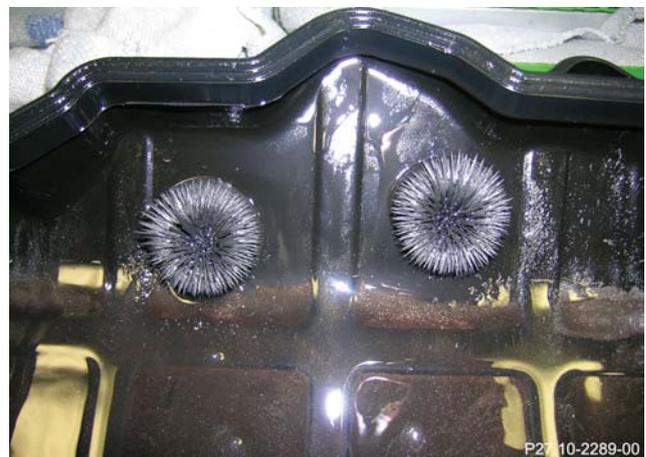
If the problem cannot be eliminated by adapting the torque converter lockup clutch, the transmission oil pan must be checked for wear debris. If the wear debris pattern corresponds to the pattern in the picture but no fault codes are stored, the torque converter must be replaced and a transmission oil change must be performed.

Oil pan with significant wear debris

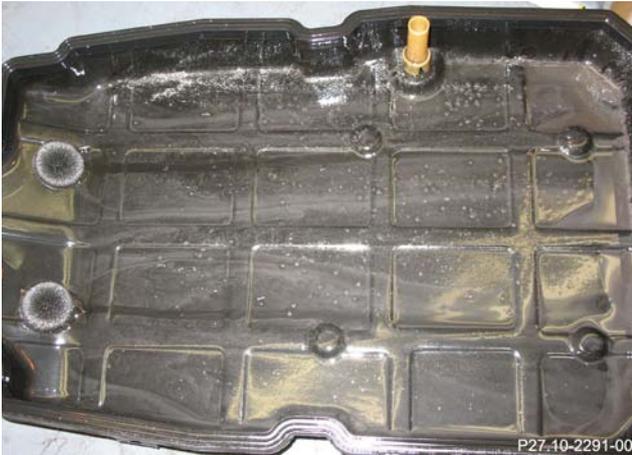
Picture 1

These pictures show examples of transmissions which are obviously mechanically damaged.

Transmissions with obvious mechanical damage

We currently recommend replacing the transmission if the following damage is present:

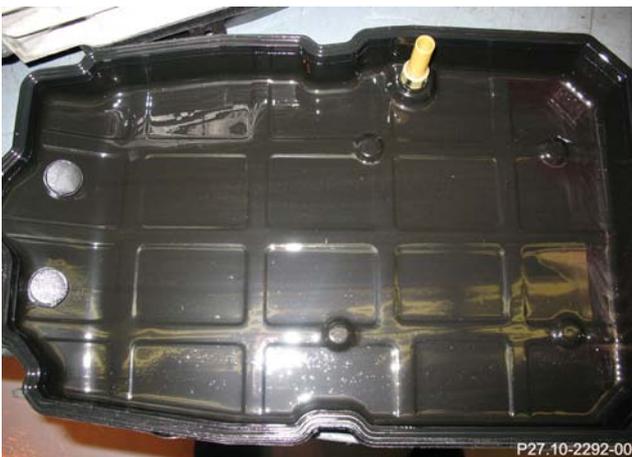
Picture 3

These pictures show examples of transmissions where it is not possible to conclude that the transmission is damaged based on the pictures.

Mechanical damage not visible based on pictures
