01-1000 Notes regarding crankcase

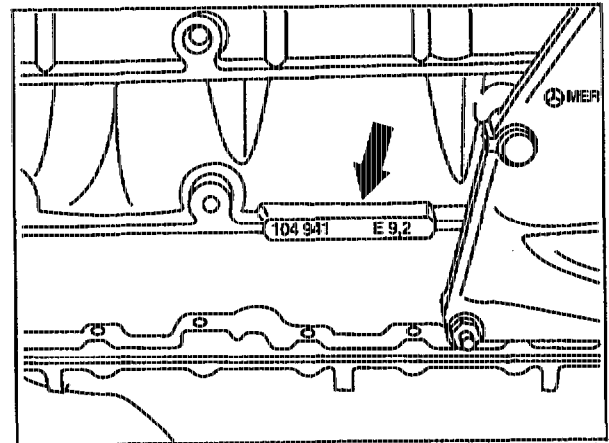
P01.40-0235-13

Replacement crankcases and short blocks do not have a stamped engine model designation and engine number.

The workshop performing repairs must stamp the engine model designation in the crankcase in the space provided for the engine number (arrow) on the right in front of the engine support to enable the engine of the vehicle to be properly identified (e.g. by vehicle inspection authority after vehicle has been laid up or by Customs if vehicle is exported etc.).

The engine compression ratio (E) is stamped after the engine number.

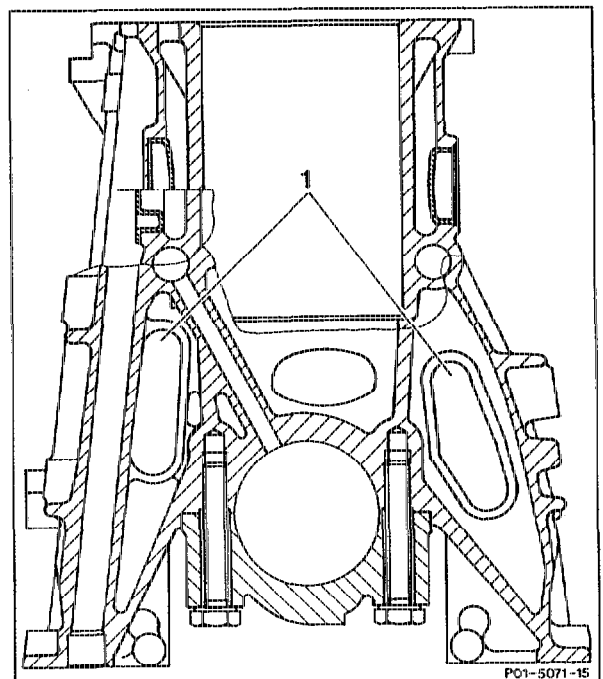
P01-5071-15

Since January 1991 crankcases with additional bearing seat openings on the side (1) have been used as standard.

This improves the pressure distribution in the crank chamber.

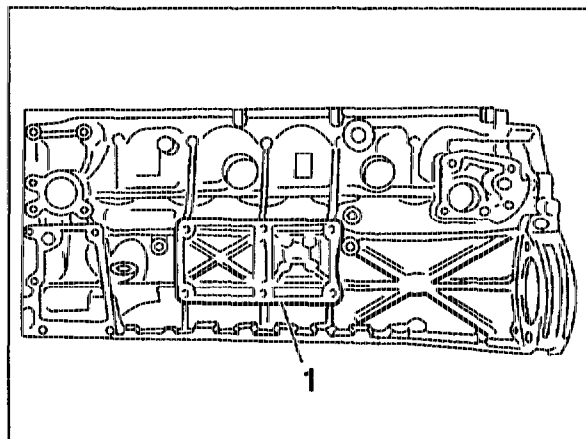
P01.40-0269-13

The crankcase of engine 104.990 has been strengthened with additional cast ribs (1) at the outer contours. This results in a change in the knock sensor signals (KSS) which necessitates a modified ignition control module (DI).

As of April 1991 2nd version

When replacing the crankcase or installing a reconditioned engine, the matched ignition control module (DI) should be used (see table). Except for USA models.

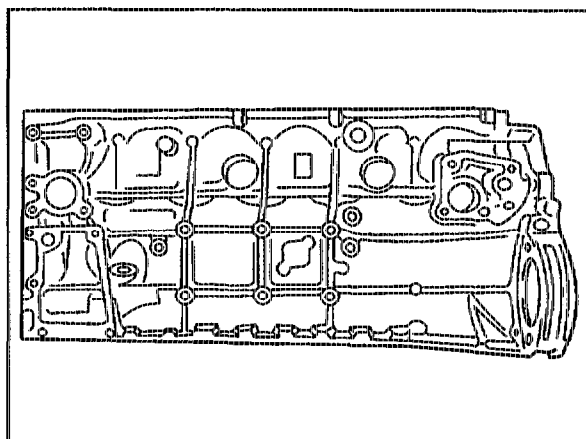
P01.40-0270-13

Up to April 1991 1st version
