AP13.22-P-1351-01A

Poly V-belt damage patterns

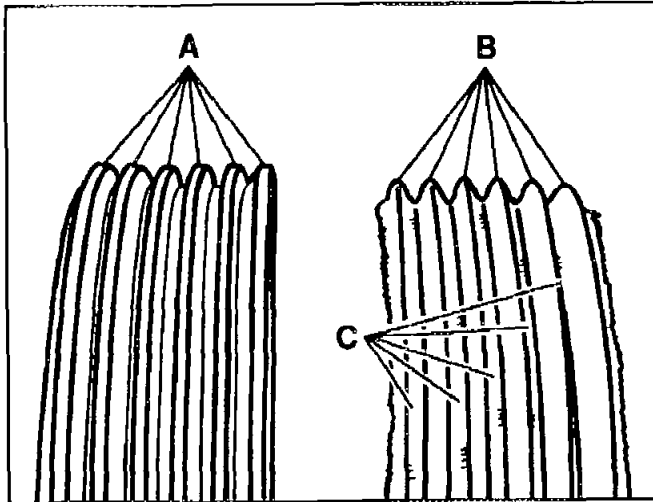
N13.22-2068-01

Edge wear - wedge shaped ribs (B) and backing cord visible at bottom of grooves (C), in new condition the ribs have a trapezoidal shape (A)

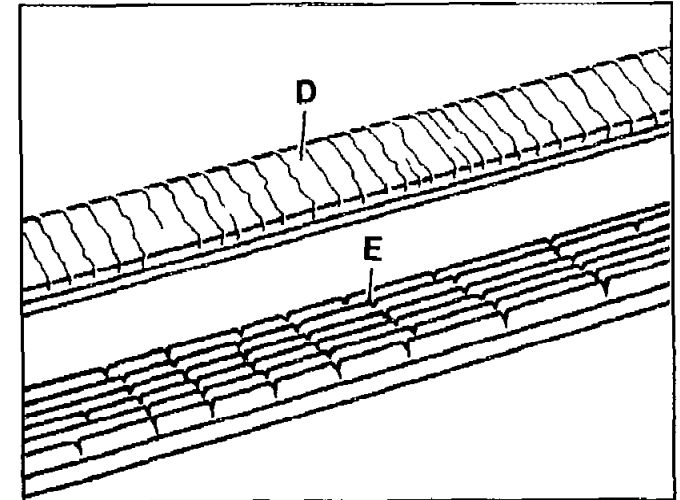
N13.22-2066-01

Lateral cracks on back (D)
Lateral cracks across a number of ribs (E)

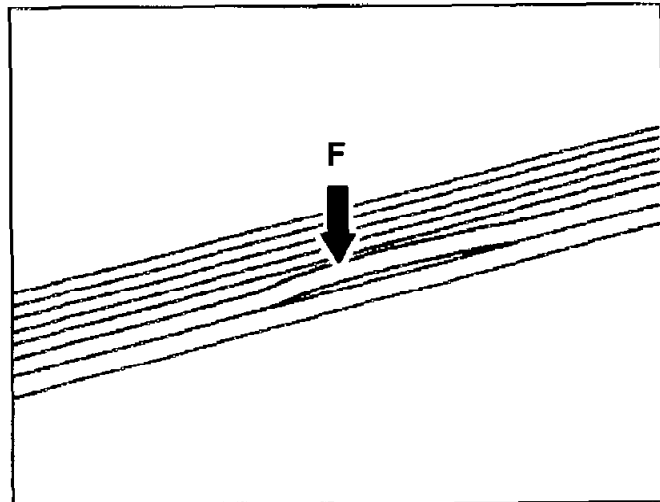
N13.22-2071-01

Ribs torn off of belt (F)

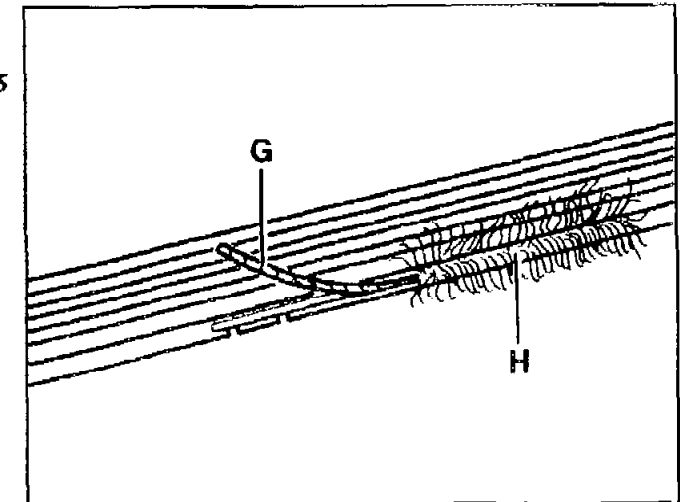
N13.22-2067-01

Belt cord pulled out at side (G), outer belt cords frayed (H)

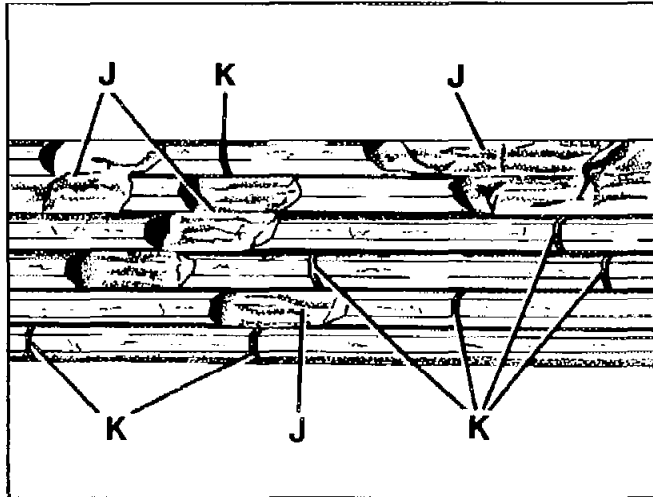
N13.22-2069-01

Chunks broken out of ribs (J)
Lateral cracks in ribs (K)

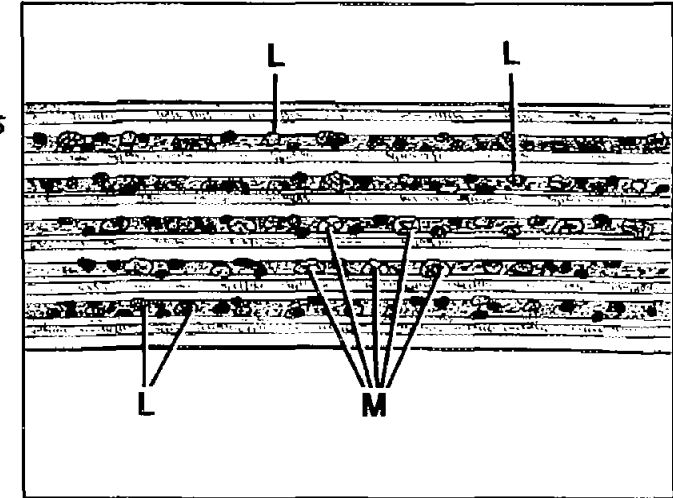
N13.22-2070-01

Chunks of rubber at bottom of grooves (L),
contamination or stones stuck in grooves (M)
