01-2240 Checking for leaks at rear of engine

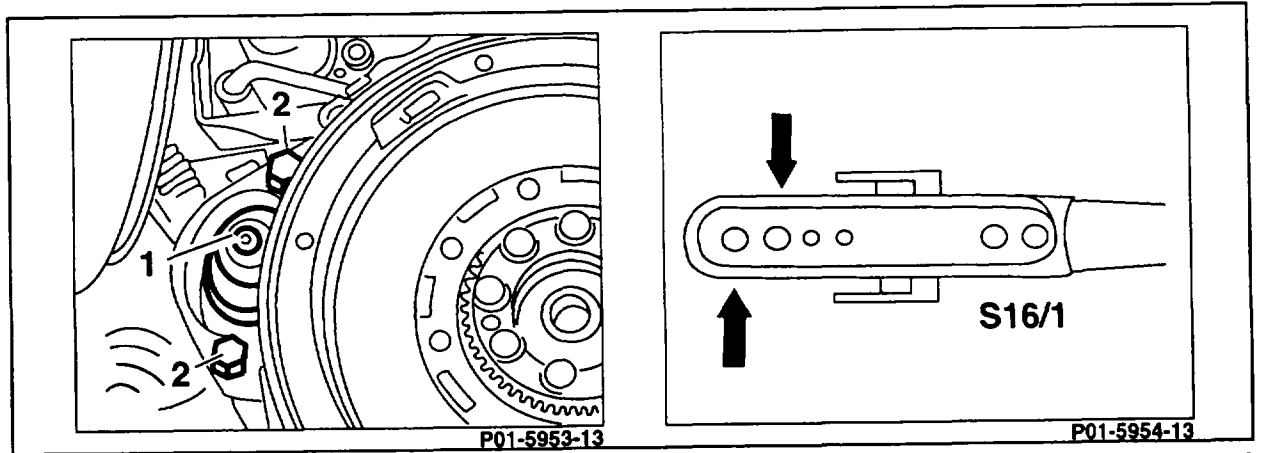
Rear of engine	clean
Dried surrounding area	spray with Mercedes-Benz white contrast spray, part no. 000 989 03 59
Oil level in engine	check, adjust to correct level (18-0020)
Manual transmission: flywheel	install (03-4100)
Manual transmission: two-mass flywheel	install (03-4620)
Automatic transmission: driven plate with ring gear	install (03-4100)
Starter (1)	bolt to crankcase with M10 × 60 hexagon bolts (2)
Engine	support at rear in installation position, secure
Automatic transmission: contacts (arrows) at starter lockout switch (S16/1)	bridge
Engine	start and check for leaks
