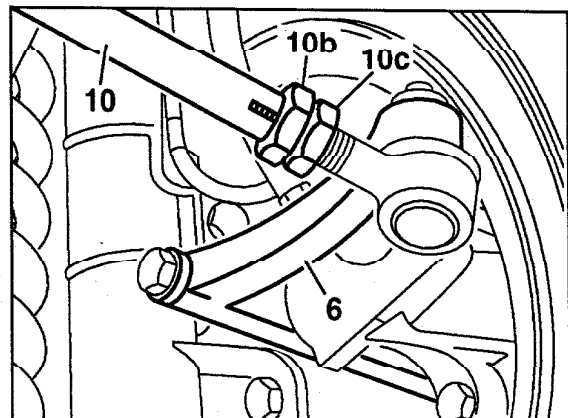
P46-2272-13

The ball joint secured with the tapered clamping ring (10b, 10c) must be fixed to the steering control arm (6) on the steering knuckle side.

- Joint of tie rod (10) If there is play or the rubber boot is damaged, replace tie rod. If the rubber boot was damaged when the tie rod was removed, replace rubber boot (46-7202).
- Installed position of tie rod Observe, refer to notes.
- Tow-in Adjust (40-0323).
