# M104 Electronic Throttle Actuator Removal, Insulation Inspection and Rewiring Guide by G. Culler

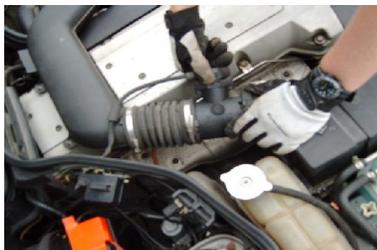
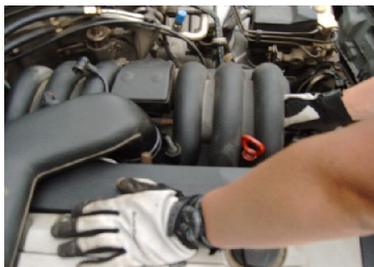
Remove duct work from the air cleaner to the TA connection boot

In order to remove the crossover pipe, the hose clamp on top of the ETA connection boot must be loosened. It can be accessed by reaching in under the intake manifold from the front with a flat screwdriver.

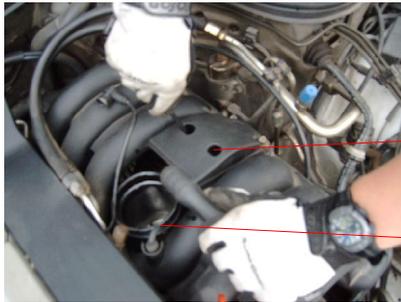
Next, remove the air resonance valve by removing the four Allen screws. Two will be under rubber plugs, simply pull the plugs out to access the screws. Unplug the harness connector very carefully as they can become brittle with age

Air resonance valve

ETA Boot, remove in the next step

Now loosen the bottom clamp on the bottom of the ETA boot and remove the boot. You may have to pry on it, wiggle it until you discover the correct combination of four letter words to get it to come loose.

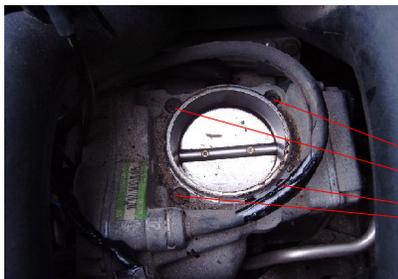
Next, remove the four bolts holding the ETA to the intake manifold

Remove these bolts

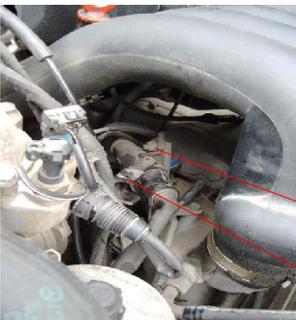
Now disconnect the main wiring harness and remove the two 10mm nuts attaching the ETA harness to the engine.

Remove this nut and one on the bottom of the bracket

Unclip and unplug this connection

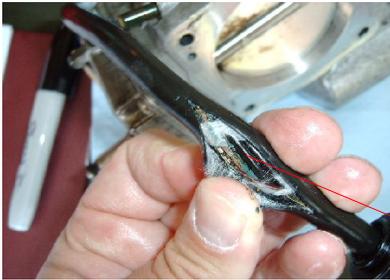
Cut a slit ~2-3" long in the sheathing covering the wires. Open the slit to inspect the insulation on the wires. If there is any evidence of cracking or flaking, you will need to rewire the unit.

Plastic filler cords

If your insulation inspection shows cracked or missing insulation, silt the rubber sheath from the wiring harness connector up to about 1"-2" from the ETA body. Cut the sheath completely away from the connector, taking care not to cut any of the wires inside yet. Inside the sheath you will find eleven wires and several plastic filler cords. Go ahead and pull the fillers out, their removal will allow the replacement of the other wires to proceed easier.

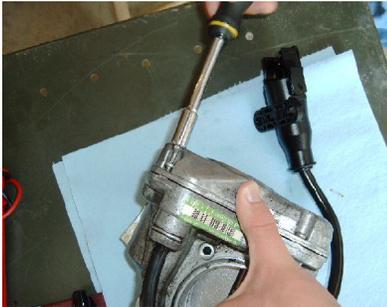
Using a #20 Torx bit with a center hole, remove the 4 bolts holding the cover on the end where the wire bundle enters the ETA. Once the 4 screws are removed, the cover can be pried off with a thin flat blade screwdriver. Note there is an anti tamper post that will break as the cover is removed. Don't worry as this repair will constitute tampering.

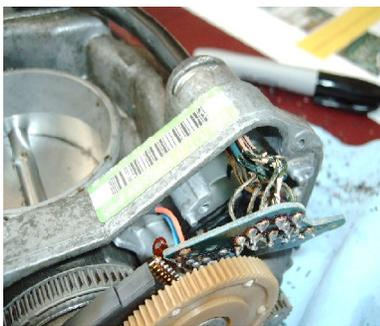
Remove the two screws holding the circuit board in place and gently pull the circuit board out while pushing the wires through the sheath to create enough room to solder in the new wires

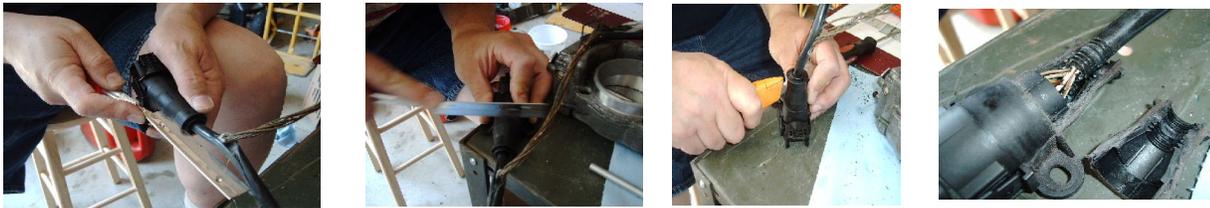
The next step involves cutting open the harness connector. We used a razor saw followed by a utility knife, but it can be done with a utility knife alone. Cut along the mold parting lines on the sides and for the top, cut between the 1 and 4 in the first three digits of the molded in part number. Once the cuts are

completed, the cut section can be pried loose.

Unfortunately, the pin holding portion of this connector does not seem to be removable, so the new wires will have to be soldered to the old ones.

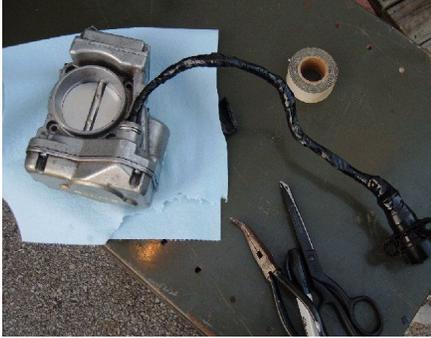
Finish the job by wrapping the repaired ETA wire bundle with self amalgamating tape or high quality PVC electrical tape. Self amalgamating means that it will bond to itself over time making one continuous rubber tube. Cheap PVC tape gets slimy with age, but good quality PVC tape is not as bad.

Reinstall on the car with a new gasket and enjoy!
