[PeachParts Mercedes ShopForum](#) > [Technical Information and Support](#) > [Tech Help](#)
How I fixed my duovalve (W210), got my heat back and saved myself \$250!

How I fixed my duovalve (W210), got my heat back and saved myself \$250!

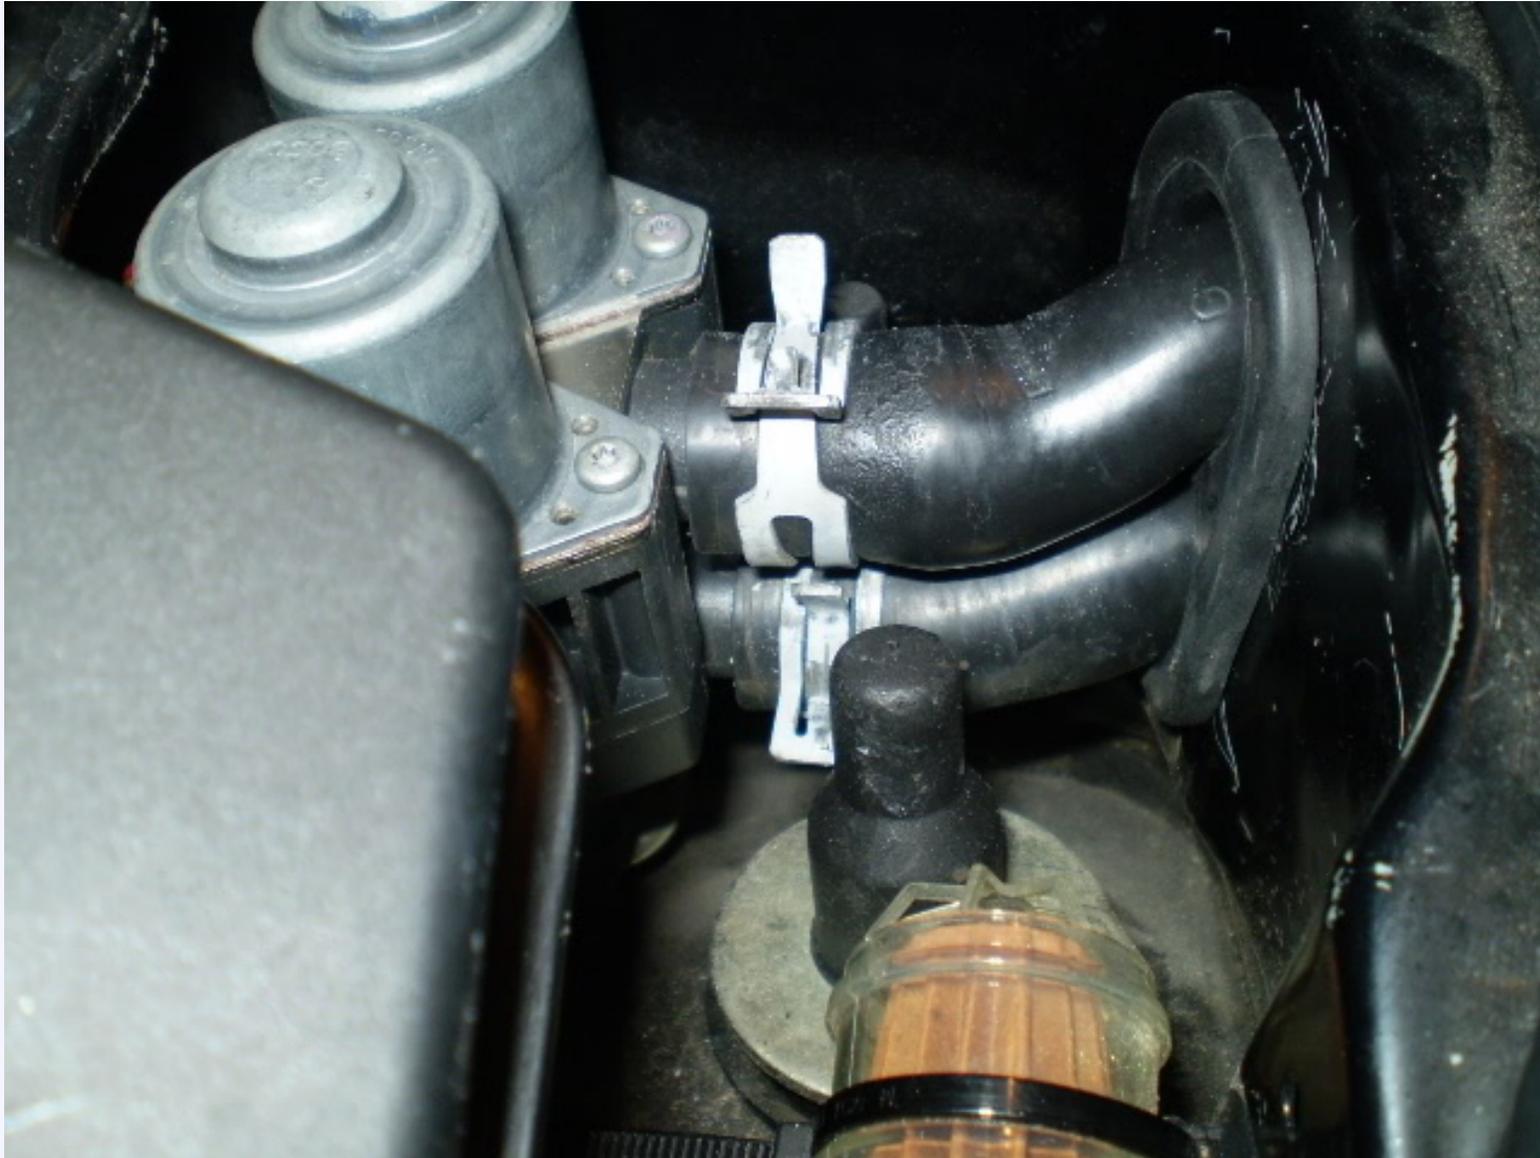
To remove the duovalve, first unlatch the top of the air filter housing and move it aside for better access to the hoses. Then remove the top spring clamp and hose. Next, push the top hose and the large rubber grommet out of the hole in front of the bulkhead.

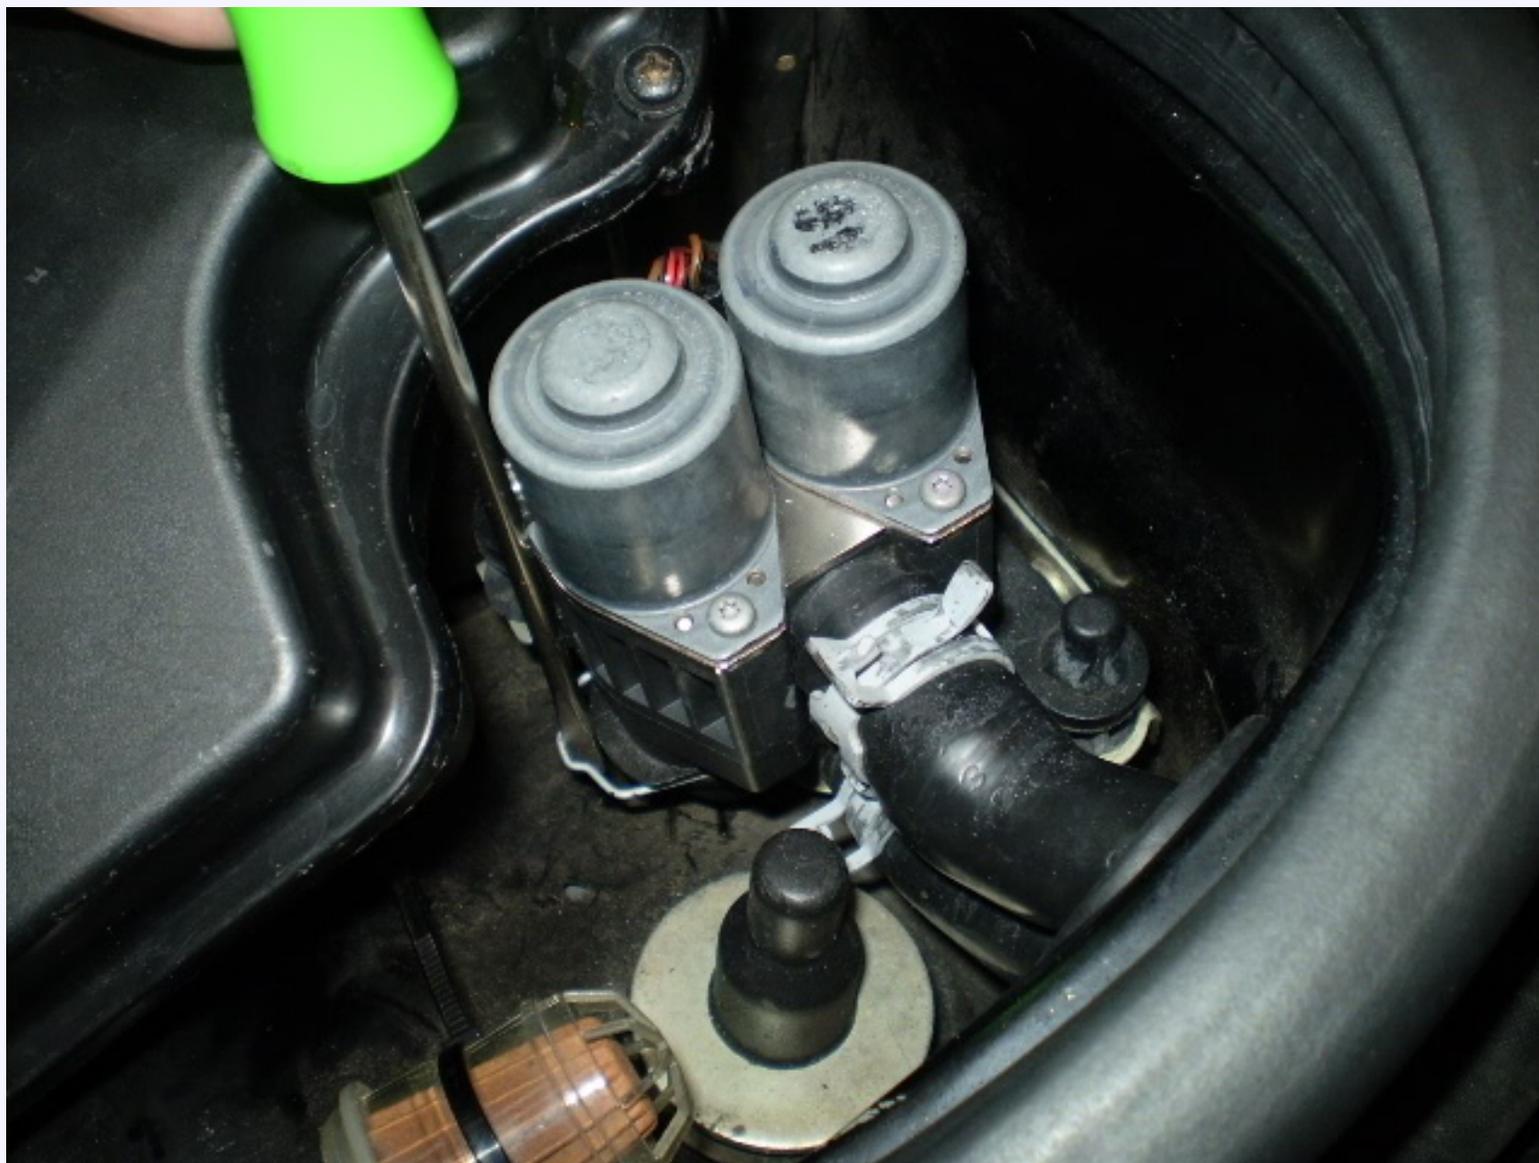
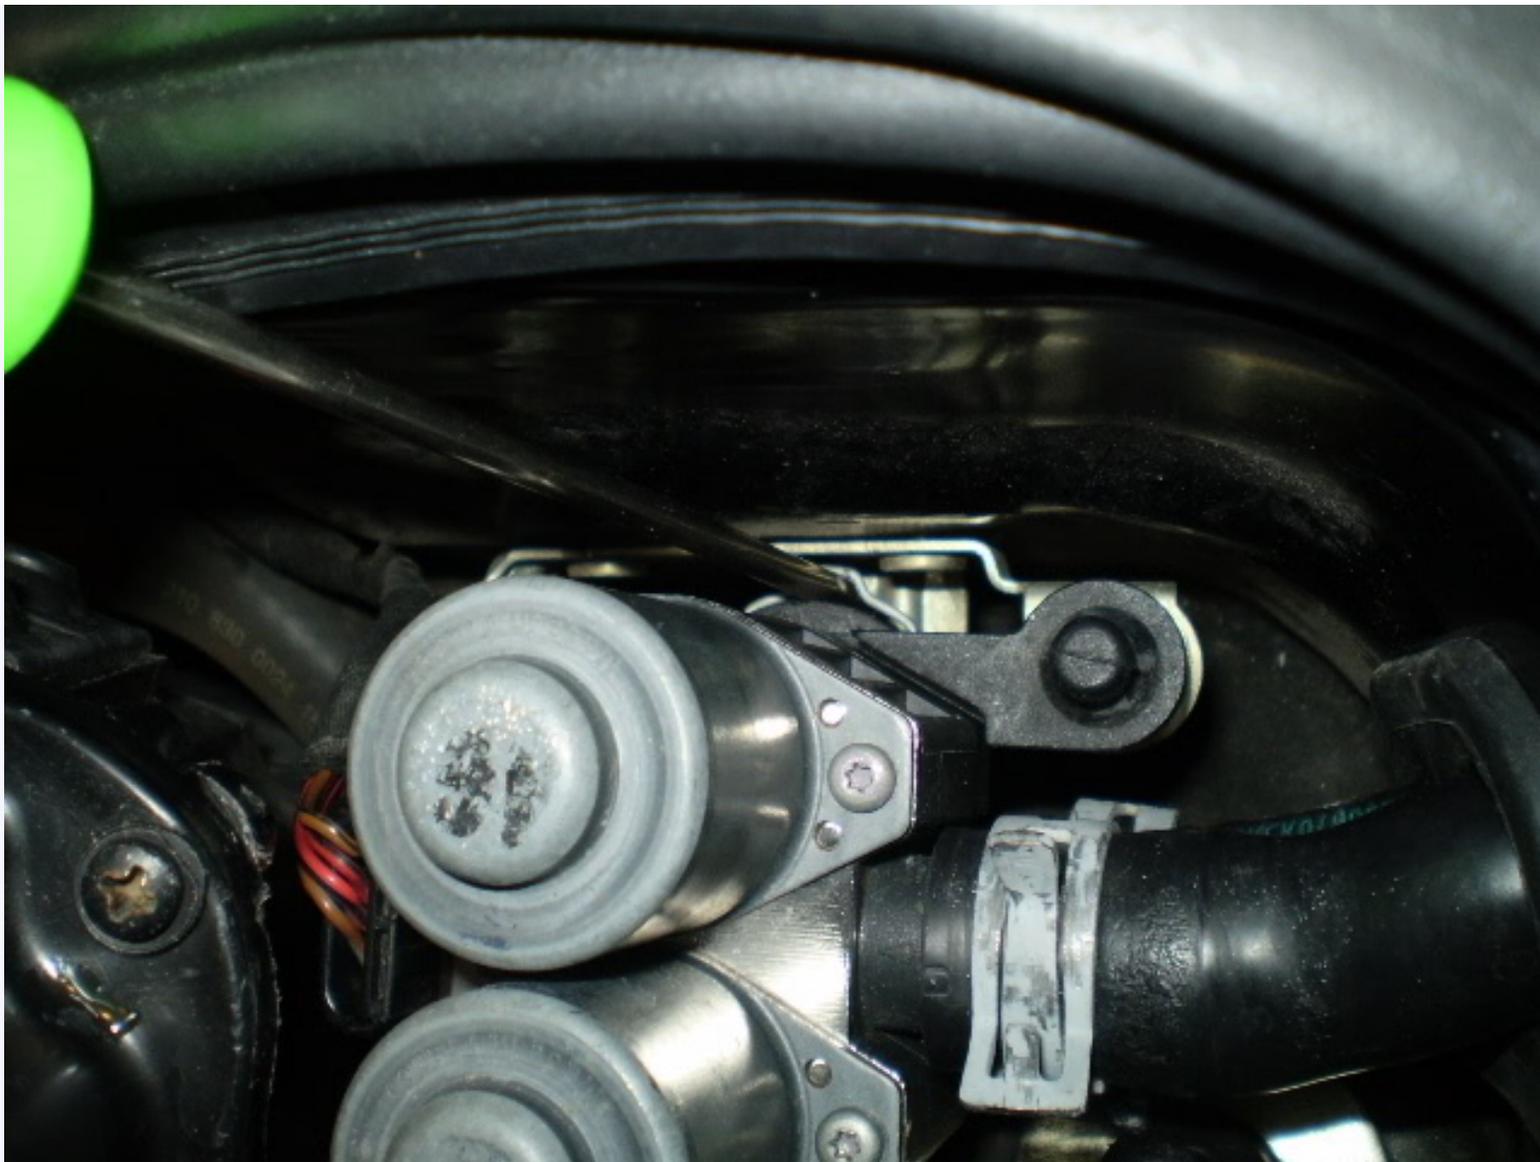
Take a screwdriver and gently pry the lower retaining clips out until they make a small "snap" sound at which point, they'll stay in the out position. There's one on each side.

After the clips are opened, grasp the two metal coil housings and gently wiggle and pull them upward to free the upper assembly from the lower one. You may need to place the tip of the screwdriver on the flange of the bottom piece and gently press downward while pulling up to free the parts. Once the top part is free, unplug the electrical connection and then remove the bottom spring clamp and hose.

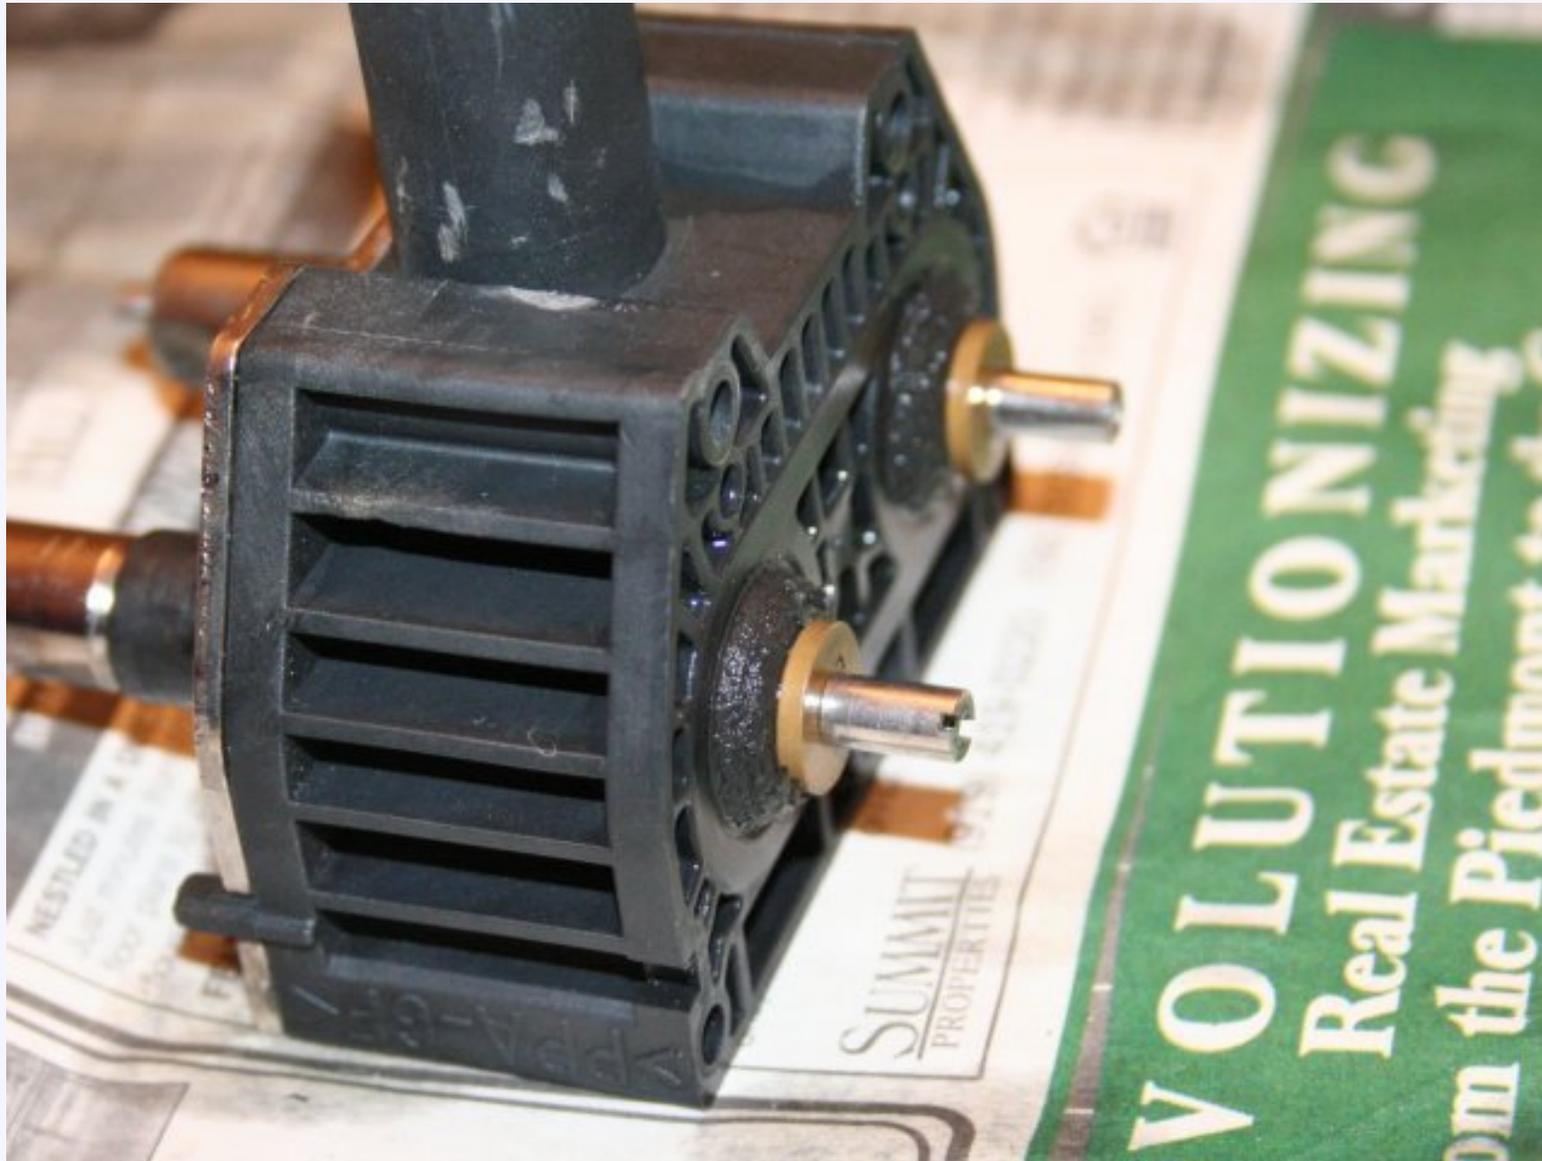
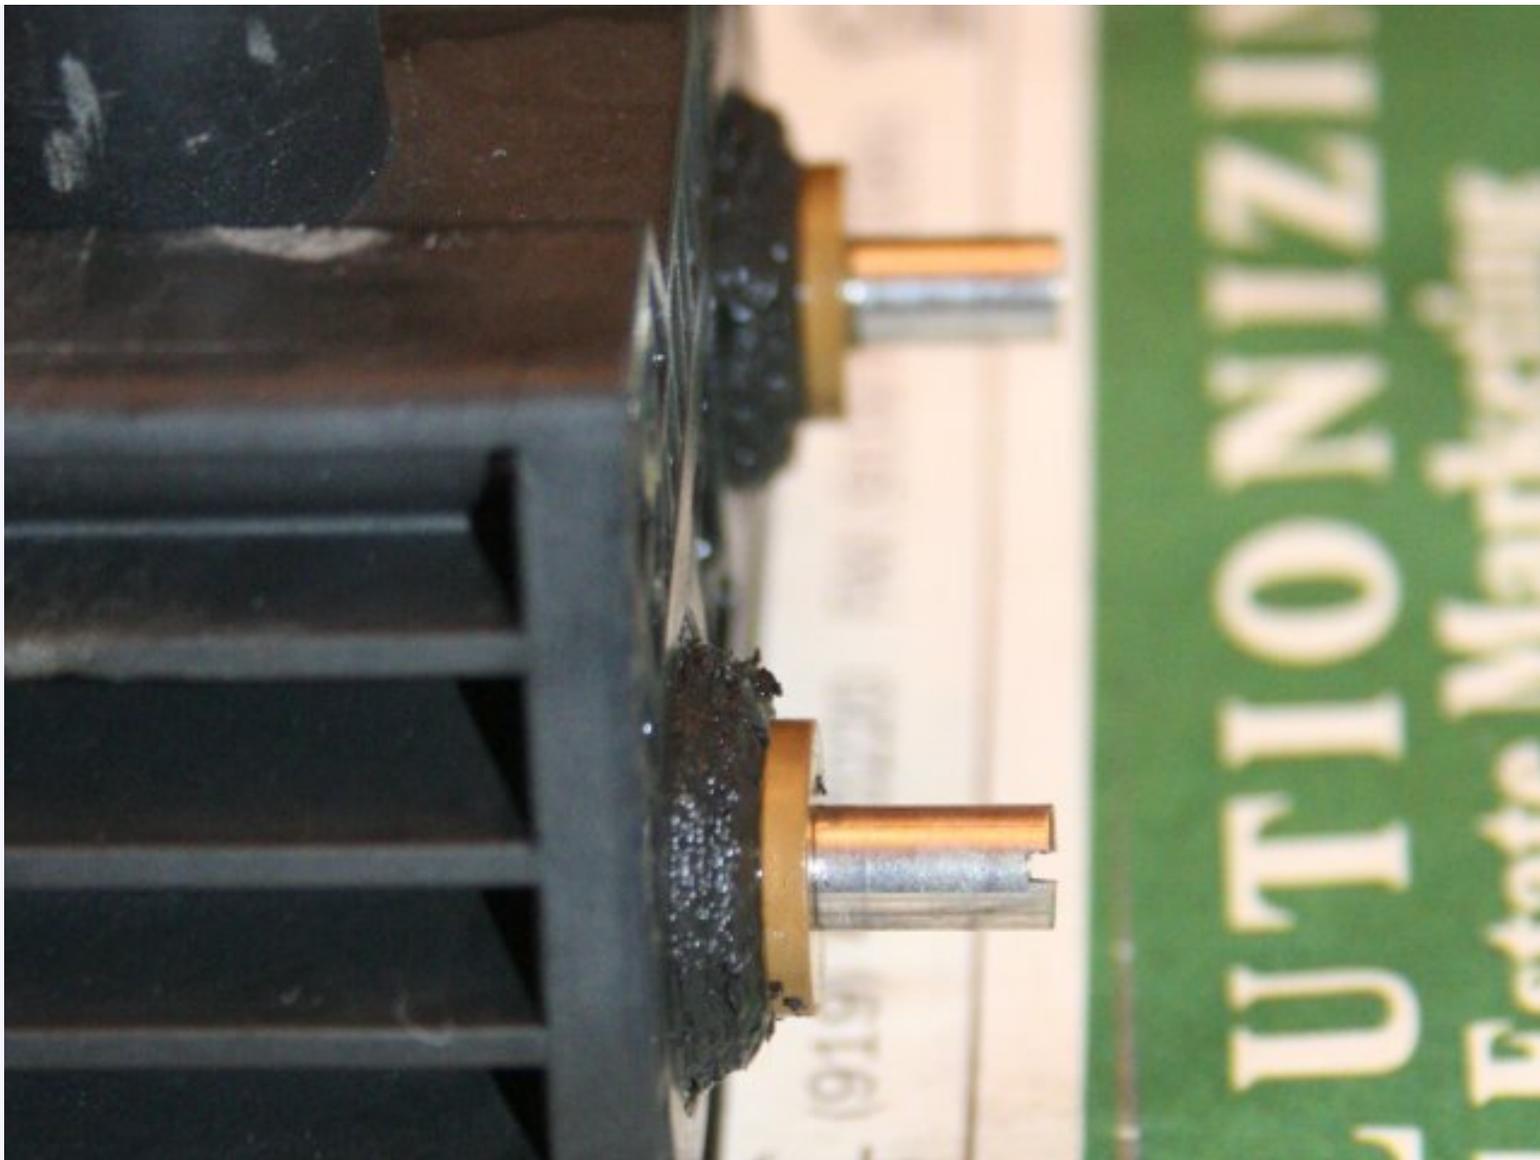
These pictures show why the valve quit working. The seal had swolen to such an extent that it prevented the valve from opening and allowing water through. You can see valves pushed out by the swolen rubber. They should actually stick out a little but not nearly that far.

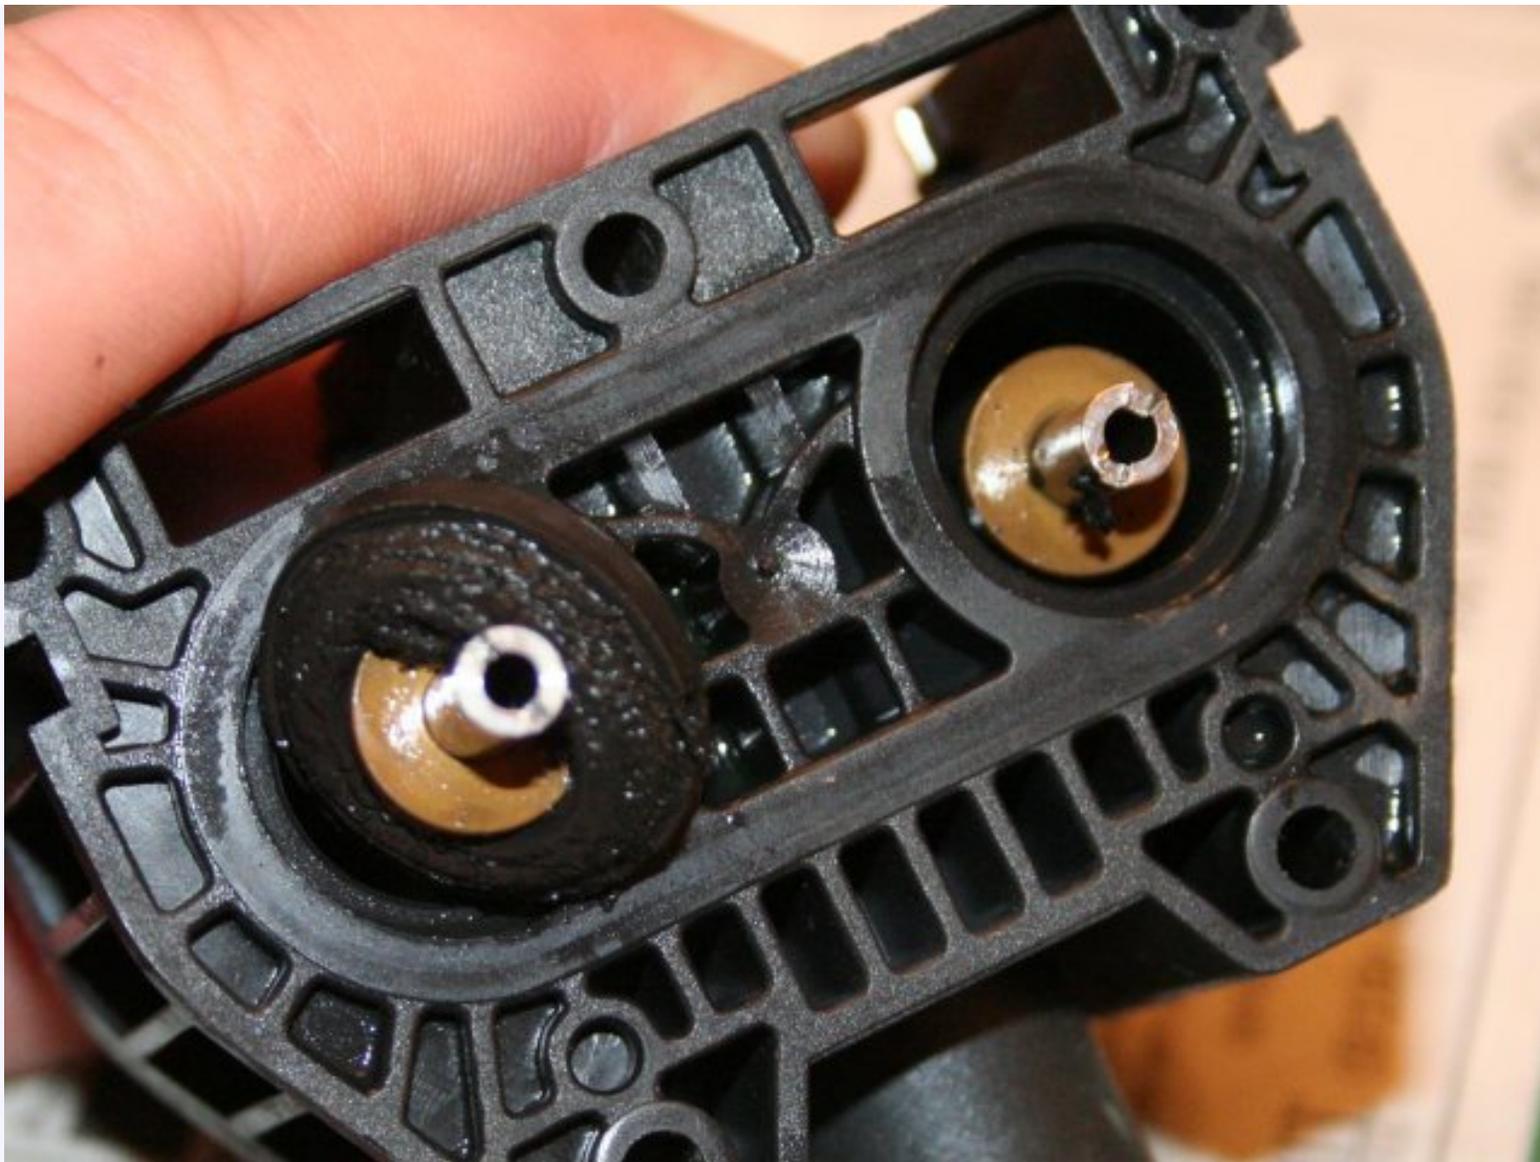
Press the valve control rods down and this will allow you to slip a screwdriver under them and pry out the seals.

Once the seals are out, the silver plate with the valve control rods will slide out of the top of the assembly.

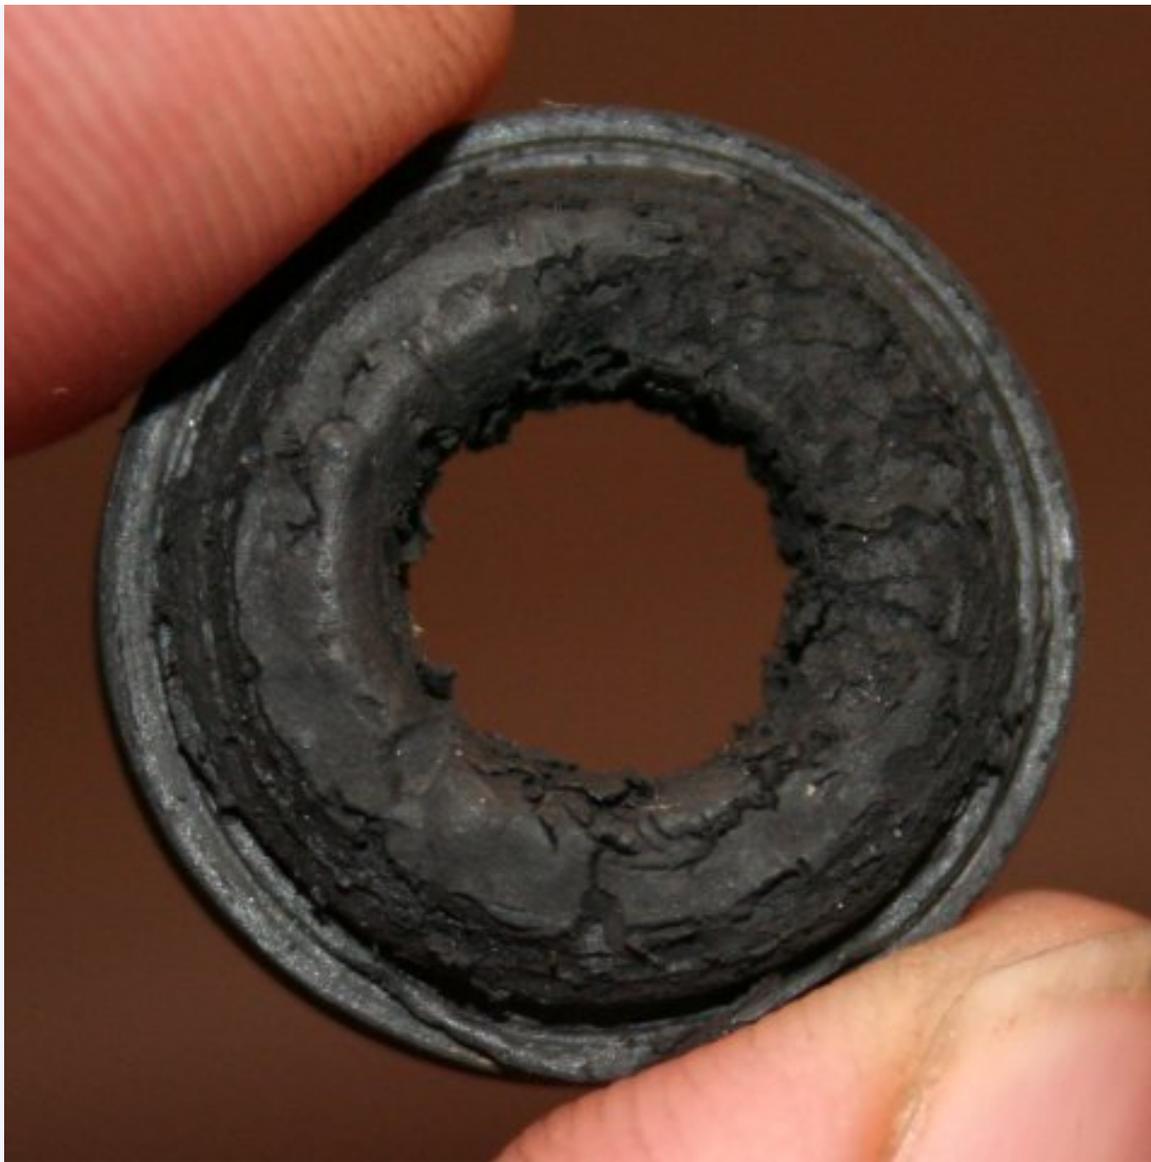
This is a closeup of the valve seal showing the poor shape it's in:

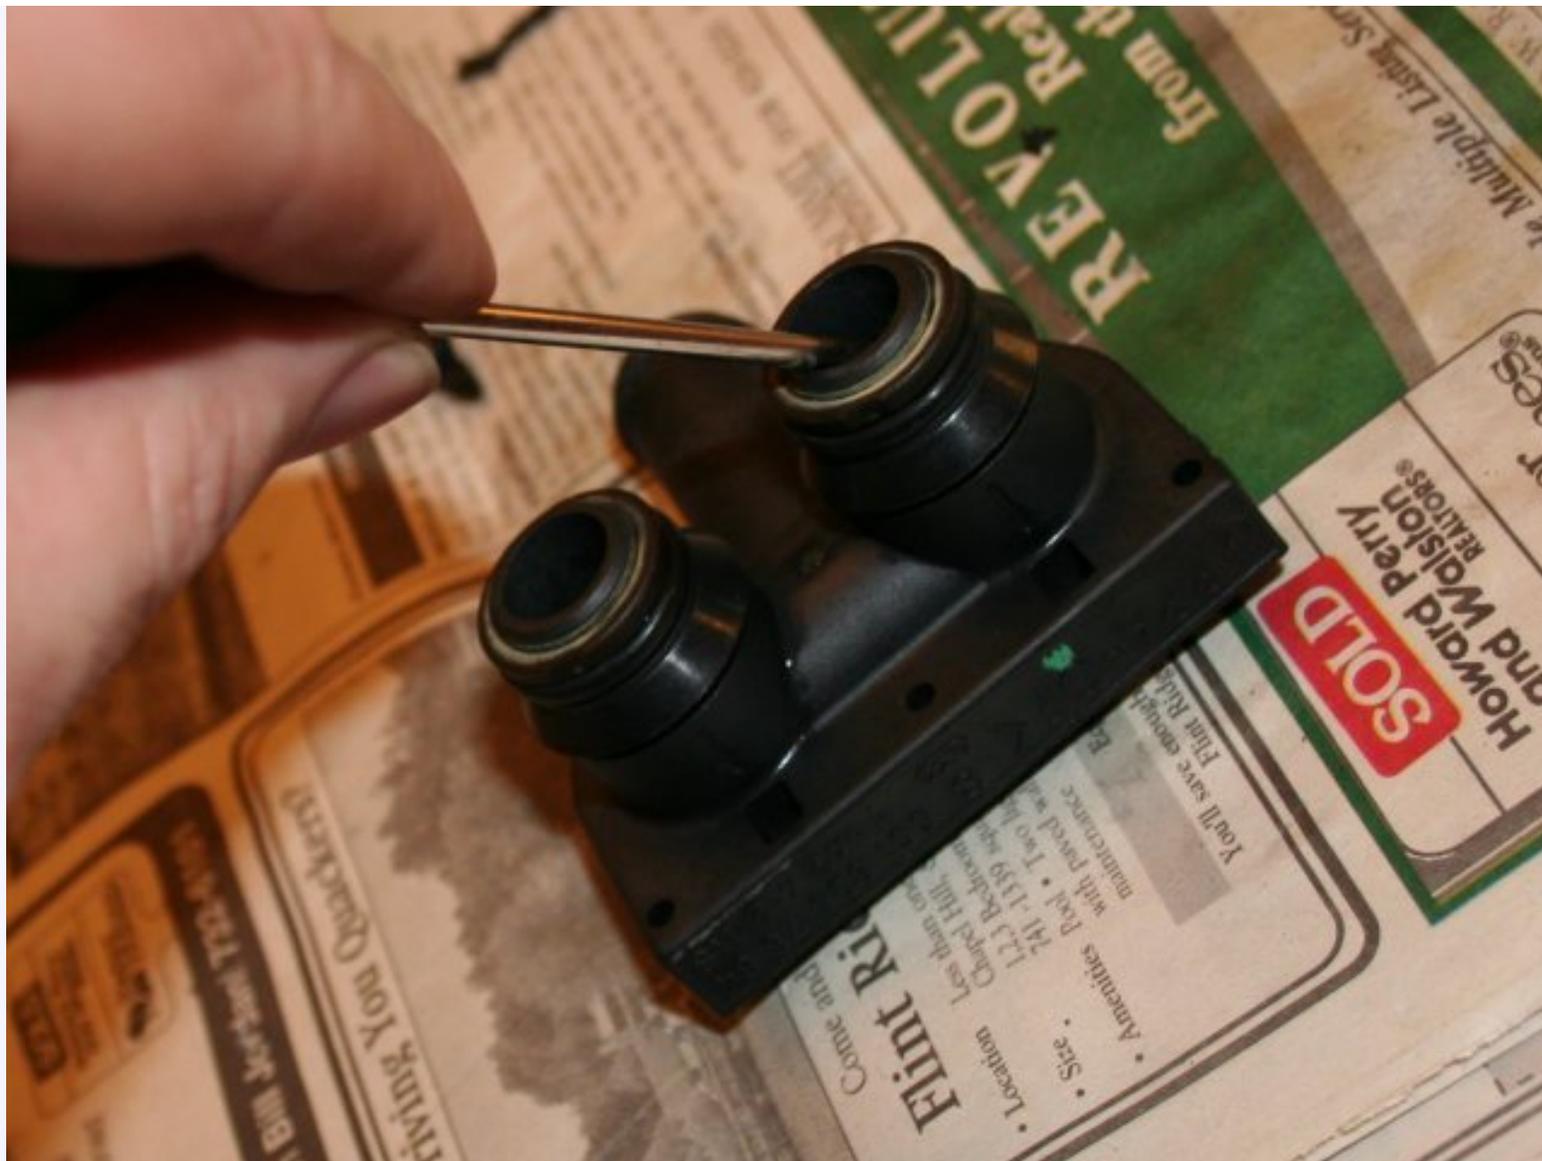
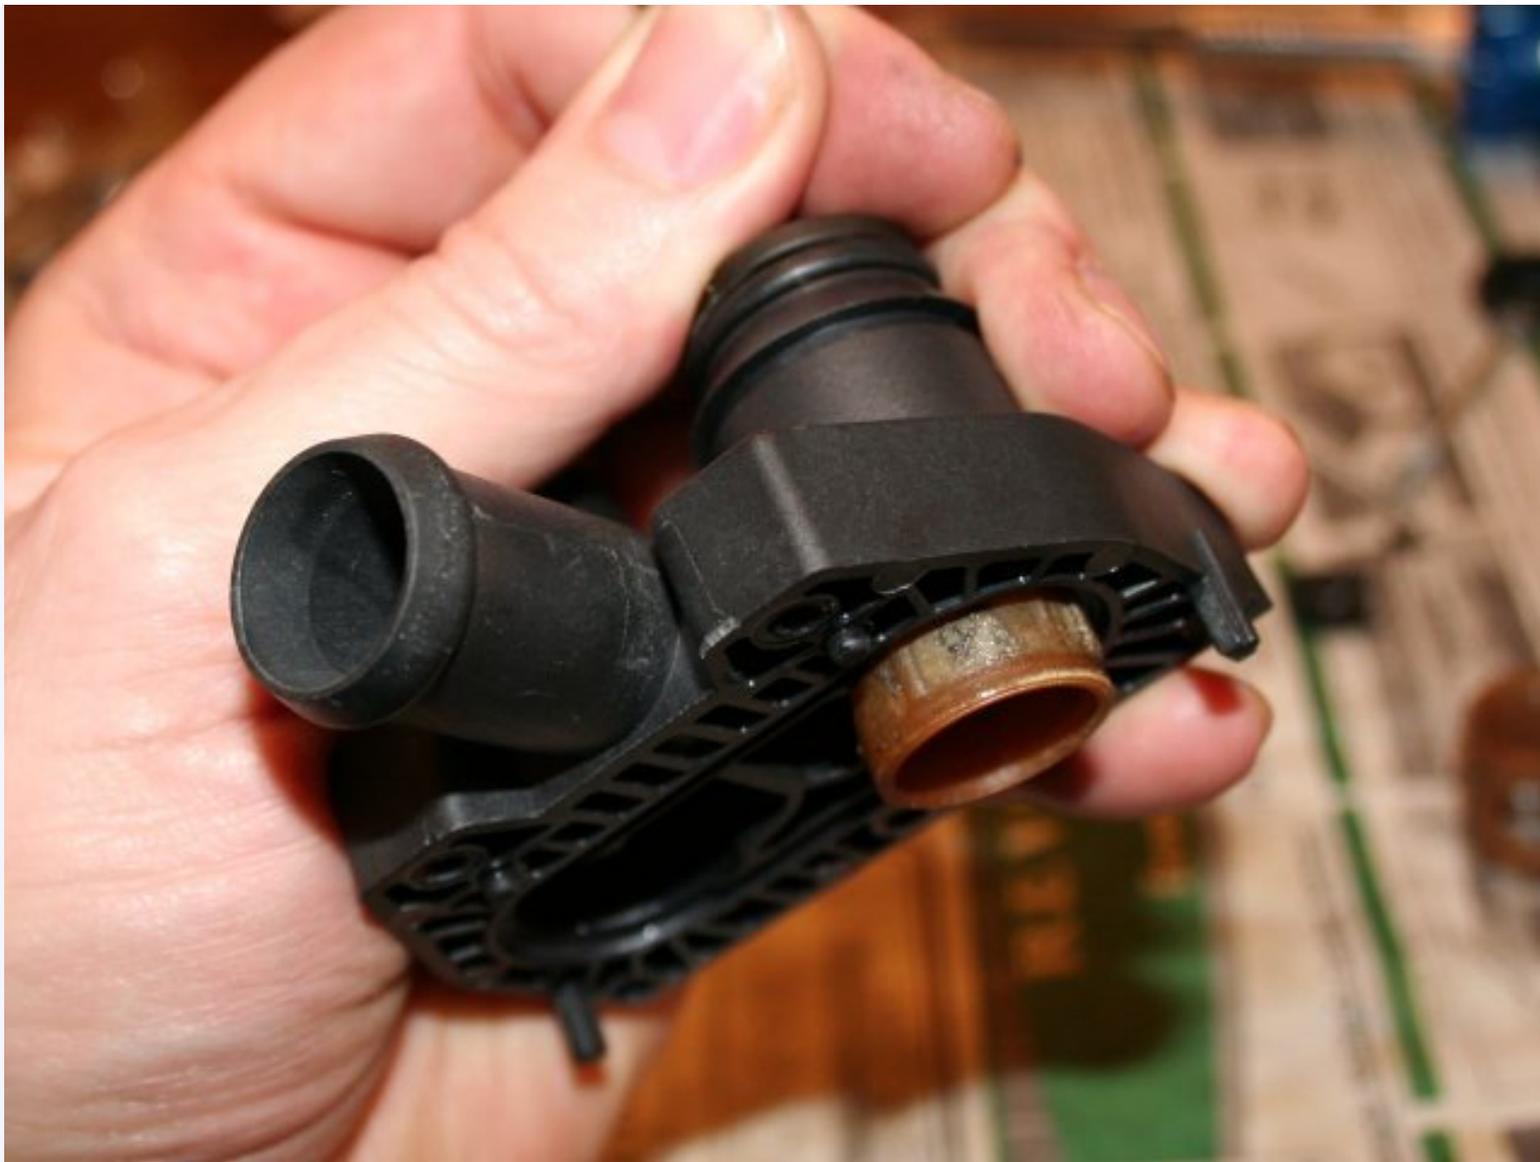
There are two more identical seals in the lower half of the valve. Take a screwdriver, inserted through the lower hole and press against each of the two seals and the brown plastic retaining cylinders. A little bit of force is needed to dislodge them. Once free, you can pull them out by hand and then pry out the rubber seals.

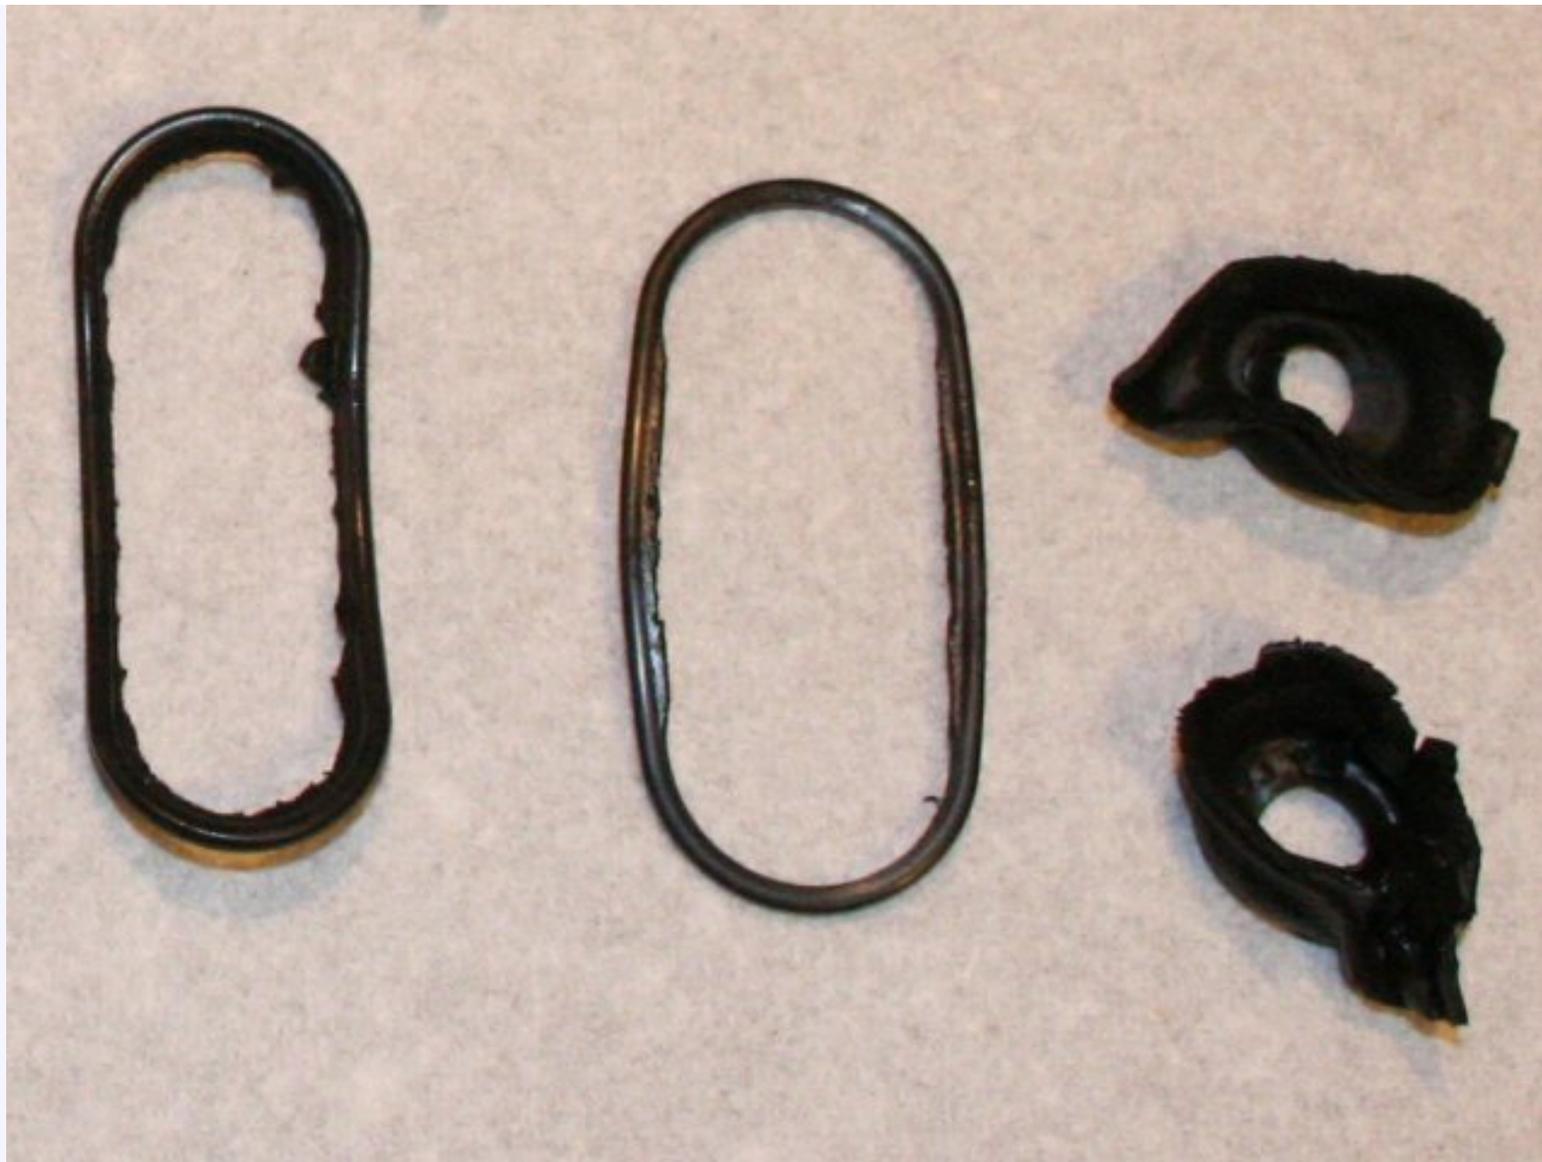
There will also be 2 O-ring seals, one between each section. Depending on the condition of the parts, you may need to do some trimming to make them usable again. I took a pair of scissors and carefully trimmed the excess rubber of in order to re-use them. The two pieces on the right were discarded.

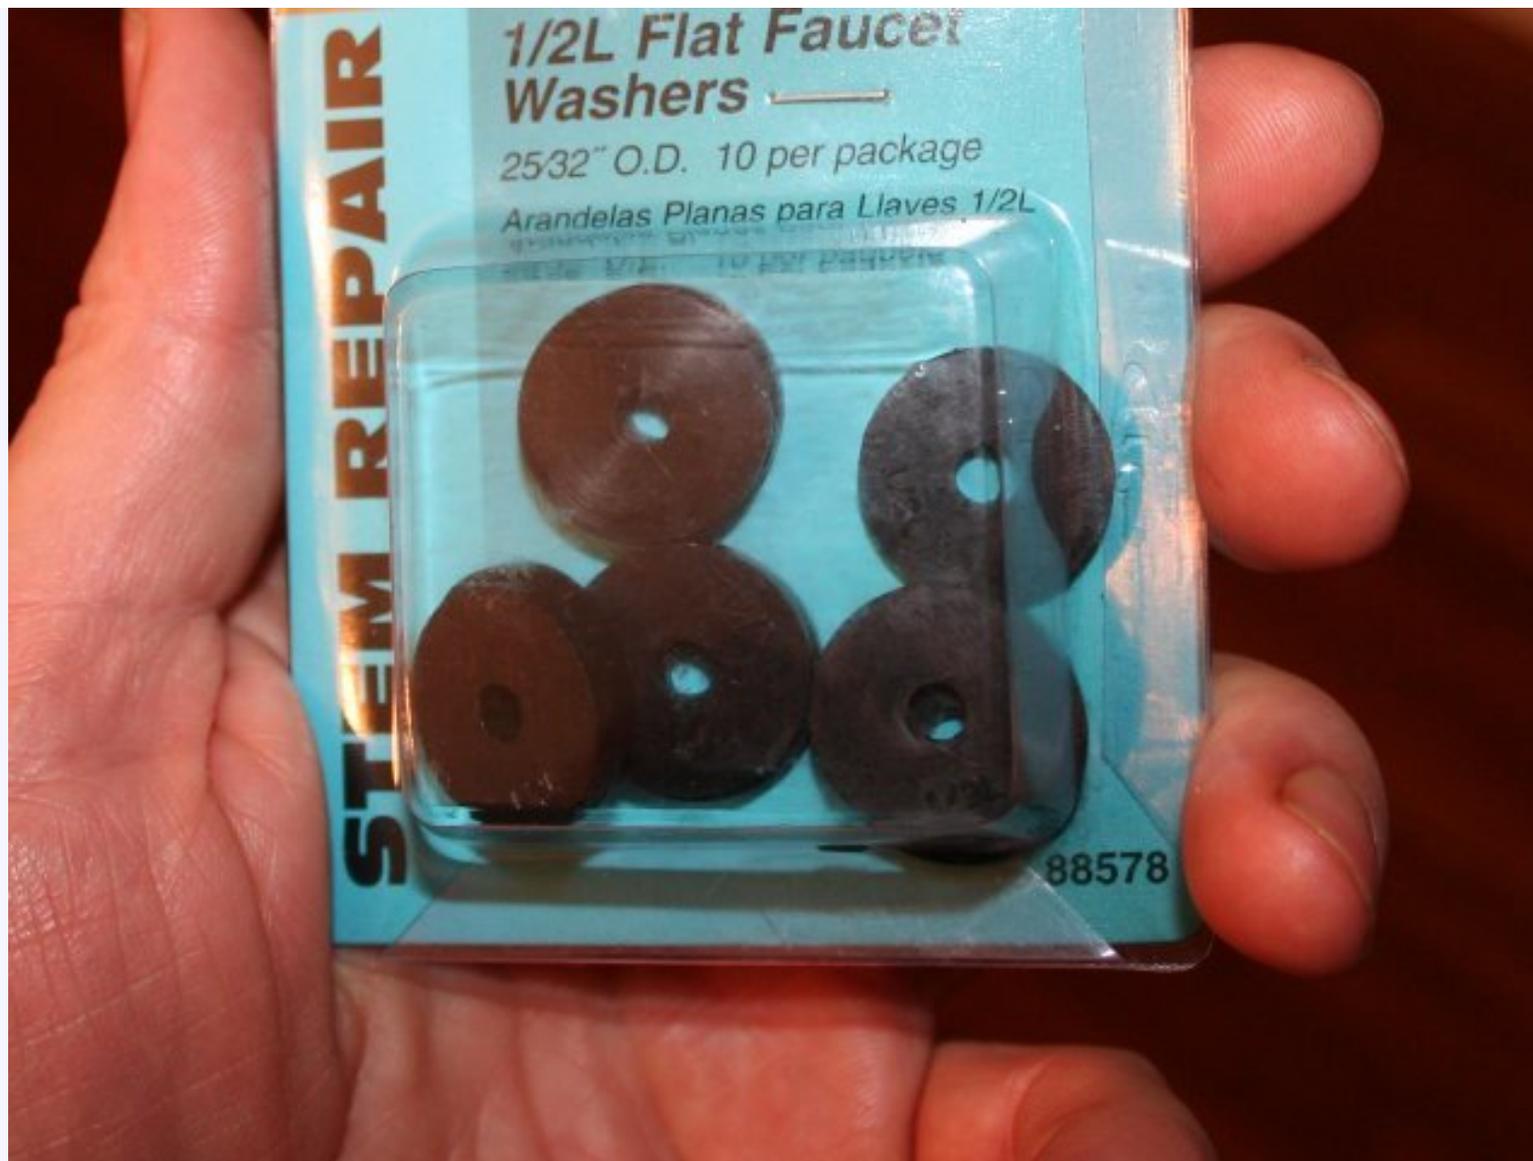
Now for the fun part. Go to the store and pick up a box of 1/2L faucet washers.

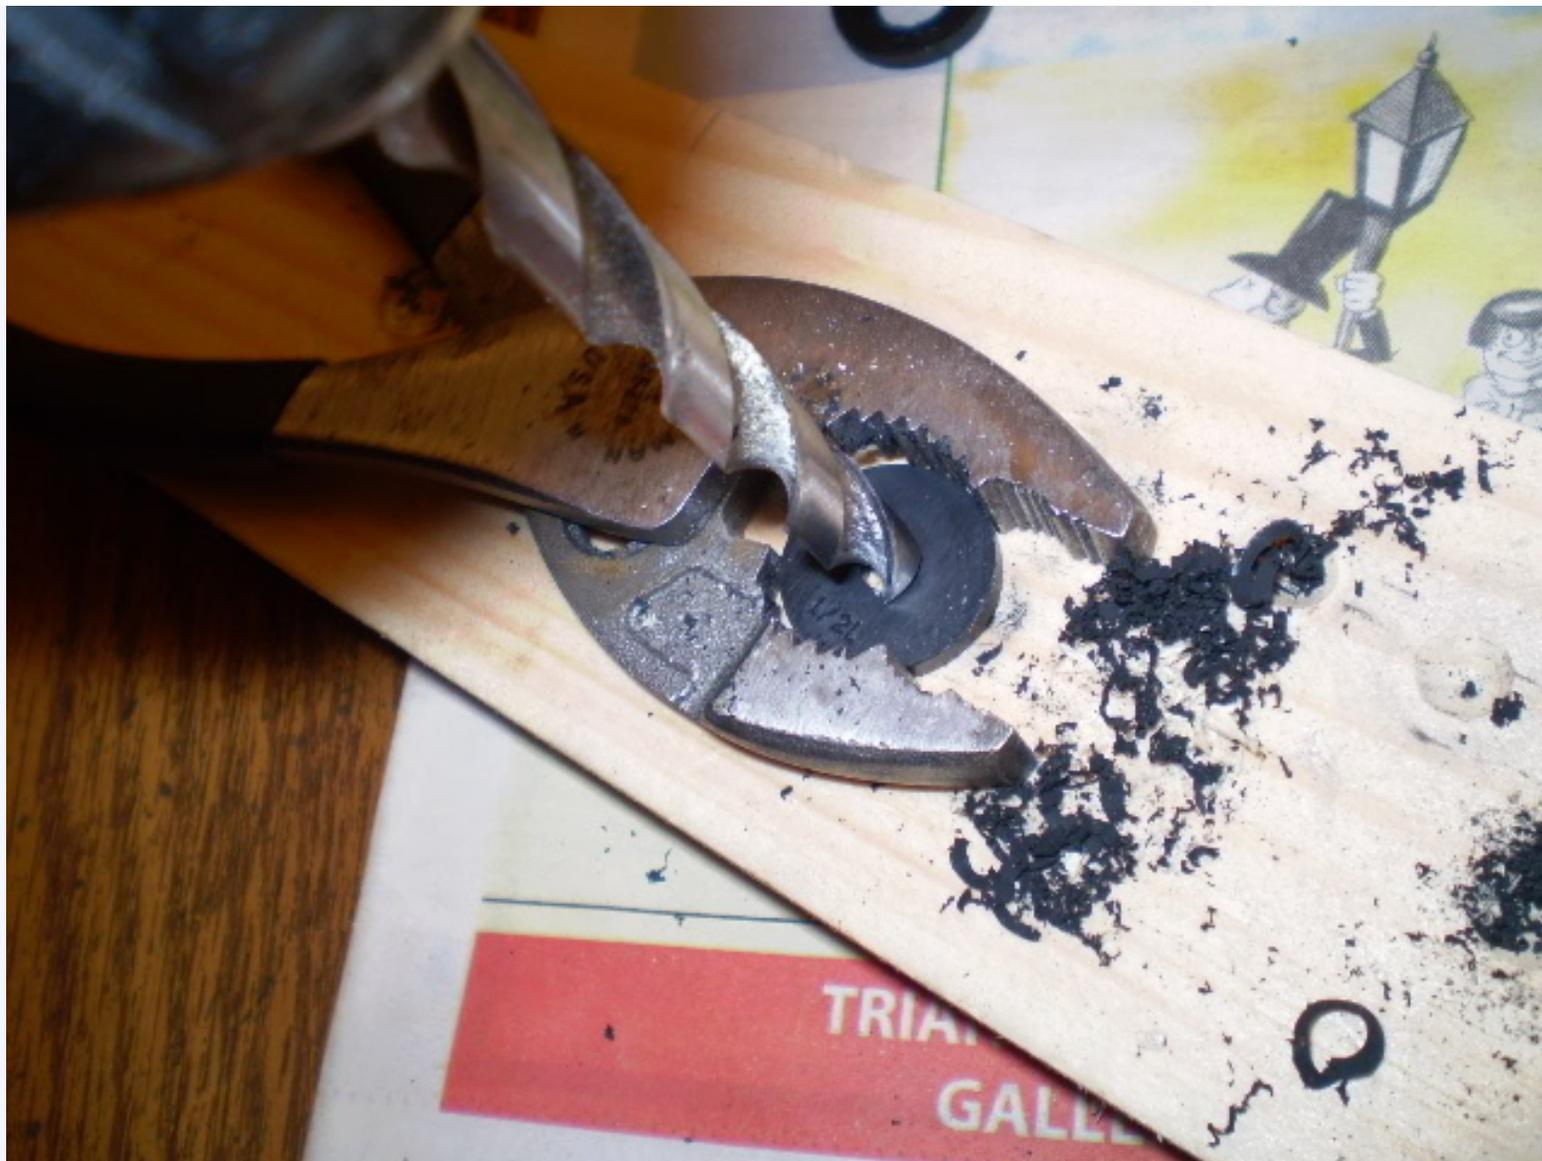
Take a 5/16" drill and carefully enlarge the center holes in 4 of them. I used a pair of pliers and gently held the washer in place while drilling in order to keep from distorting it. It's not critical to get the hole perfect because the tapered valve poppets are self-centering.
