[PeachParts Mercedes ShopForum](#) > [Technical Information and Support](#) > [Tech Help](#)
How I fixed my duovalve (W210), got my heat back and saved myself \$250!

How I fixed my duovalve (W210), got my heat back and saved myself \$250!

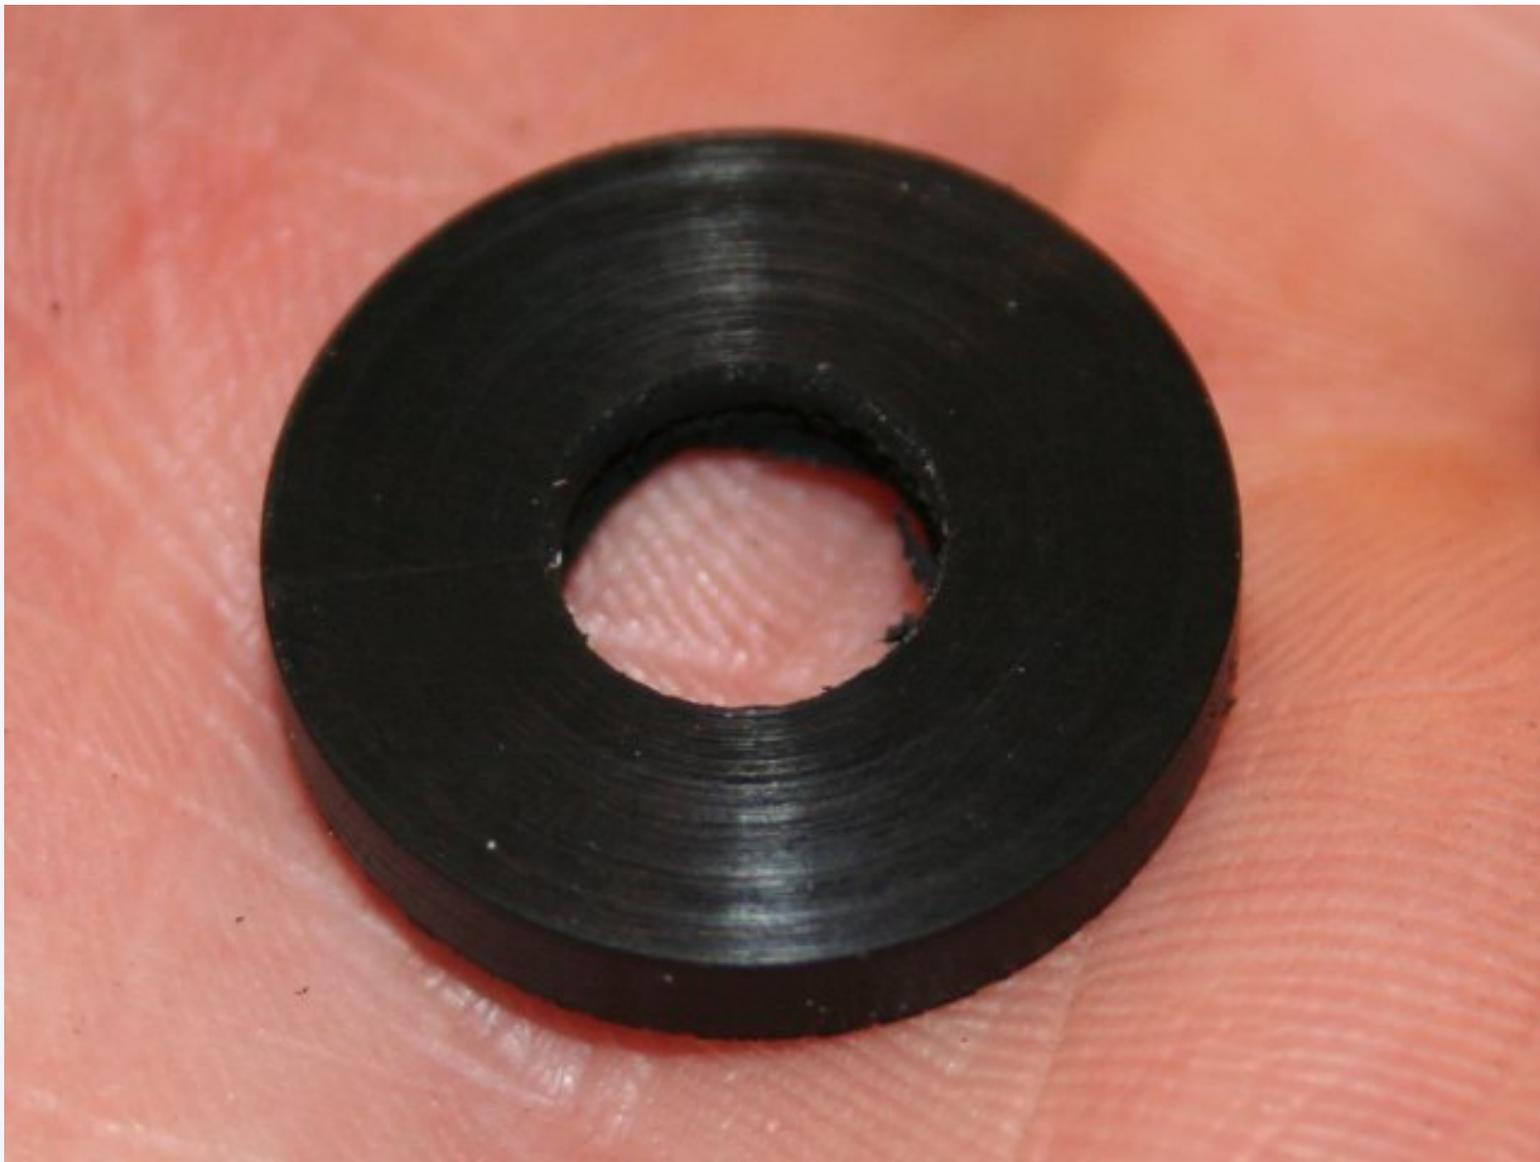
This is what they should look like when you're done:

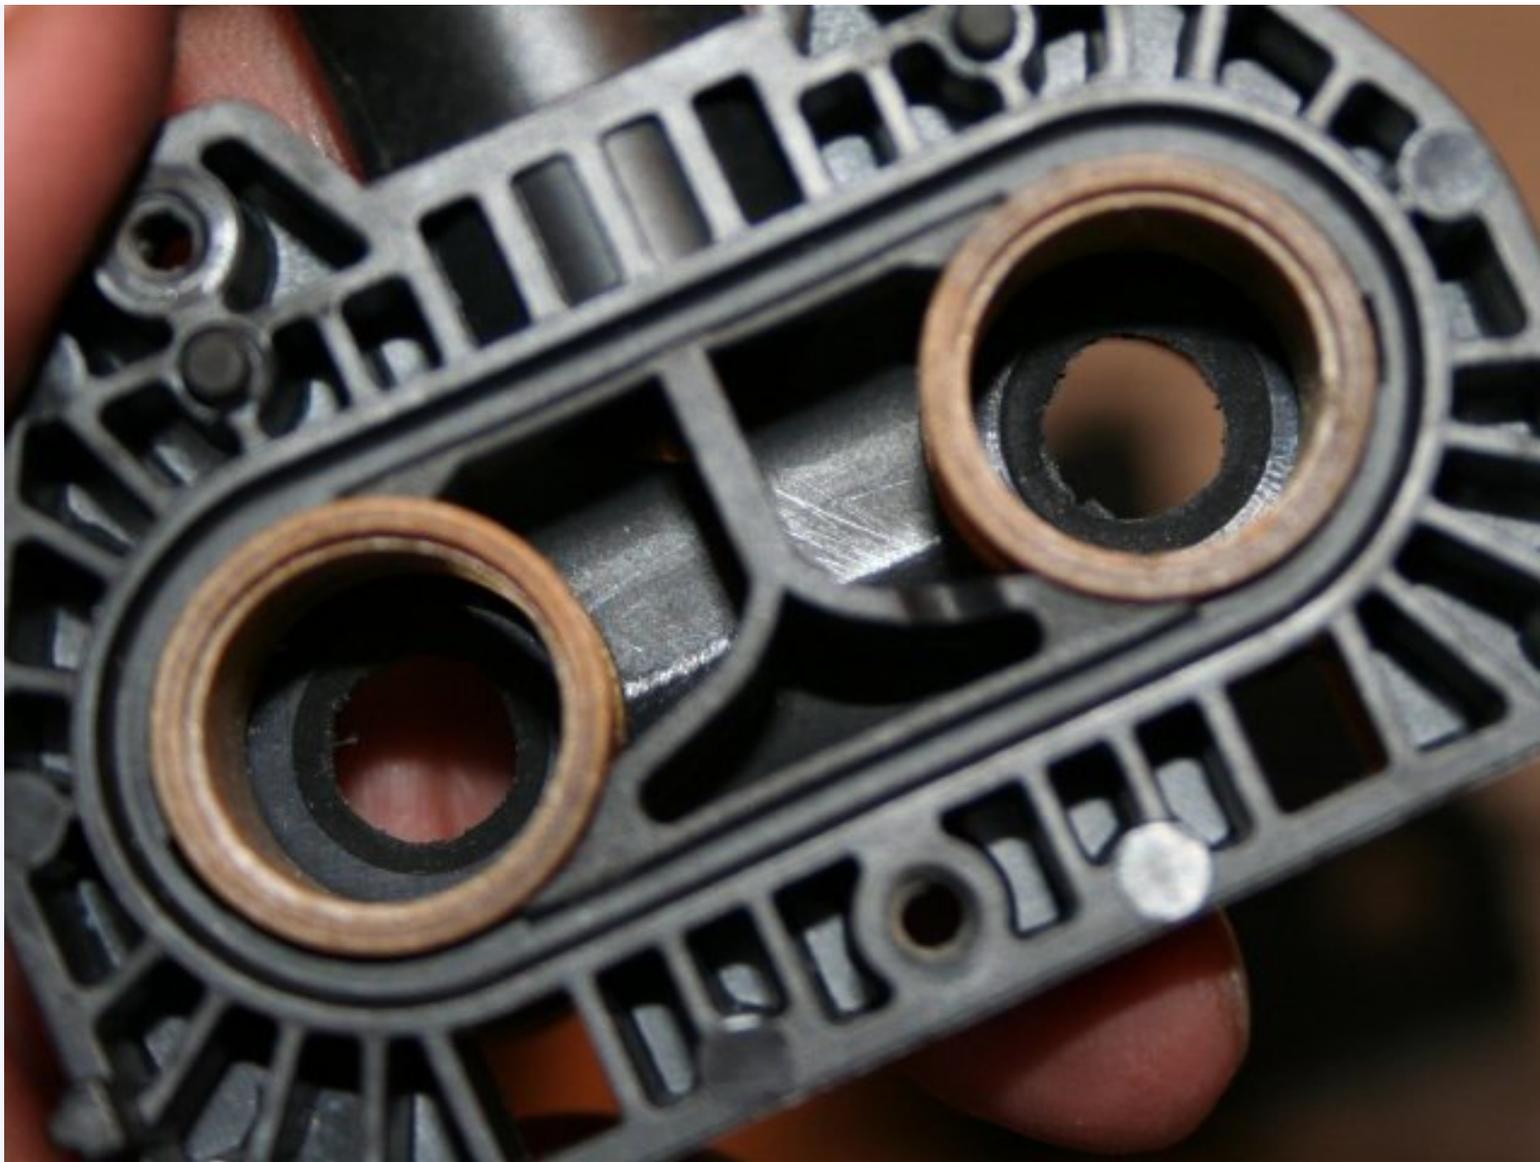
Next, insert one in each side of the bottom half. Press them all the way down then re-insert the brown plastic Cylinders. The cylinders have a shallow "key" in the back that keeps them aligned so insert them carefully and press them down all the way. When installed correctly, they will not be quite flush with the top surface of the valve body. When you're finished, it should look like this:

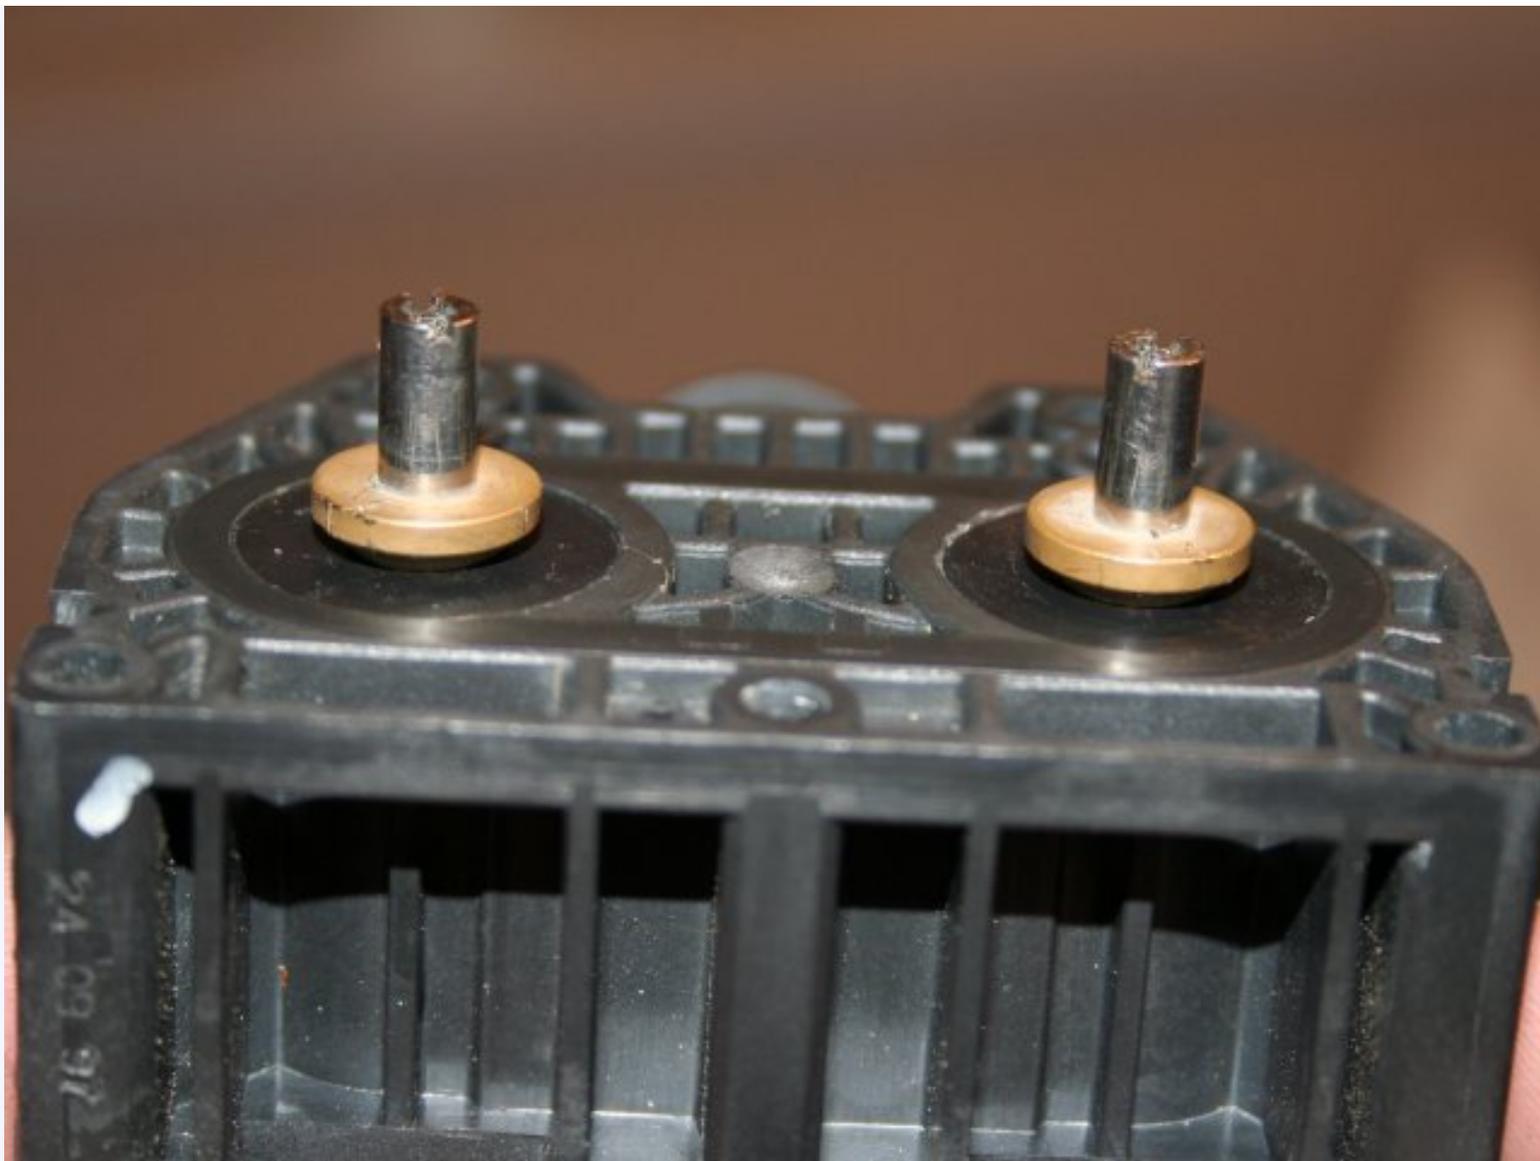
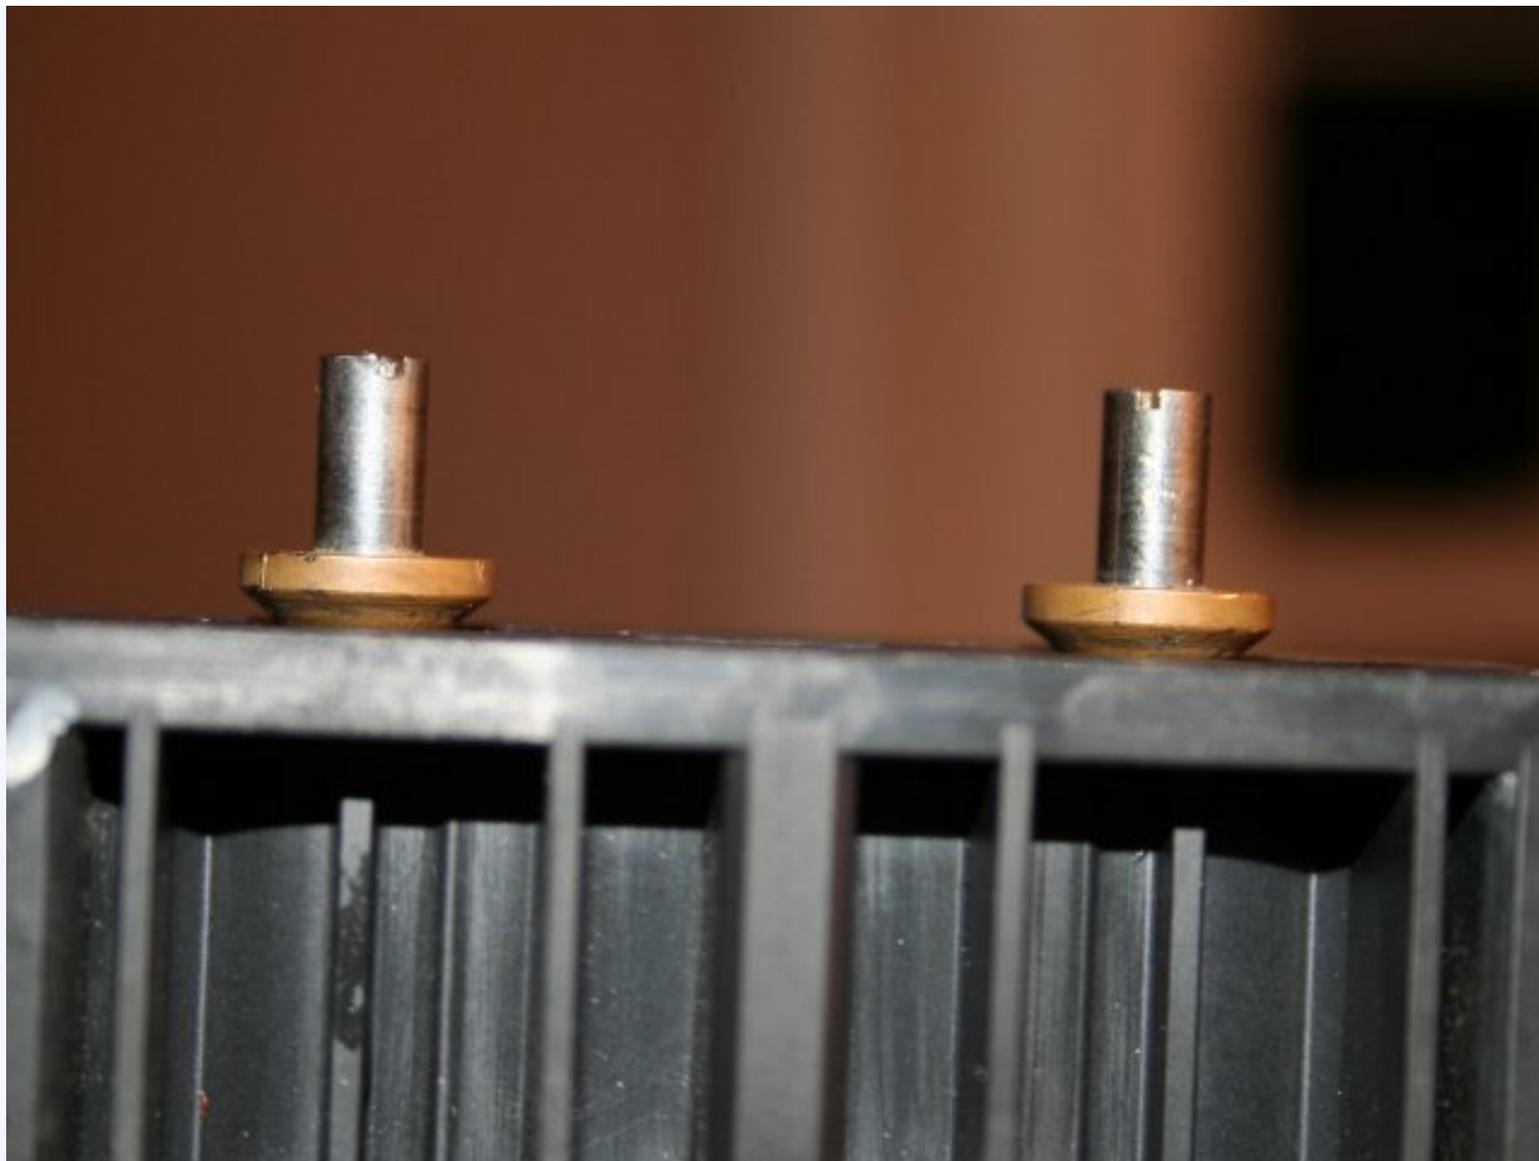
On the top half, first take one of the oval shaped O-rings and place it in the groove on the top side of the valve body. Then slide the silver plate and valve control rods back in. With one hand, press on the valve control rods (the side with the silver cylinders) and compress the springs fully. This will allow you to work the new rubber seals over the brass parts and into place in the valve body with the other hand. This part is a bit of a struggle but it's not too bad. Be careful to avoid bending the control rods. They should look like the photo below when you're done. Note that the brass parts stick up just a bit above the surface of the valve body. This is critical to the proper operation of the valve.

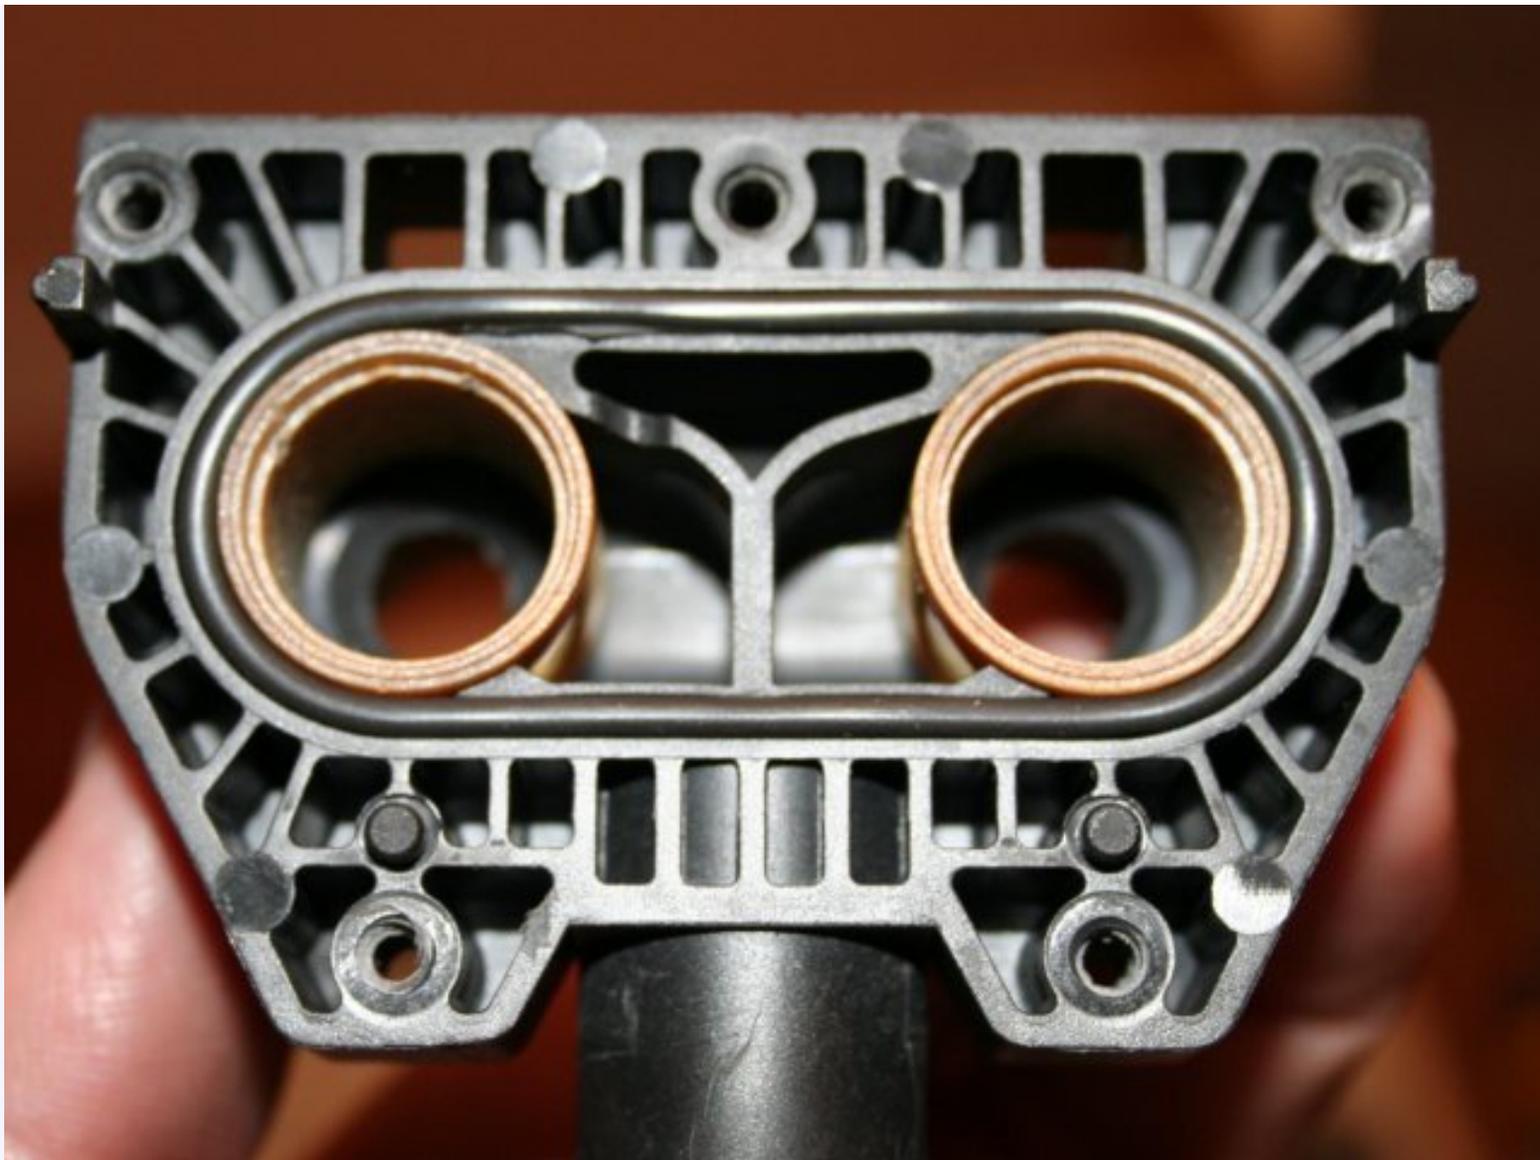
Finally, place the remaining oval O-ring on the opposite half of the valve body.

Return the loose umbrella shaped poppets to their position in the ends of the valve control rods and then slide the two halves together. There are two additional O-rings on the top side of the assembly for sealing the electromagnetic coils. Make sure they are in place then slide the coil assembly back onto the valve body. While holding it all together with one hand, insert and tighten the 5 T-10 screws singly. When assembly is completed, you should be able to shake the valve back and forth and hear it rattle.

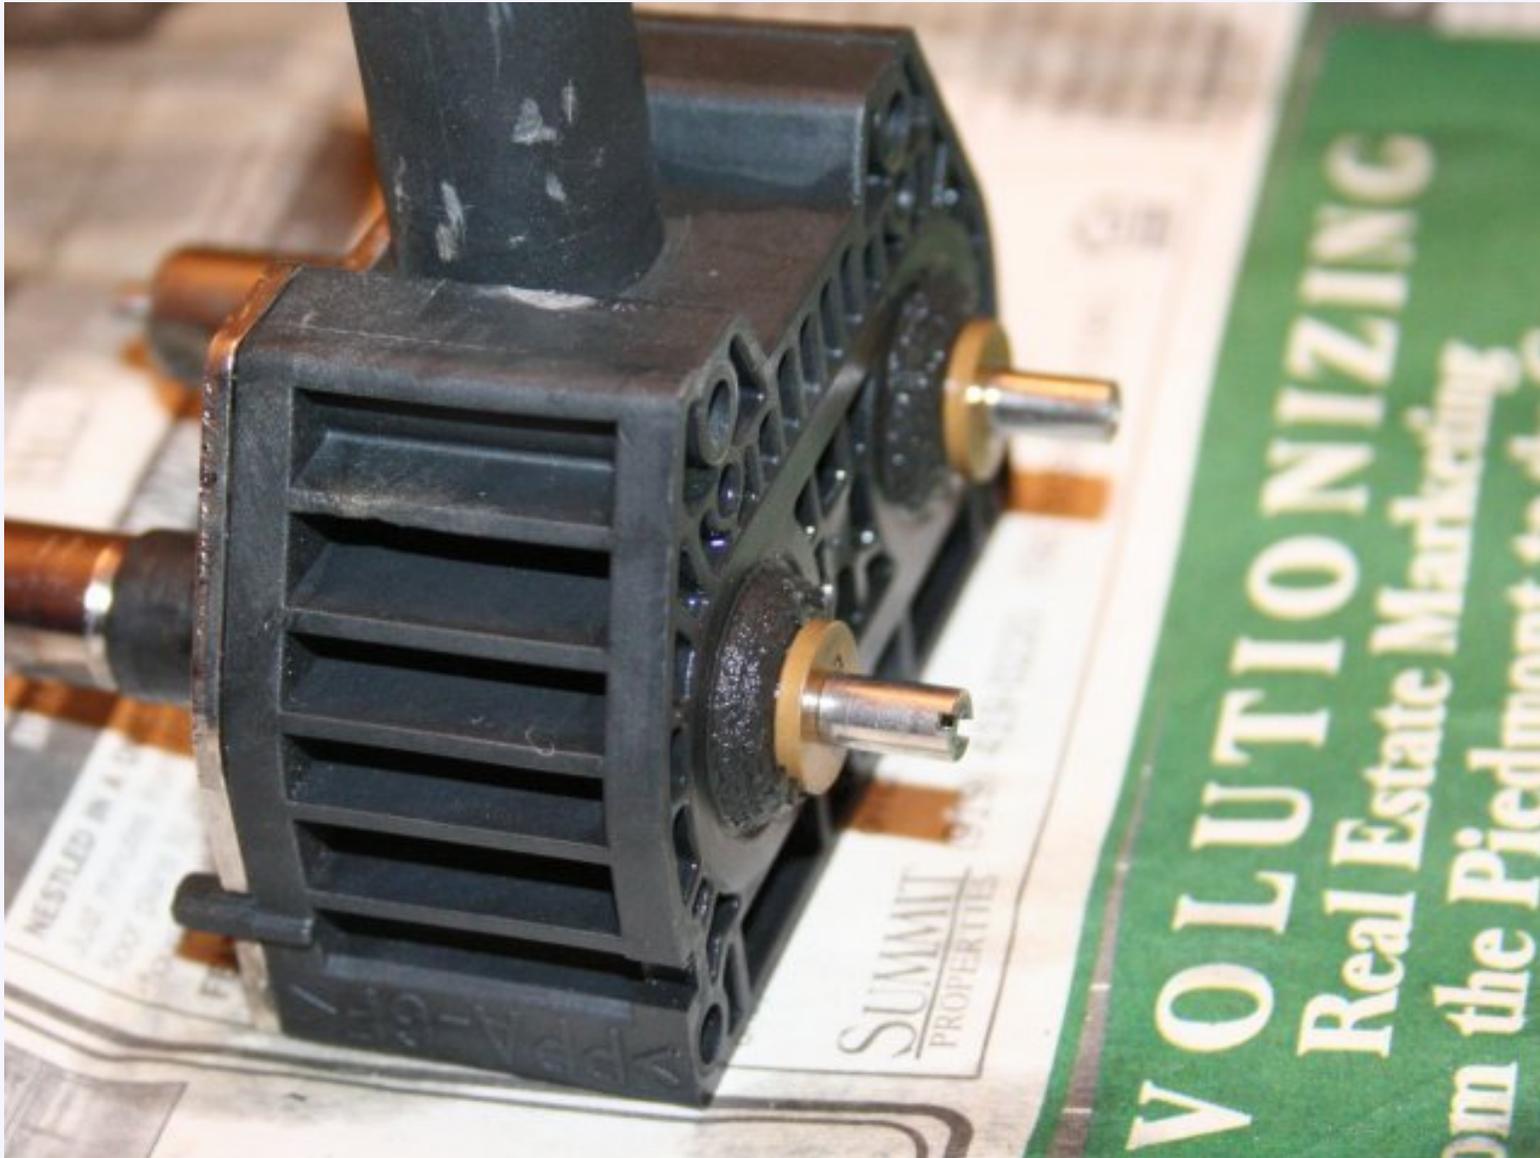
I actually ended up rehabbing my valve using parts from a valve off an E320 so was able to compare them side by side. Basically, the E420/E300 valve has an extra layer... which is pretty much this section from previous photos...

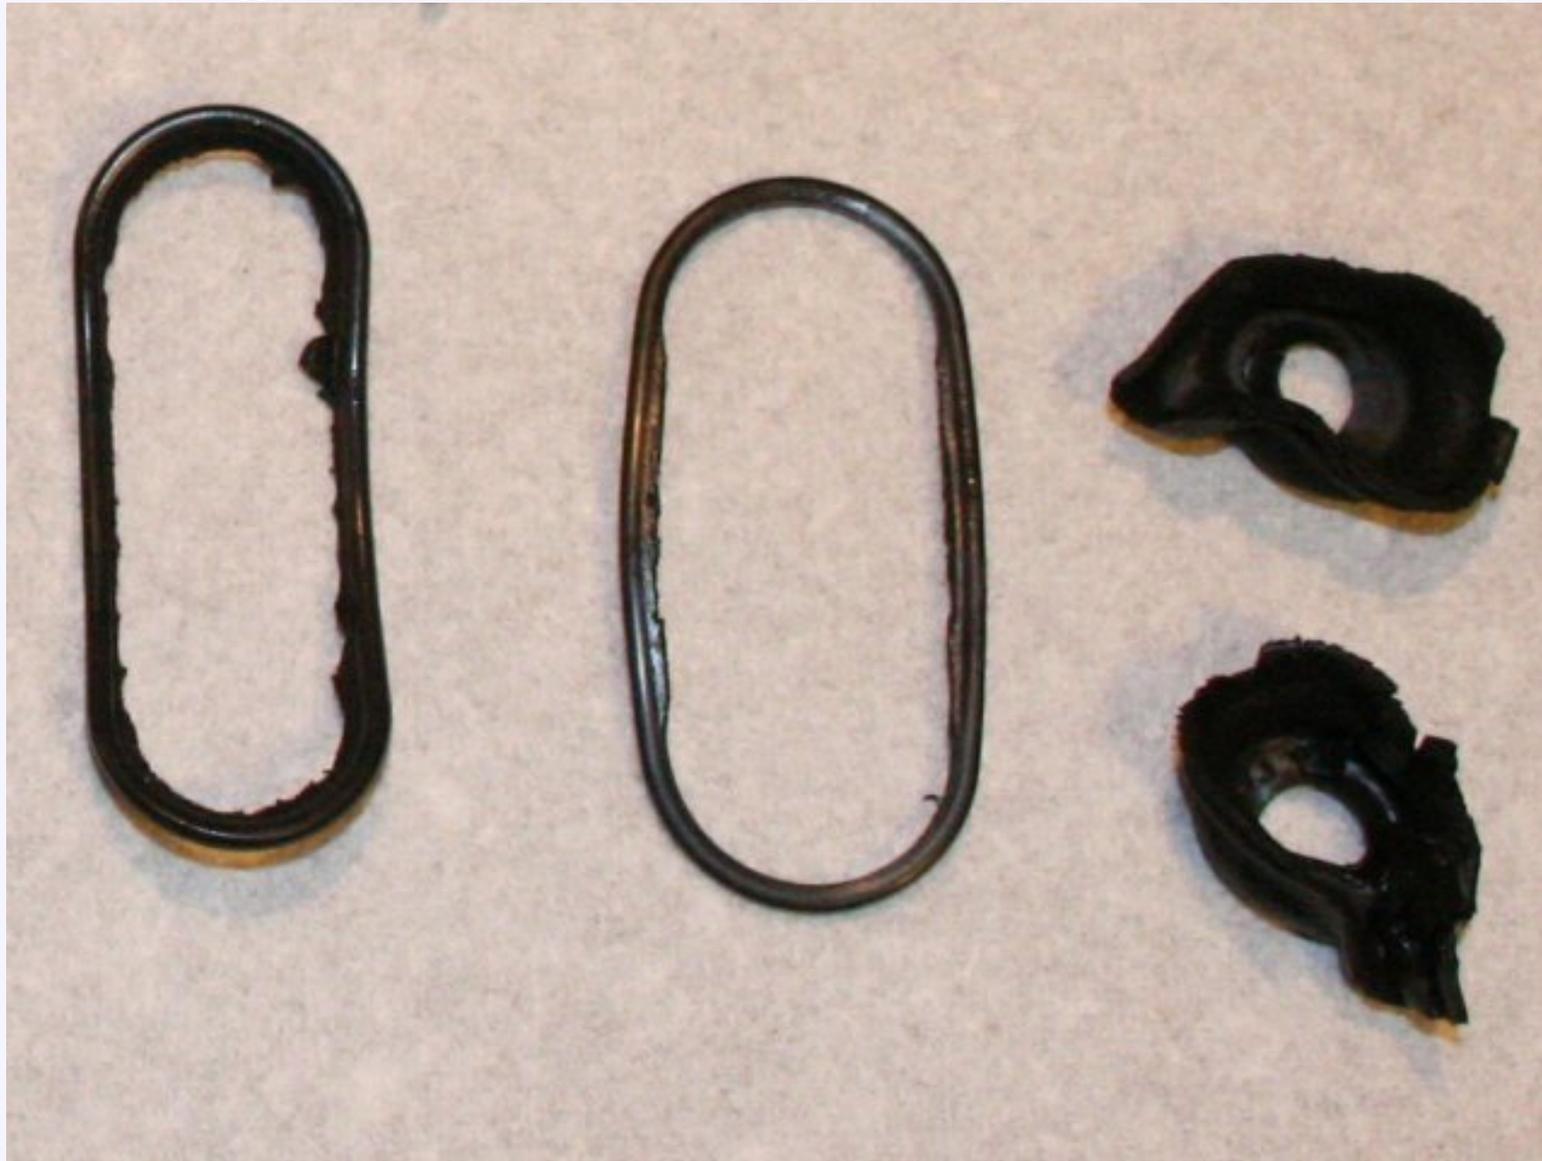
I believe the biggest issue with my valve was the degraded O ring... this part...

The center section from that seal was all gummed up inside the valve. Probably would have had a pretty good chance of the valve working right just by cleaning up/trimming the center section as outlined in the instructions (and also removing the tattered bits, of course). I was able to scavenge a similar seal off the surplus E320 valve I found.

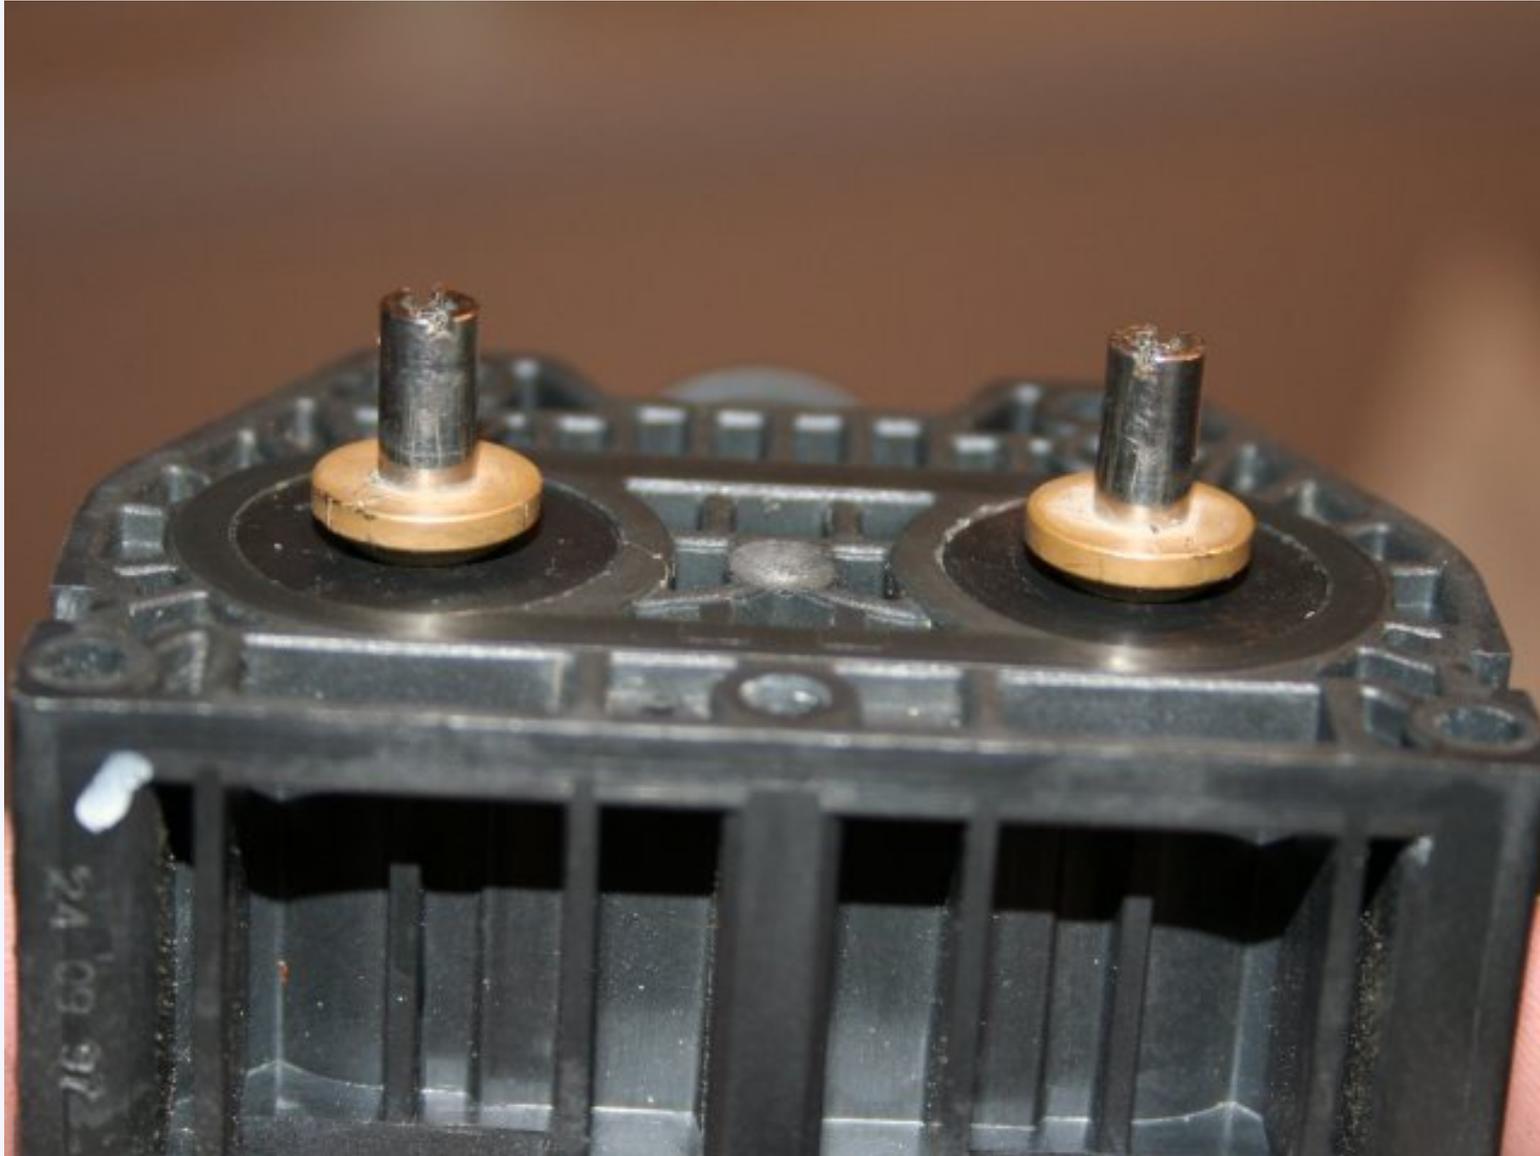
Sounds like you either didn't get the electrical connector secured properly or you didn't ensure that the valve poppets were positioned exactly like the ones in the earlier picture.

It's critical that they sit up just like the picture because there's a balance in the distance between open and closed. The balance ensures that the valve can direct water either of two ways. If the balance is disrupted, the valve will be biased towards too cold or too hot.
