7G-TRONIC (722.9) in the Workshop Tips and Tricks

Service Information Brochure

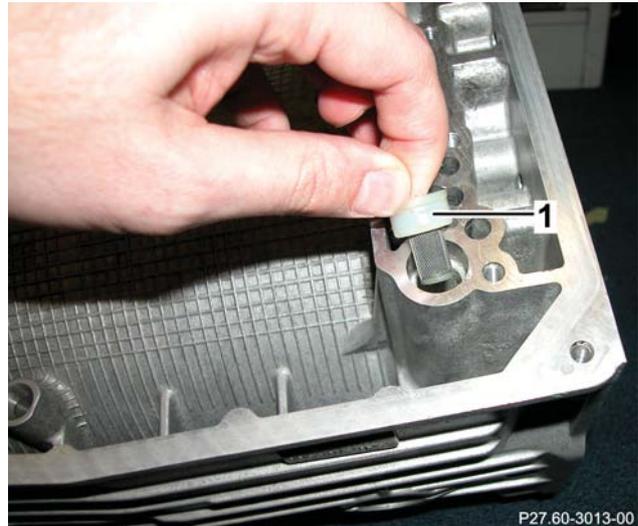
1 Converter return flow strainer
Electrohydraulic controller unit removed, front of transmission housing, on left in direction of travel

- 1 Unscrew bolt
- 2 Remove tension spring
- 3 Remove both valves (torque converter lockup clutch valve and working pressure control valve)
- 4 Carefully remove particles from fine-mesh filter using a cloth
- 5 Insert valves
- 6 Insert tension spring
- 7 Tighten bolt to 9 Nm

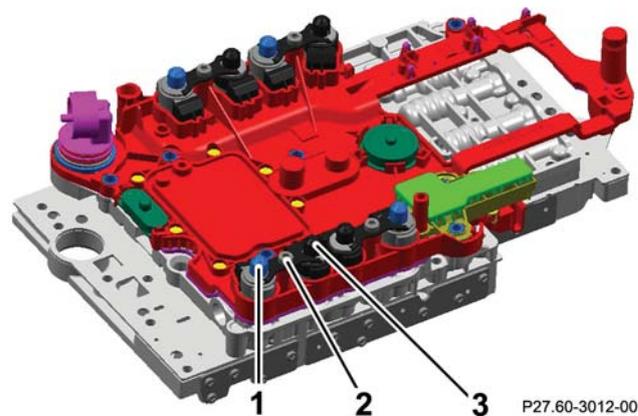
1 Torque converter lockup clutch valve
2 Bolt
3 Working pressure control valve
Clean torque converter lockup clutch valve and working pressure control valve

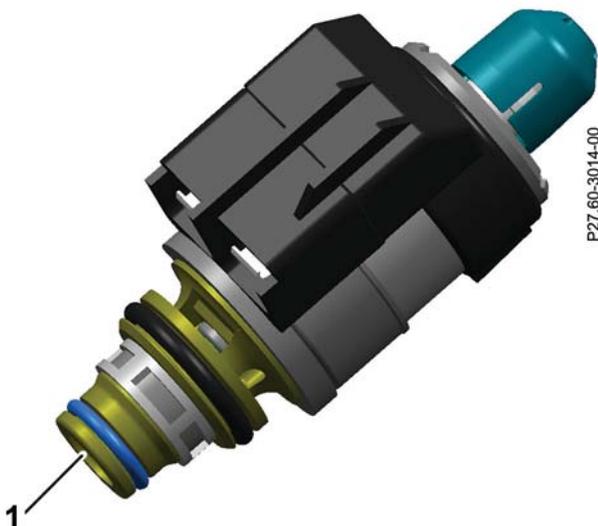
Valve

- 1 Fine-mesh filter

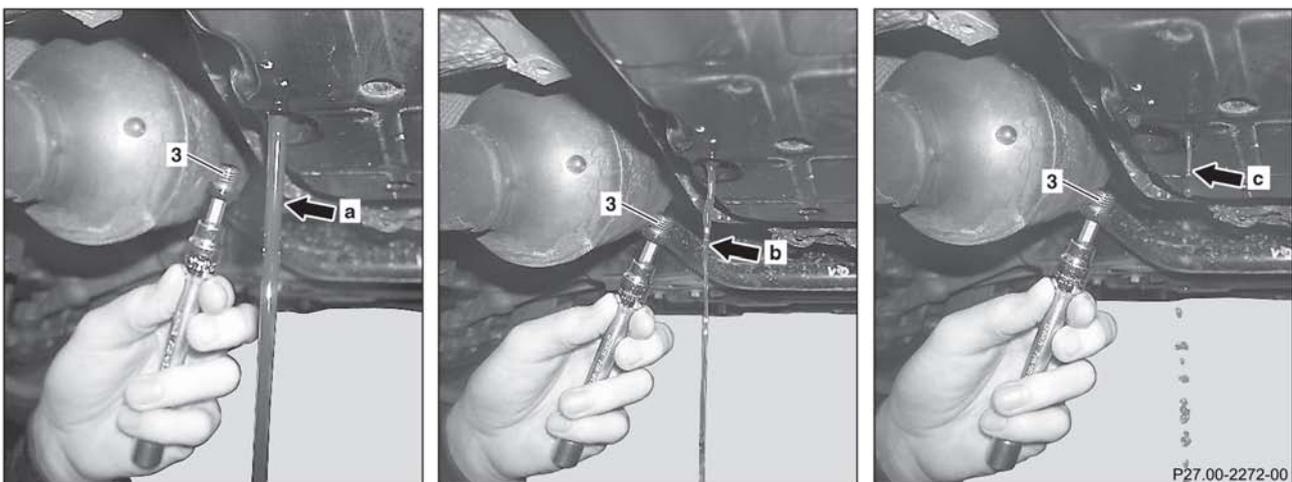
The transmission oil level is then adjusted to the center of the tolerance range. If the oil level was previously at the OK level on the drawing, it is possible that only 0.1-0.2 l of transmission oil was added. In this case, the transmission was **not underfilled** previously even though no oil ran out.

If more than 0.3 l of oil is required to reach the state indicated by arrow b, the oil level was outside the tolerance.

Inspect oil level, adjust to correct level if necessary

- a Transmission oil level is OK with this flow rate
- b Transmission oil level is OK with this flow rate

- c Transmission oil level must be corrected and re-checked with this flow rate
- 3 Oil drain screw
