Mercedes-Benz

service information

REF. NO. 30/11A

SUBJECT: **MODELS 124.034/036 (ENGINE 119.974/5)**
ROUTING OF EA/CC/ISC ACTUATOR HARNESS

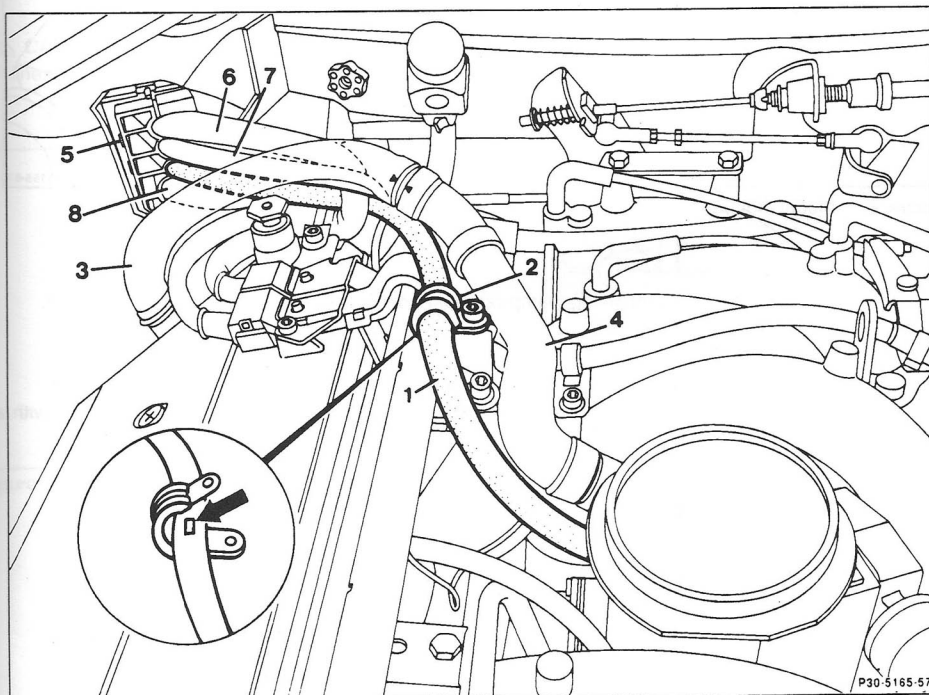
Figure 1 Model 124.036

On model 124.036, the harness (1) must be routed as shown in Figure 1, under the formed hoses for crankcase ventilation (3 and 4) and then through the hinged grommet (5, Figure 1).

The harness (1) as well as the mounting clamp (2) must be installed as depicted in Figure 1 and 2.

The white mark on the actuator harness (arrow) must be positioned inside the mounting clamp (2, Figures 1 and 2). In this case, the familiar mark on the circumference of the harness is replaced with a white rectangle.

Route all electrical harnesses (1, 6, 7, Figure 1) as well as the engine coolant return line for the heater (8, Figure 1) through holes (6, 7, 1, 8, Figure 4) in the hinged grommet (5, Figure 4). Reconnect hinged grommet by pressing together.

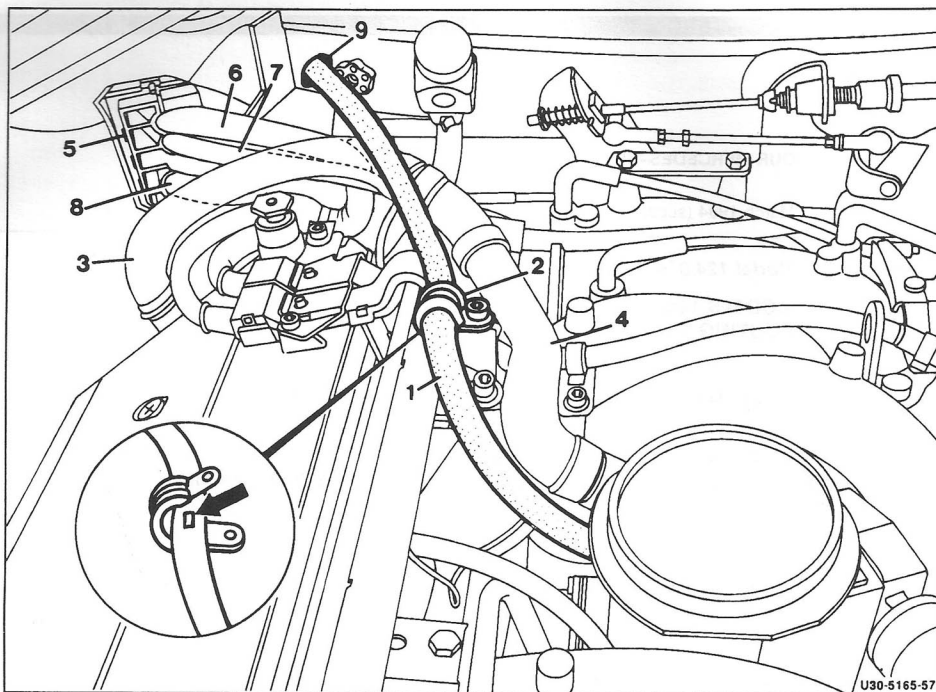
Figure 2 Model 124.034

When installing the air cleaner, ensure that the EA/CC/ISC actuator harness (1, Figures 1 and 2) is not damaged.

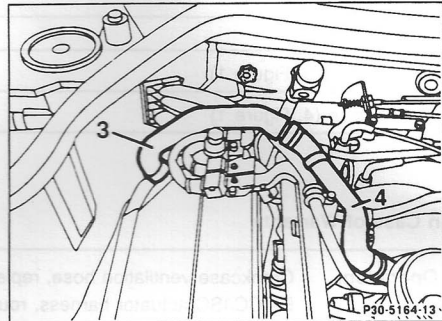
Figure 3

On vehicles up to engine end number 001910, replace formed hoses for crankcase ventilation (3 and 4, Figure 3) and route according to layout shown in Figure 3.

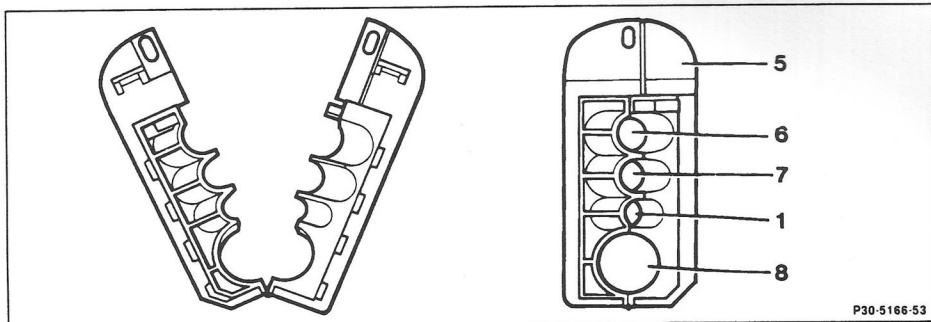
Figure 4

All lines running through the hinged grommet must be positioned in the correct holes (Figure 4).
