05-2218 Replacing threaded bush in front of camshaft

Preceding work:
Camshaft removed (05-2200)

Exhaust camshaft

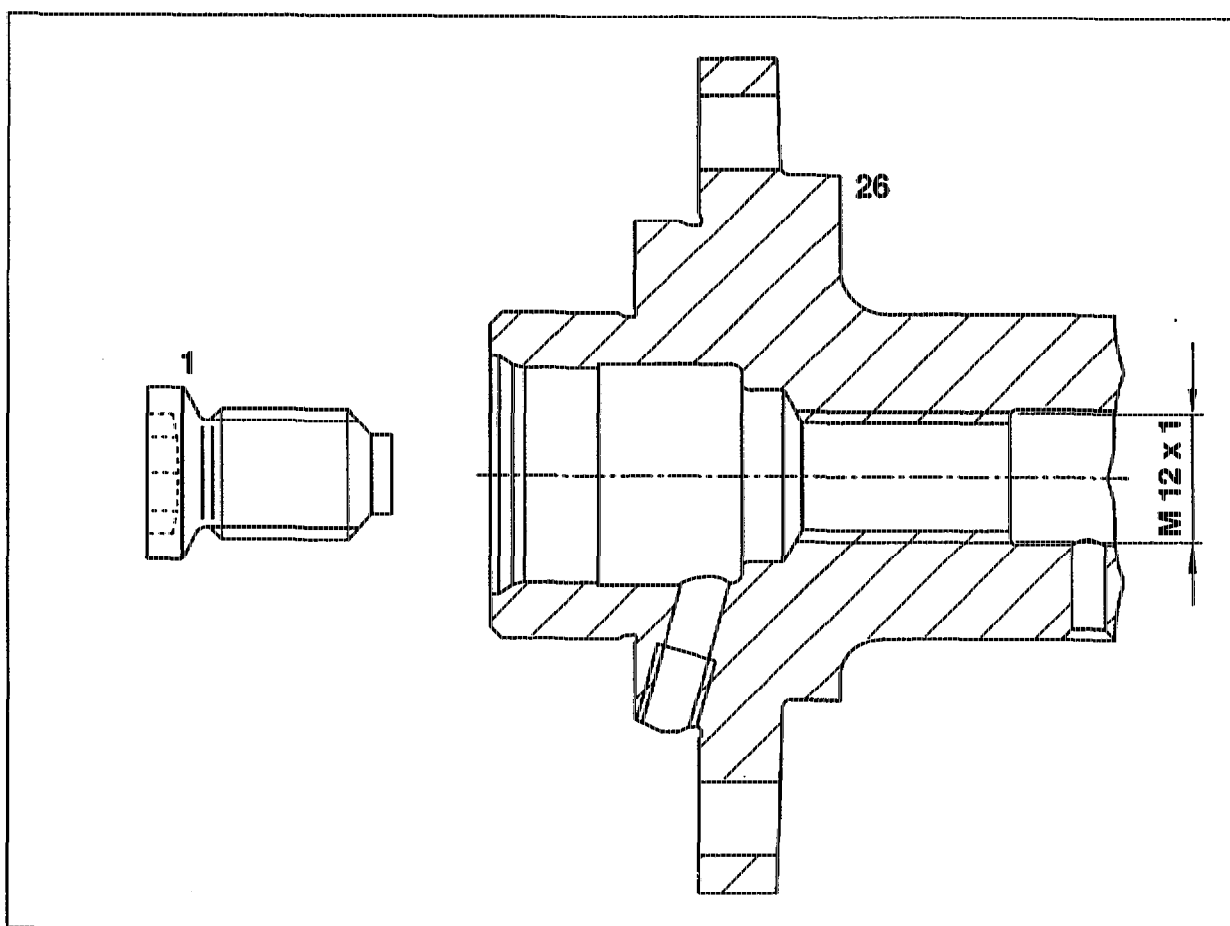
P05.20-0259-57

Threaded bush (1)	unscrew (torx).
Hollow-drilled camshaft (26)	clean.
Thread at front of camshaft (26)	clean, remove grease.
Threaded bush (1) (microencapsulated) part no. 103 997 00 15	replace, tighten (45 Nm).
